Confidential Inspection Report

LOCATED AT:
3000 Sample Road
Buford, Georgia 30519

INSPECTED ON:
Sunday, August 20, 2017

Inspector: Robert Conley ASHI #257097 NACHI #16052017
Conley Home Inspections, LLC
8189 Willow Tree Way, Alpharetta, GA 30005

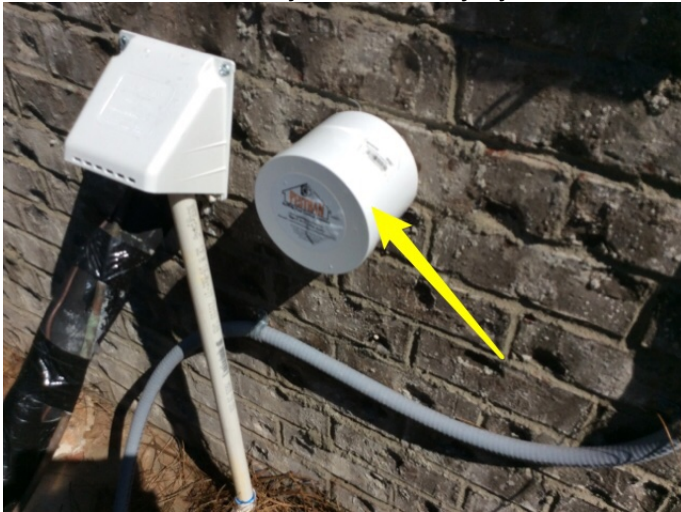
27: - A Pest Control System delivery system was observed on the left side of home.

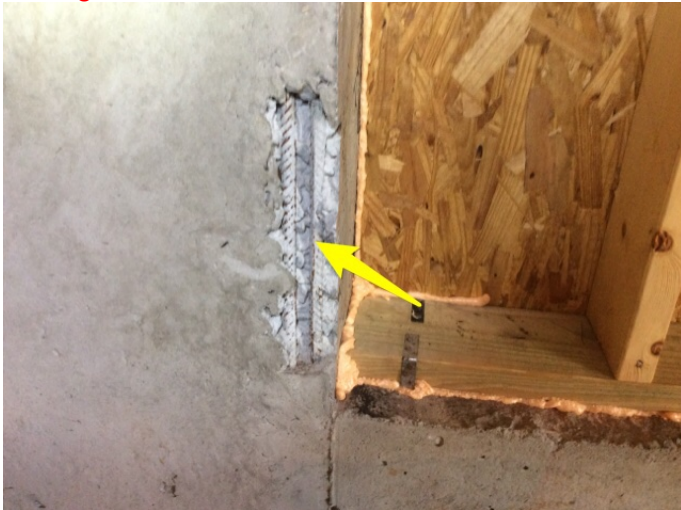
34: - Exposed reinforcing steel was observed at the left side basement foundation wall corner. Recommend the corner be filled and patched to protect the interior reinforcing steel from exposure and subsequent rust damage.

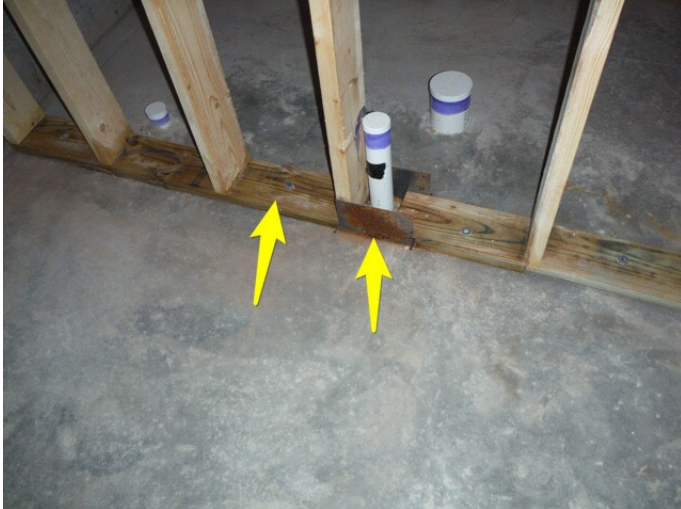
MO 35: - There were dry water stains found on the basement left side floor and sill plate from a past water event. Floor insulation was missing above this area where plumbing pipes were located and that may have had a leak. However, no leaking was observed at the time of the inspection, recommend monitoring.

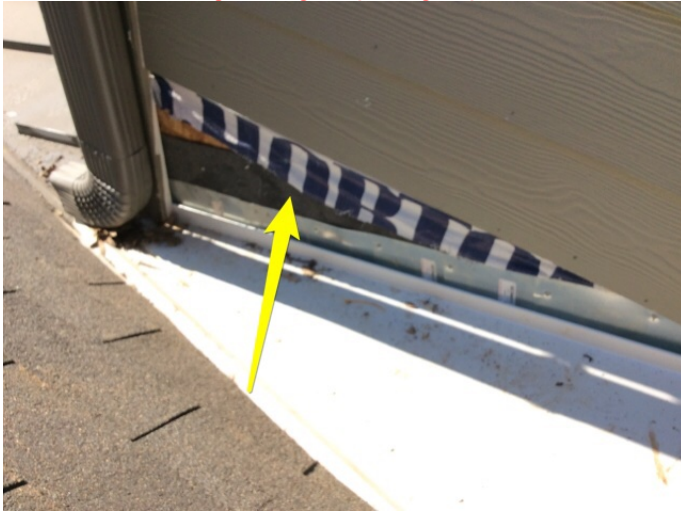
RE 40: - Missing siding requiring replacement was observed at the right side dead valley.

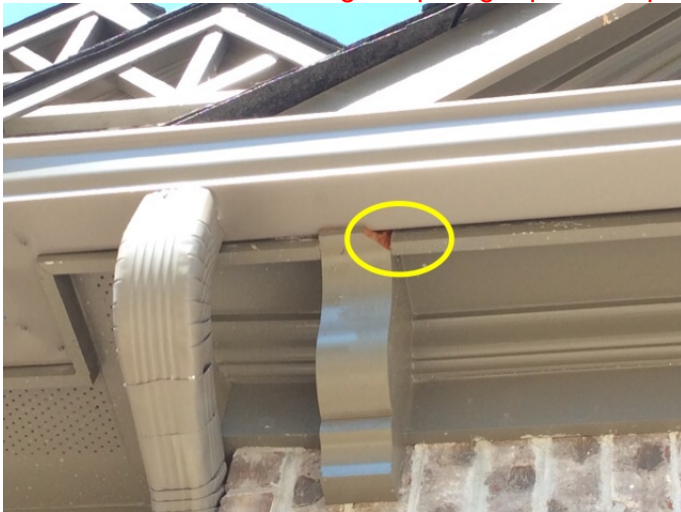
RE 42: - Minor trim damage requiring repair or replacement was observed about the left garage.

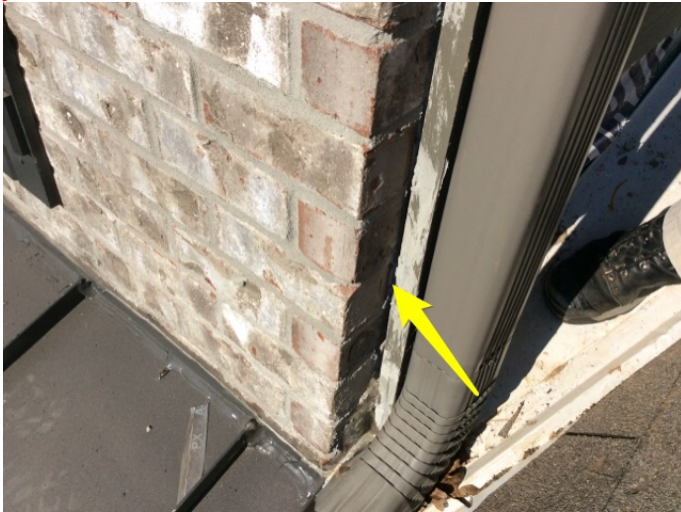
MA RE 43: - Unsealed caulking gaps were observed at the following locations including; front right corner above front porch metal roof, around all exterior light fixture mounting bases, trim/brick junction rear left corner and trim/concrete foundation step downs, rear right corner siding and trim/brick junctions, right rear corner trim/brick junction full height, around right side main electrical panel, right side soffit end/brick junction, around vent termination covers right and left sides, around all window trim/brick junctions at (right side 1, left side 2, front 4), at trim/brick junction front right corner, around both garage door openings trim/brick junctions, around front porch column base trim/stone junctions, at front left window bump out right and left sides trim/brick junction, around left side electrical disconnect box, A/C pipe set cover, and pest delivery location.

front right corner above front porch metal roof

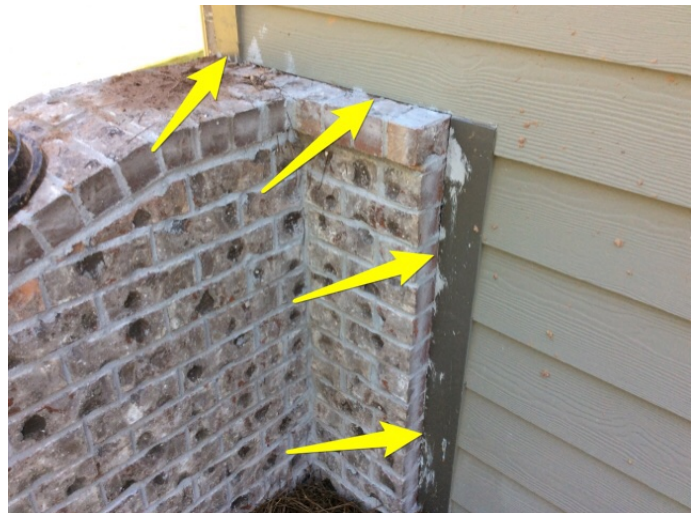
trim/brick junction rear left corner and trim/concrete foundation...

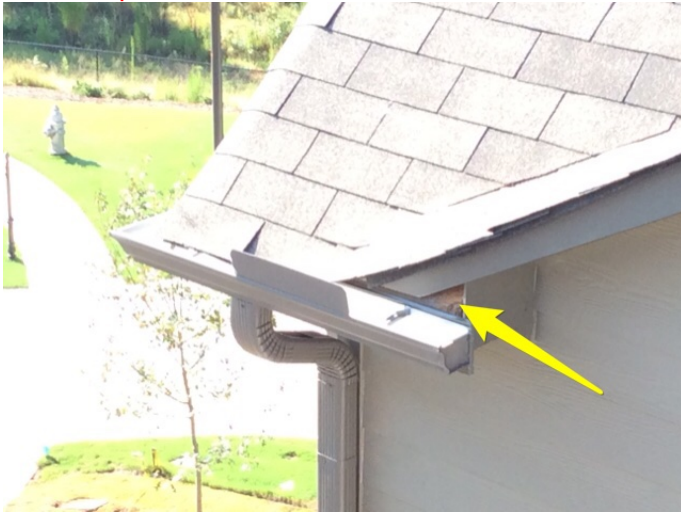
RE 44: - A small section of missing trim requiring correction was observed at the right side rake return above the front porch.

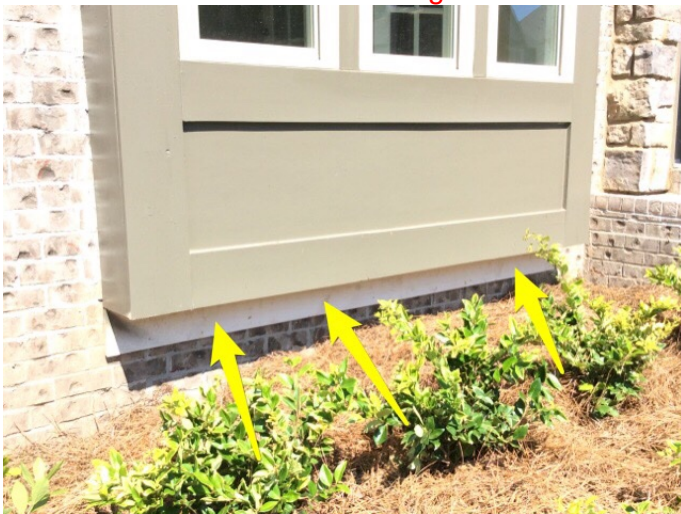
RE 45: - Paint was found missing at the trim board below the front left window bump-out.

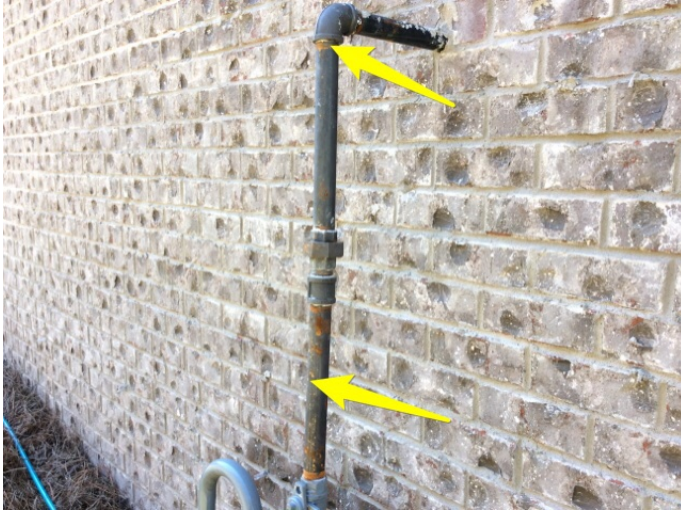
RE 46: - A rusting/corroding gas main pipe requiring rust inhibiting paint was observed at the right side of the home.

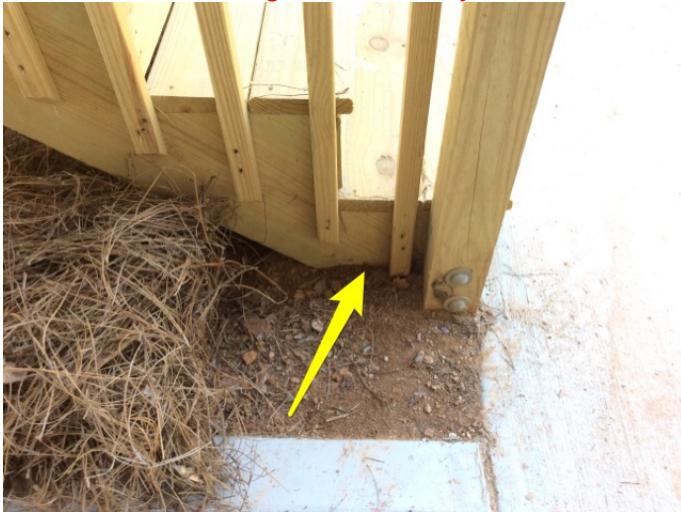
RE 47: - Earth to wood contact was observed at the bottom left and right of the rear stair framing (stringers) creating a condition conducive to moisture damage and termite activity. Recommend removal of soil and pour concrete below stringers where they are close to the ground.

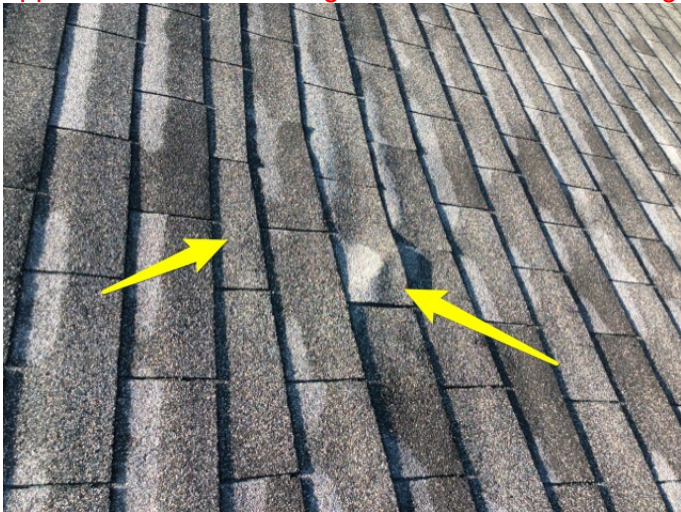
RE 57: - A rippled/puckered roof shingle requiring correction was observed at the rear left main roof area. It appears the rows of shingles above became misaligned and caused the issue.

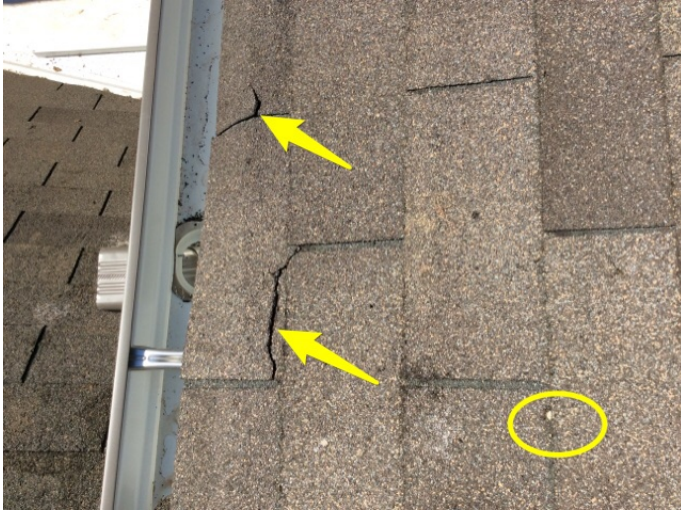
RE 58: - Two cracked roof shingles requiring replacement were observed at the right side front roof near the gutter just above the dead valley. Also, an exposed nail requiring sealant was observed.

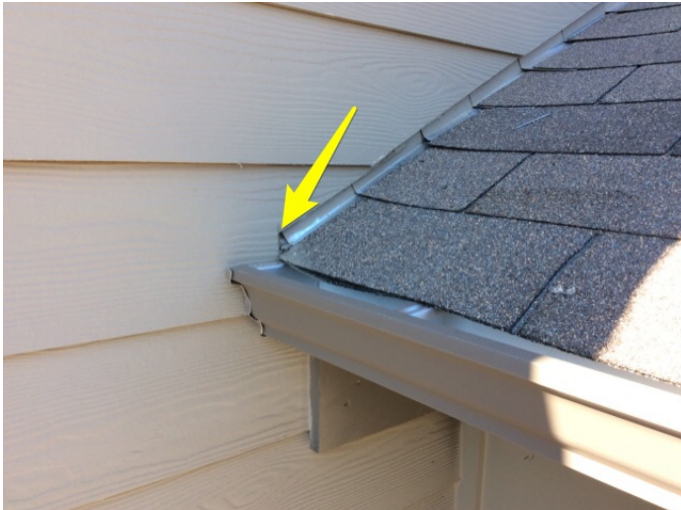
RE 60: - Kick-out flashing was not visibly installed at the roof/wall termination front right side wall and requires correction.

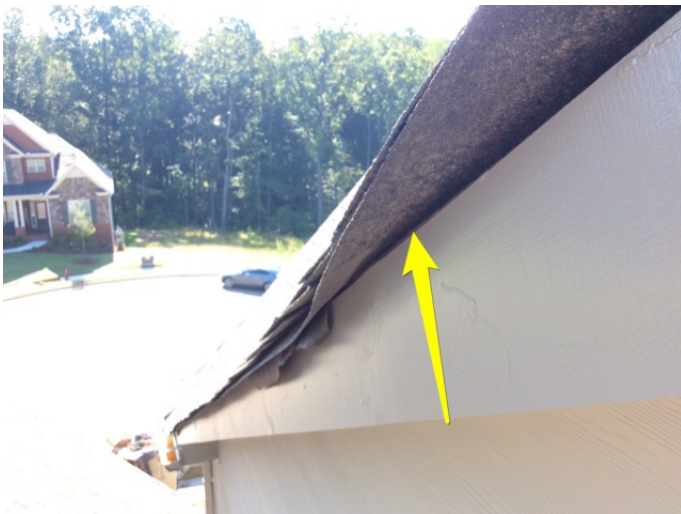
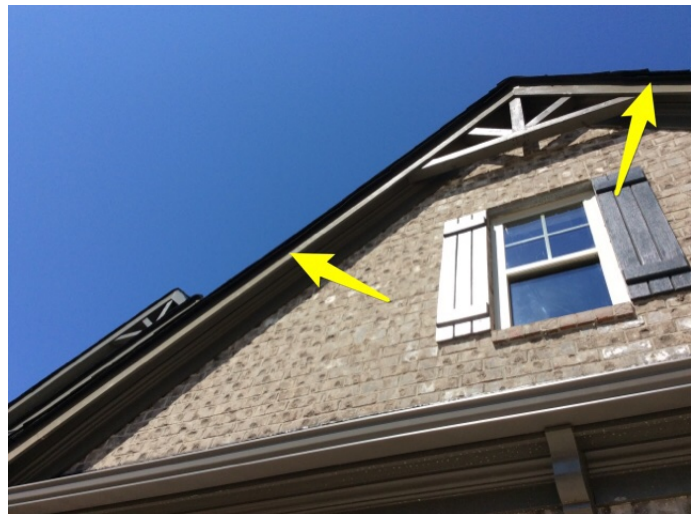
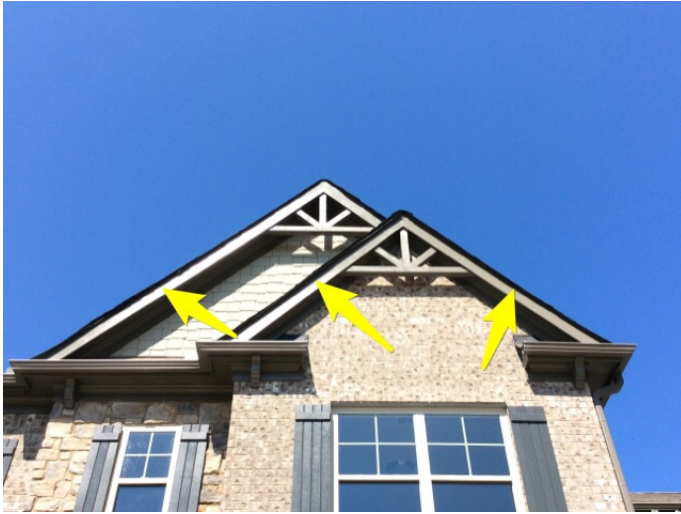
RE 61: - Drip edge flashing was not visibly installed at the rakes and of the home right side above roof and at 3 front gables of the home. This has caused shingle overhang to exceed the standard 1" maximum and shingles to bend over the rake edges. Recommend drip edge flashing is installed in accordance with industry standards as of 2014.

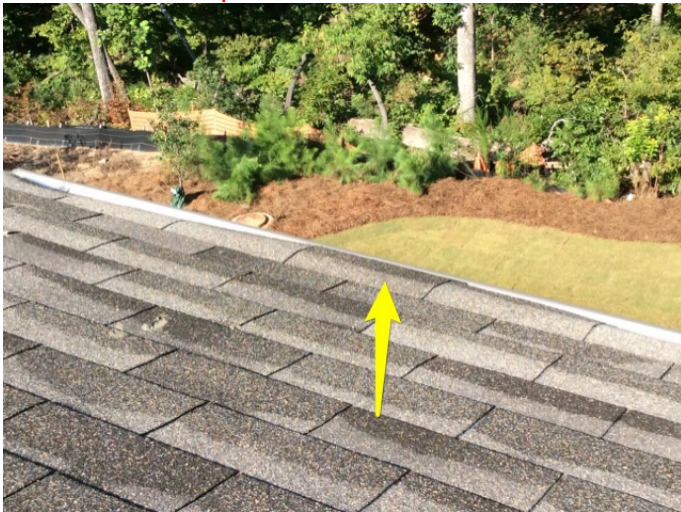
62: - Lifted drip edge flashing causing raised shingles was observed at the rear of home eaves in several locations and requires correction.

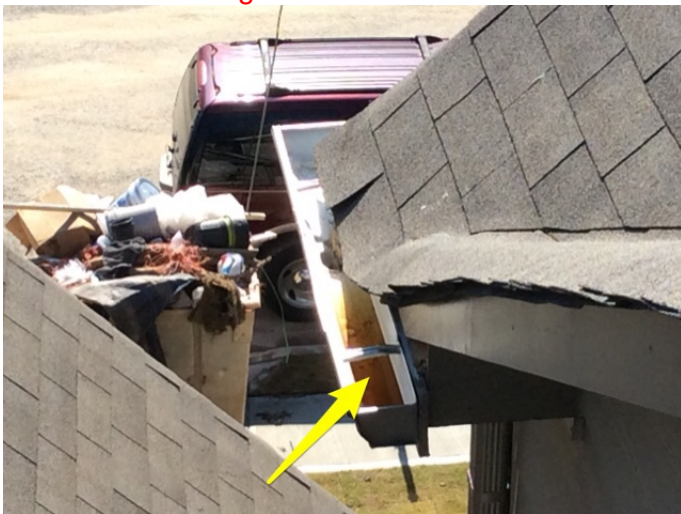
RE 65: - A short section of roof gutter was found holding water due to an improper slope and requires correction at the right front corner of the home.

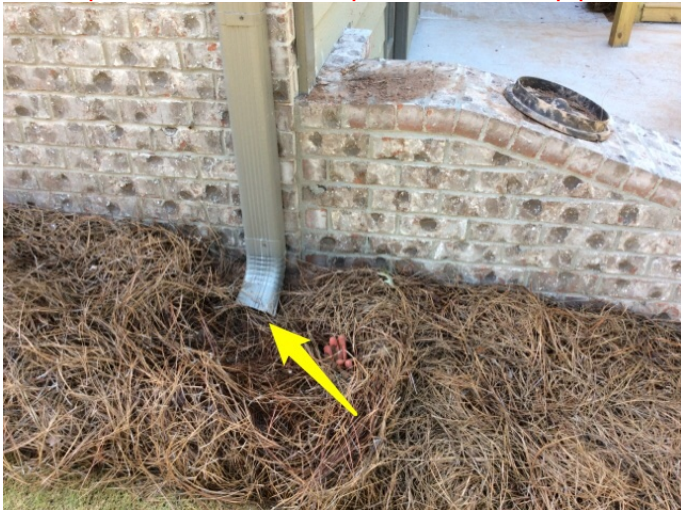
RE 66: - Splash blocks to direct water away from the foundation were not visible at the base of every downspout. Recommend splash blocks or pipe extensions are installed for every downspout.

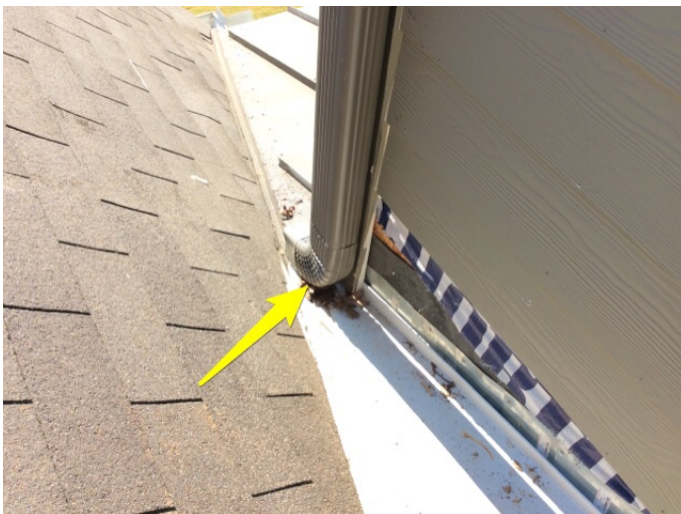
RE 67: - The gutter downspout to the right of the front porch was found installed too low and is blocking debris coming down the roof dead valley. This can eventually cause decay to the trim/siding and water infiltration into the home. Recommend raising the downspout 4 to 6 inches to allow free flow of water and debris.

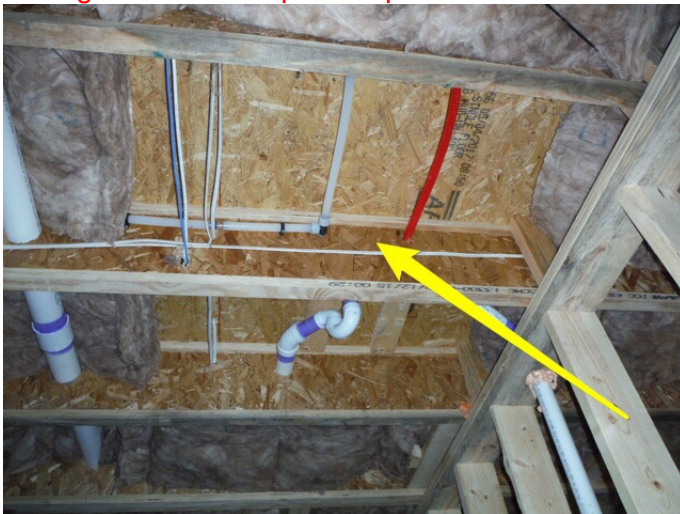
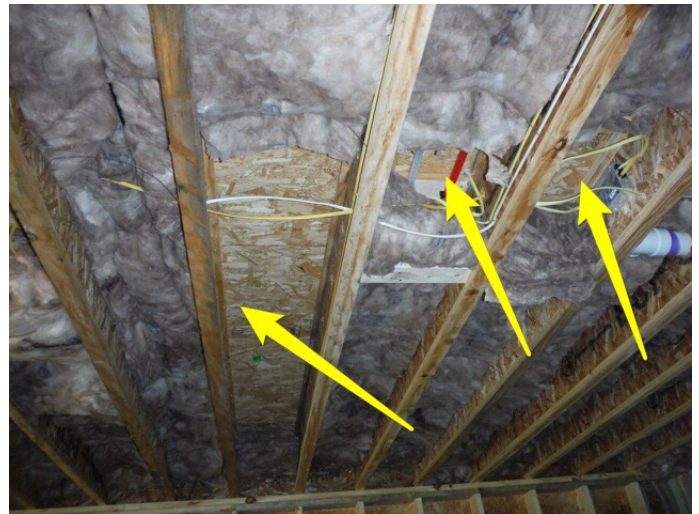
RE 77: - Fiberglass batts insulation has been removed or fallen out of place in the basement ceiling left side and right side and requires replacement.

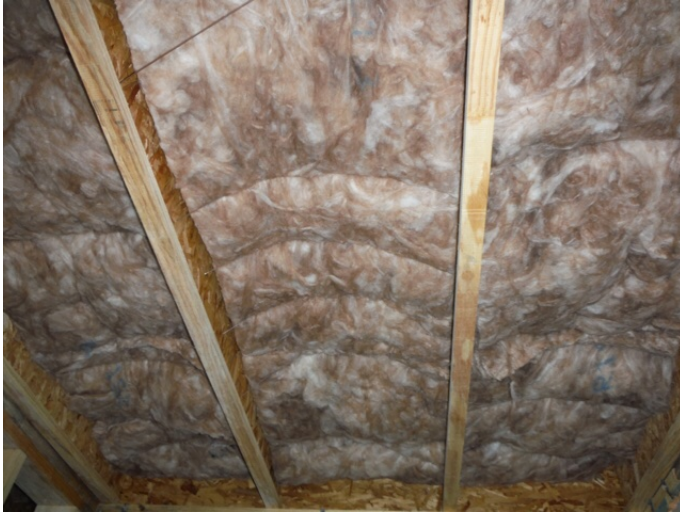
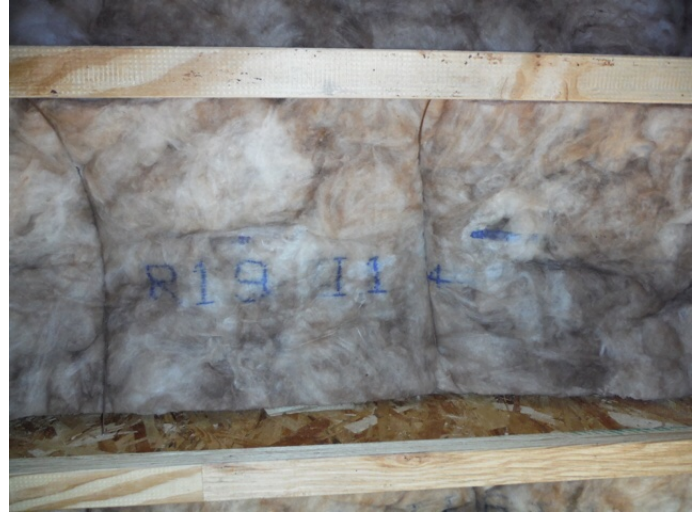
MO 78: - The Buyer made the inspector aware that most if not all the basement floor insulation was saturated with rain water prior to the installation of the roof shingles. The inspector spot checked a few areas in each room of the basement, but found no; damaged insulation, compressed insulation, trapped dirt, trapped moisture or mold growth. Although not ideal, fiberglass insulation can get wet without damaging it as long as the water was not dirty or contaminated and it did not cause the insulation to get compressed. Recommend monitoring insulation over time.

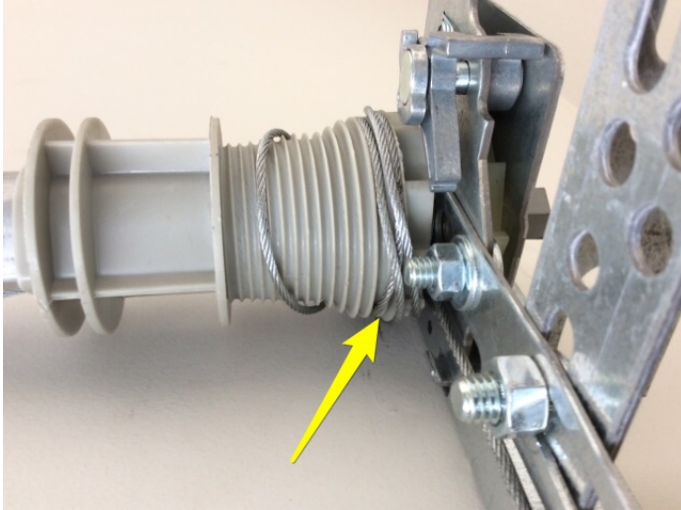
RE 96: - The left side garage door spring cable was found tangled around the spring spool preventing proper operation of the garage door and requires correction.

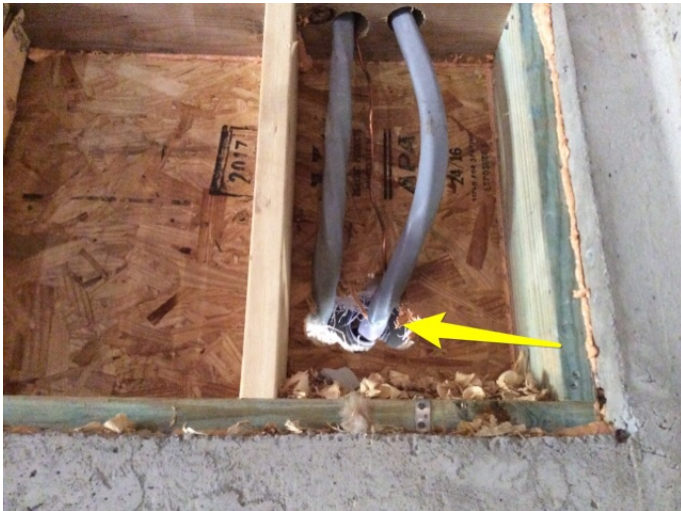
RE 109: - Unsealed openings around the electrical service cables requiring correction were found at the right side basement wall.

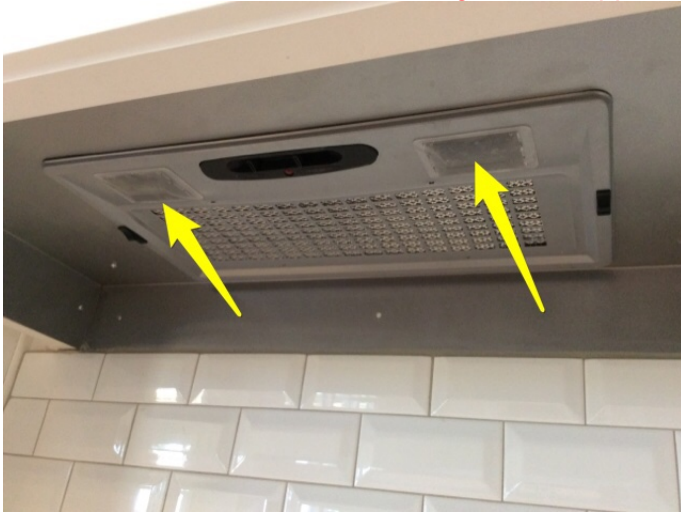
MA 125: - The kitchen vent hood light bulbs appeared to be burned out and need replacing/installing.

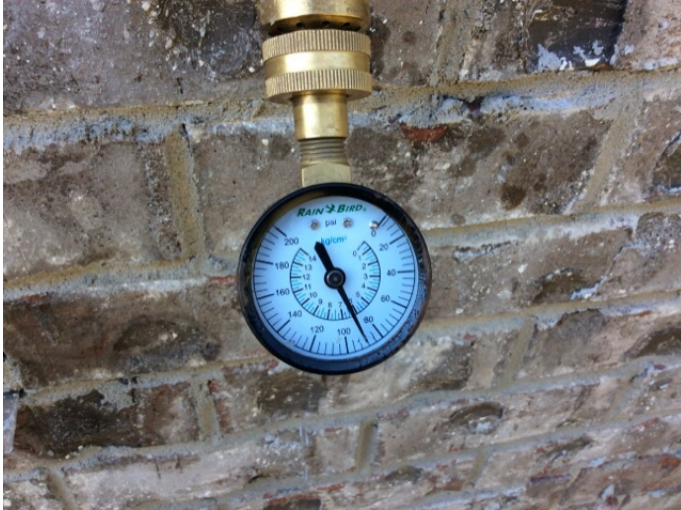
RE 142: - The system water pressure of approximately 90 psi exceeds the standard range of 40 to 80 psi, as measured at the two exterior hose bibb spigots. This can result in unnecessary leakage and damage to plumbing system valves, seats and washers. Recommend that the pressure reduction valve be adjusted or replaced if necessary by a qualified licensed plumbing contractor.

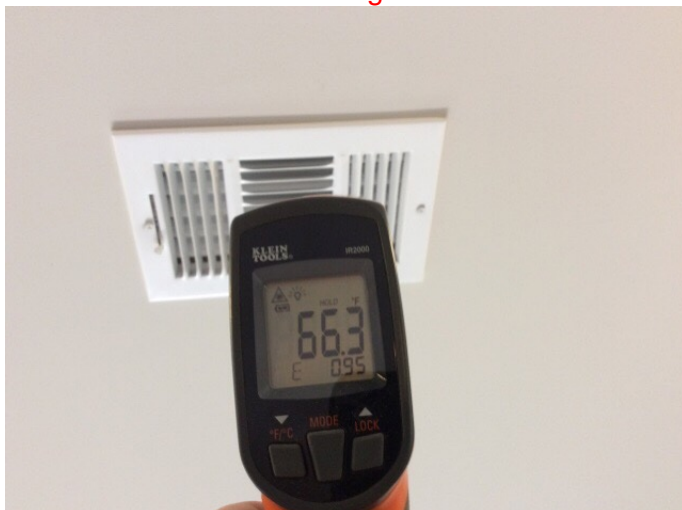
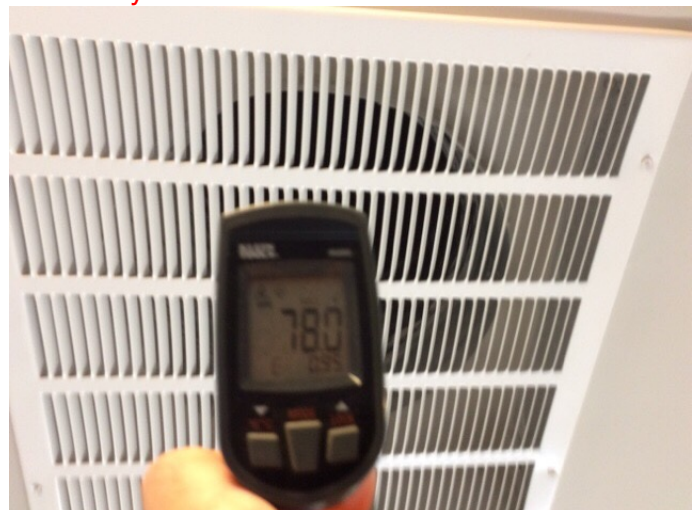
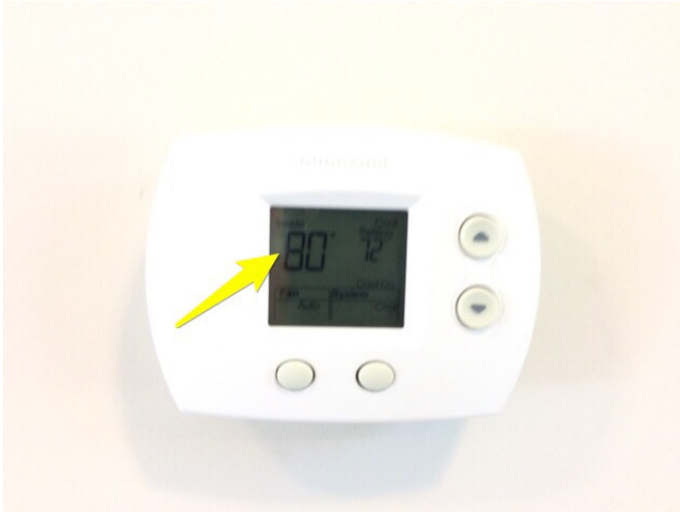
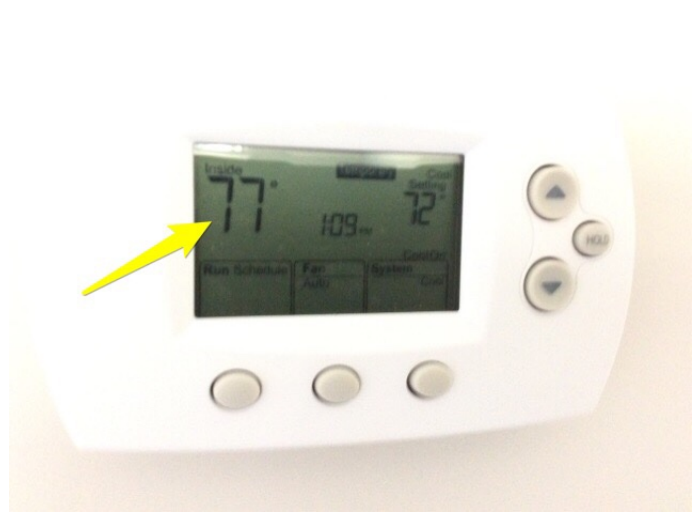
RE 171: - The A/C cooling system temperature differential of approximately 12°F was observed to be below the cooling standard of 13 to 20 degrees when tested with normal operating controls. The A/C ran for 3 hours and never brought the upstairs below 77°F and the downstairs below 80°F. Recommend a licensed HVAC contractor check refrigerant levels and make any necessary corrections.

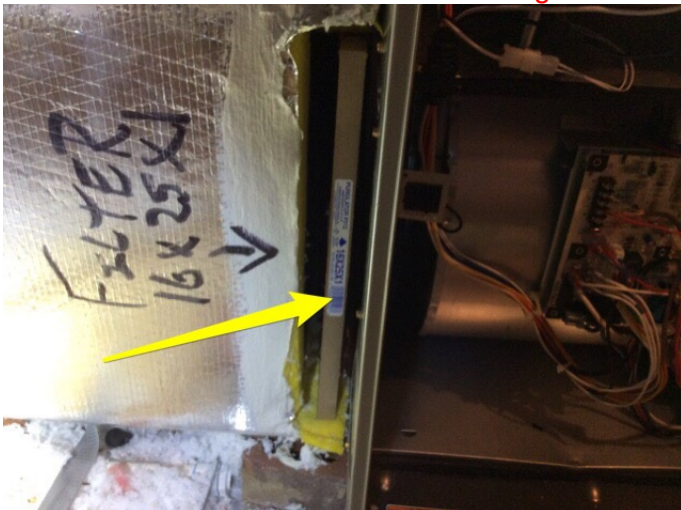
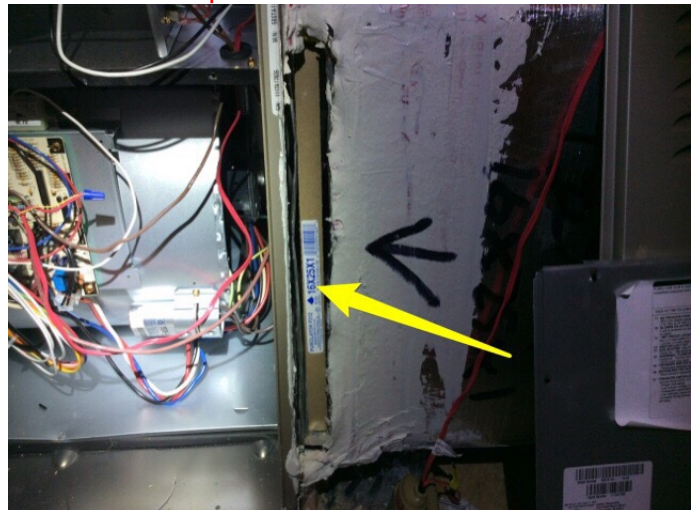
RE 184: - The furnace was found missing two filter door covers and requires correction/installation.

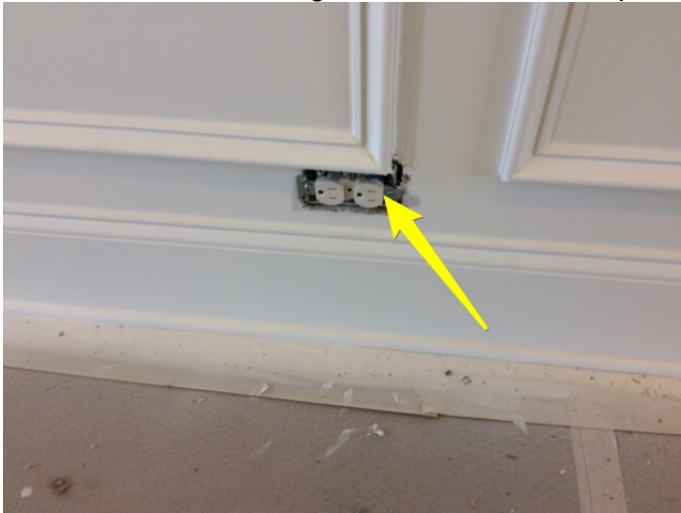
MA SA 203: - A missing electrical outlet cover plate was observed in the foyer and needs replacement.
