# Confidential Inspection Report

LOCATED AT:  
4000 Sample Ridge Lane  
Cumming, Georgia 30028

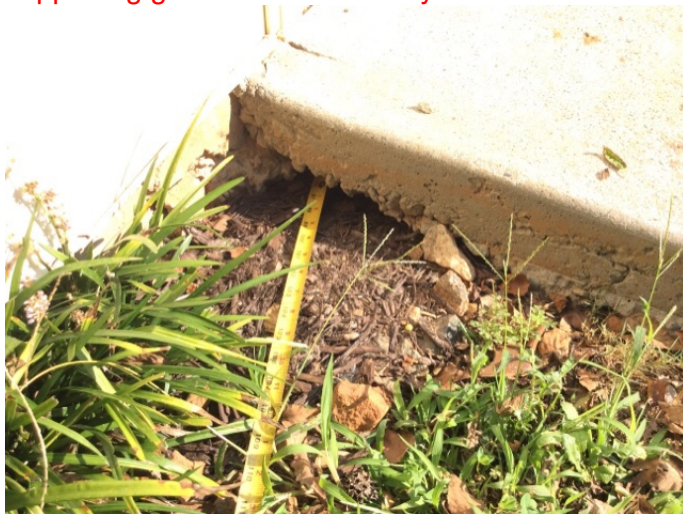
**MO RE 27:** - Soil erosion that extended laterally under the driveway approximately 8 feet was observed on the left side of the driveway near the garage. Recommend filling void with concrete or gravel to provide supporting grade below driveway.

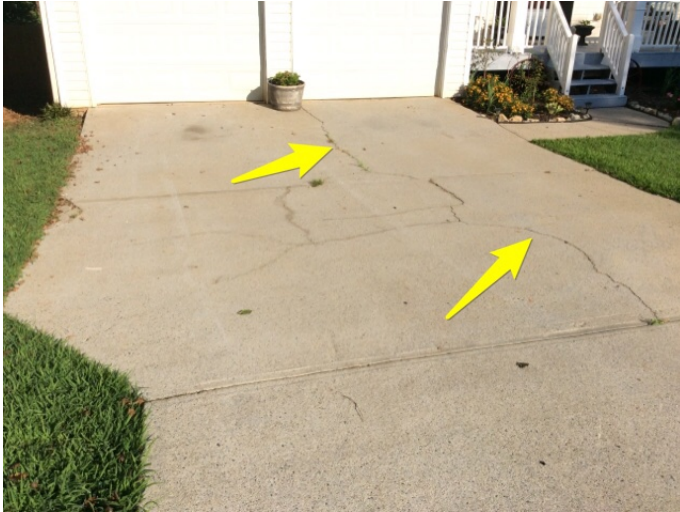
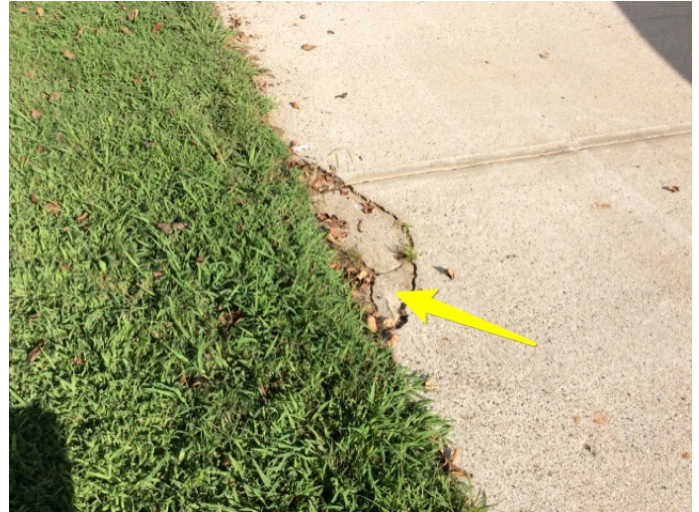
**MO MA RE 28:** - Common cracks were observed in the concrete driveway and are mostly of a cosmetic nature. Cracks can be sealed to prevent moisture intrusion and erosion, but not required. However, a small section on the left side driveway edge was found cracked off and concrete repair at this location is recommended.

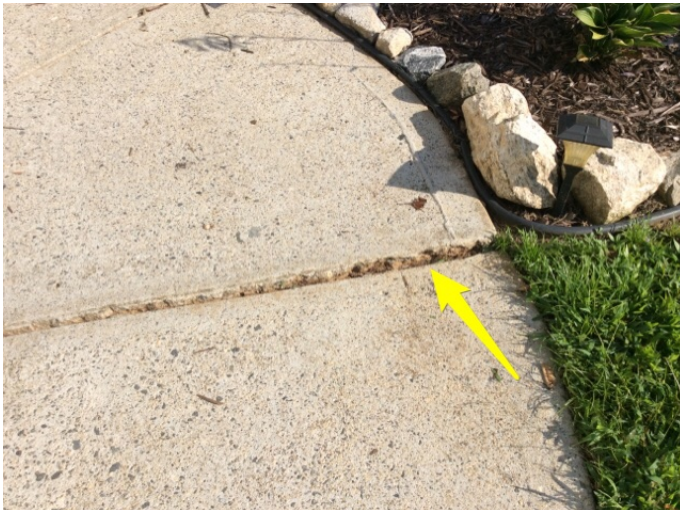
**SA RE 29:** - The front concrete walkway had a raised section approximately 1 inches at the joint creating a trip hazard. It appears settlement is the cause. Recommend patching joint, replace section, or jack section to create a smooth transition.

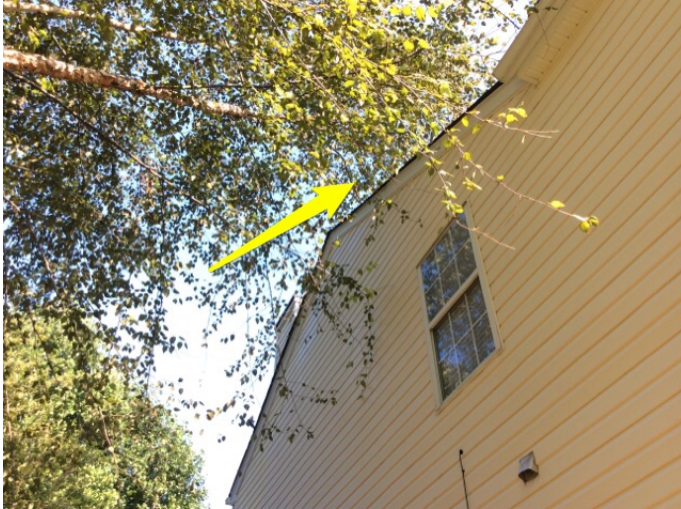
**30:** - Recommend the trees limbs overhanging the roof at the left side of the home be trimmed back approximately 12 feet to prevent wind damage to the roofing surfaces, abrasion, debris accumulation, moss growth, wild life from climbing on the roof and to allow free flow of roof runoff.

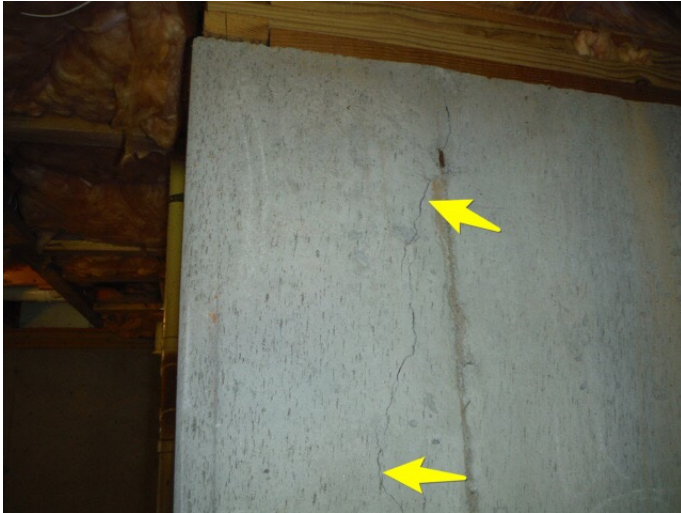
**MO 38:** - A common concrete foundation settlement type crack was observed at the left basement cornerwall. The inspector did not see this condition as needing immediate repairs, but does recommend the crack be monitored. If future ongoing movement is observed to 1/4 inch gap or displacement, then further engineering review and evaluation would then be recommended.

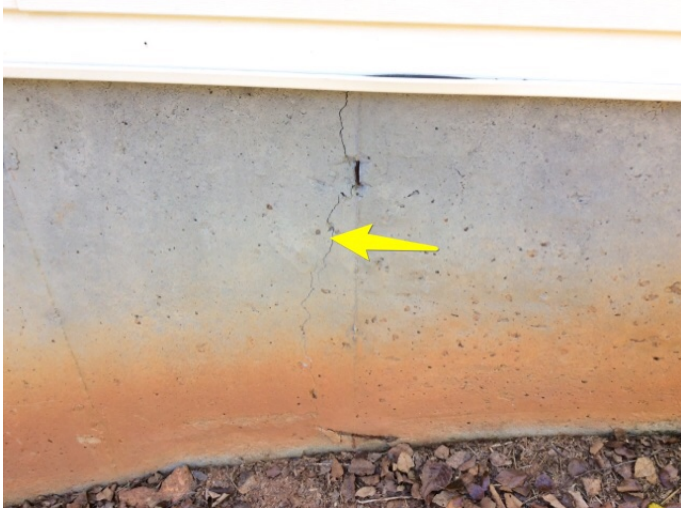
**MO 39:** - Hairline and/or small cracks, within normal tolerances, are present at the exterior left side foundation wall. This type of cracking is often a result of shrinkage of materials and/or minor settlement and usually does not affect the strength of the foundation wall. No action is indicated.

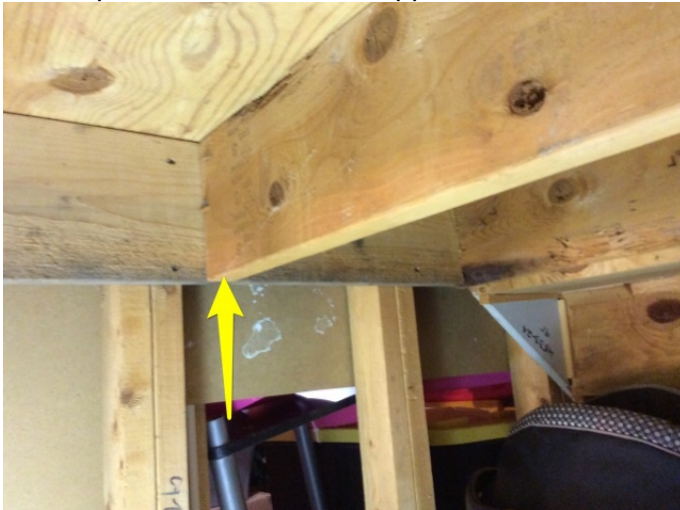
**RE 40:** - Two joist hangers were found missing at both ends of a joist below the stair landing in the basement and requires installation for support.

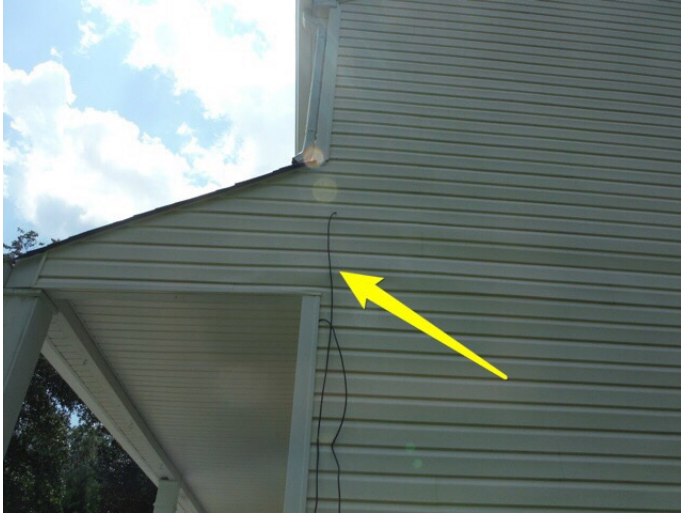
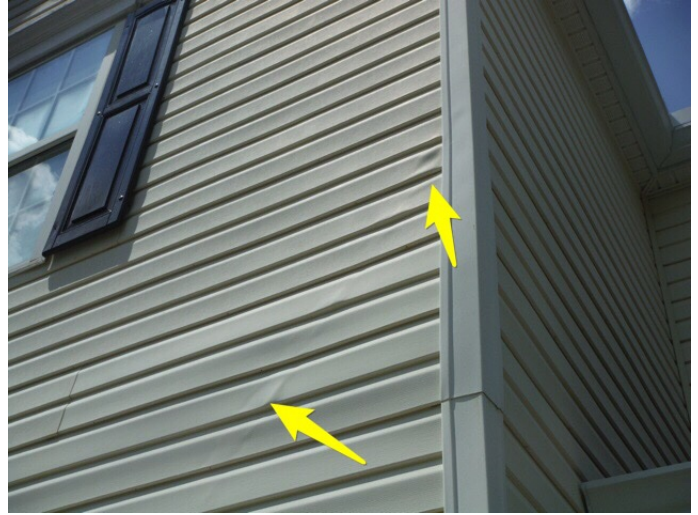
**MA RE 47:** - Small areas of vinyl siding were found punctured and require sealing or replacement at the rear of the home near the A/C unit, at the left side of the home in several locations and at the front adjacent to both garage doors.

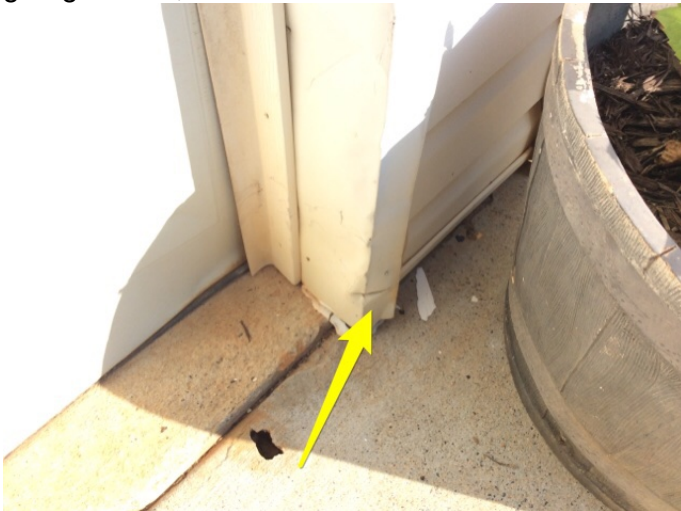
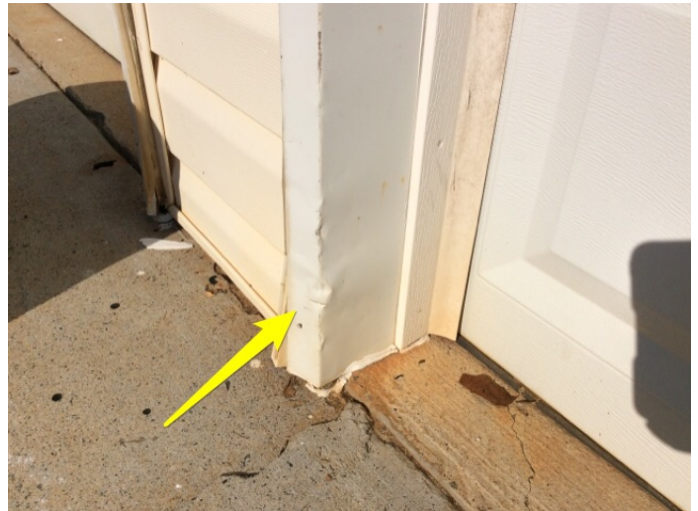
**MA RE 49:** - Previously damaged/decayed wood trim with repairs was observed at the lower trim of the front entrance door.

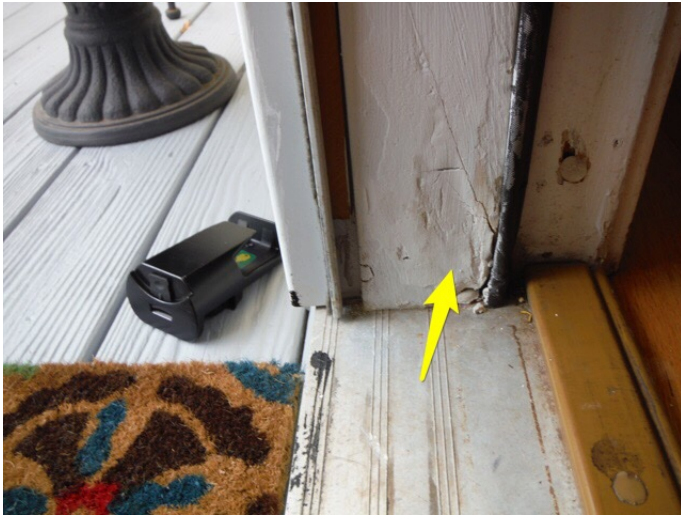
**MA 50:** - Unsealed caulking gaps requiring sealant were observed at the rear right and left corners of the vinyl trim / concrete foundation junctions.

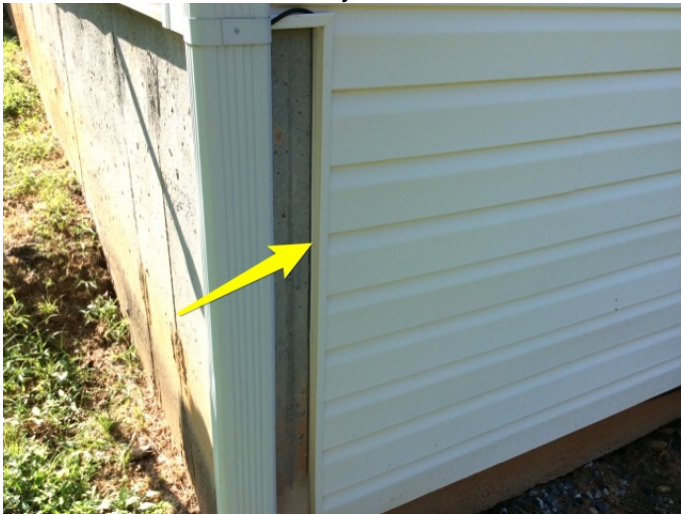
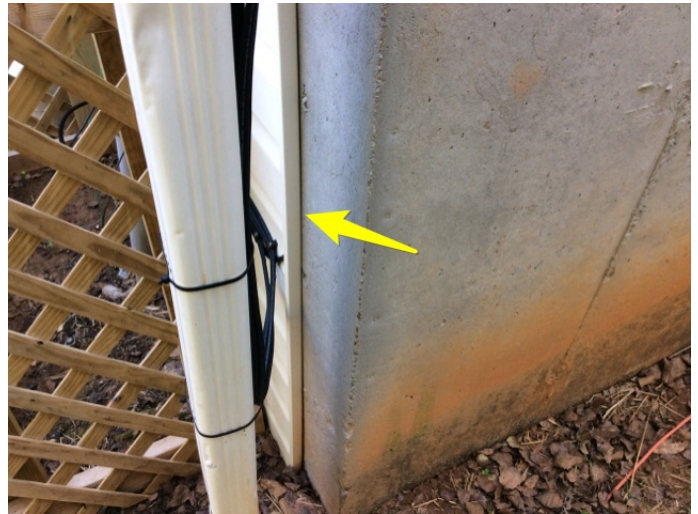
**MA** 51: - Slightly loose metal fascia covering was observed at the front gable rake above the garage.

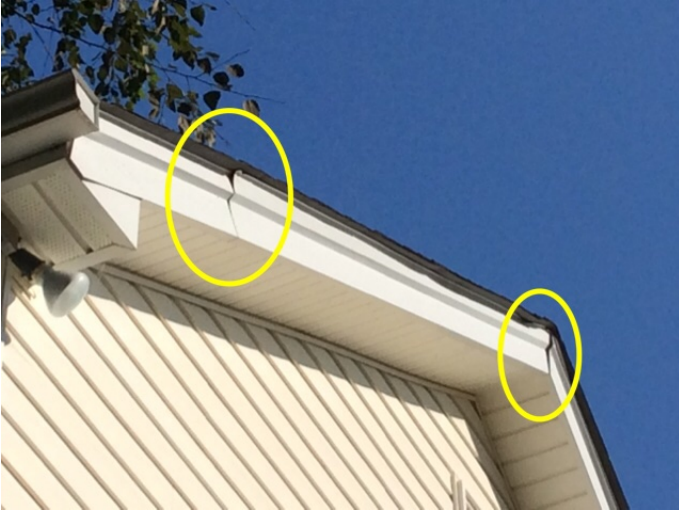
**MA RE** 52: - Approximately 6 window shutters were found damaged / melted at their top and require replacement.

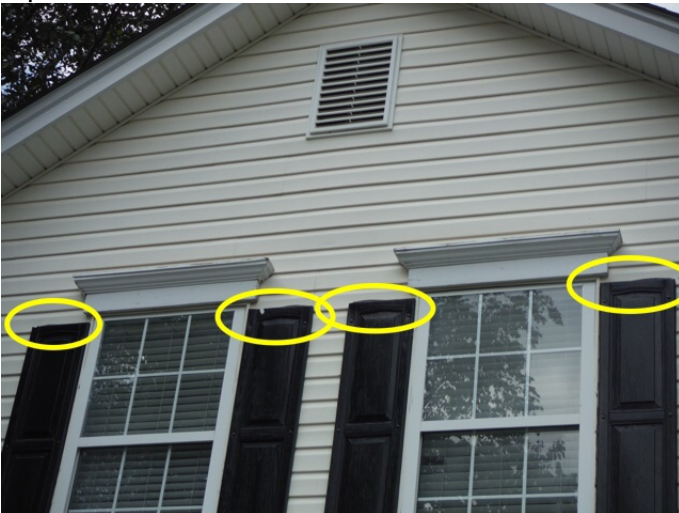
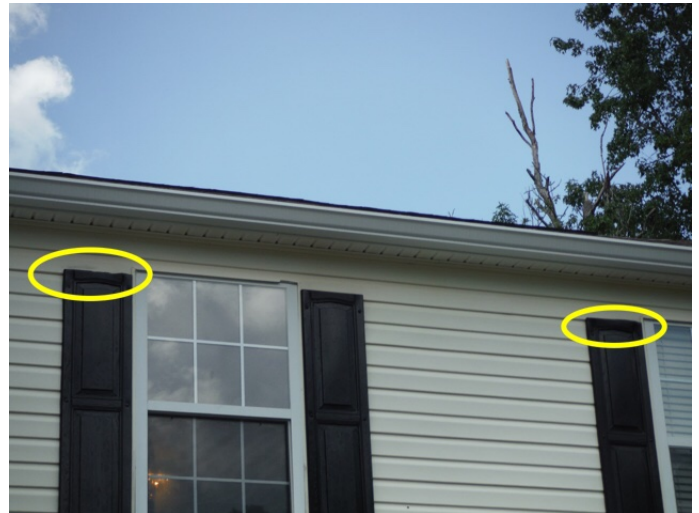
### CAULKING/PAINT/STAIN

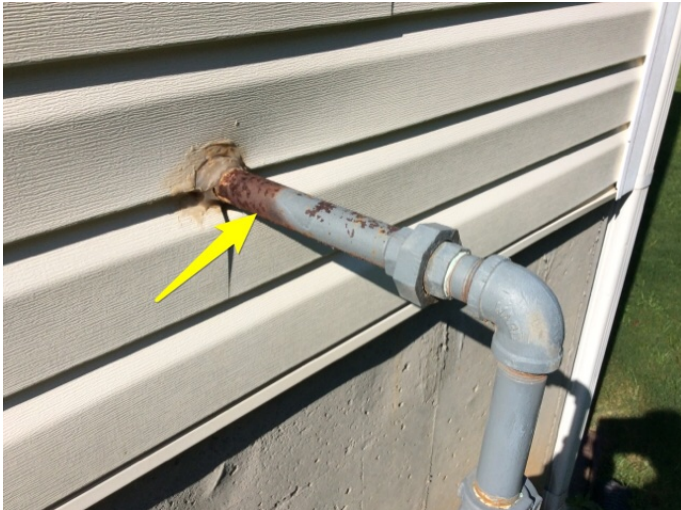
**MA 53:** - A rusting/corroding gas main pipe requiring rust inhibiting paint was observed at the right side of the home.

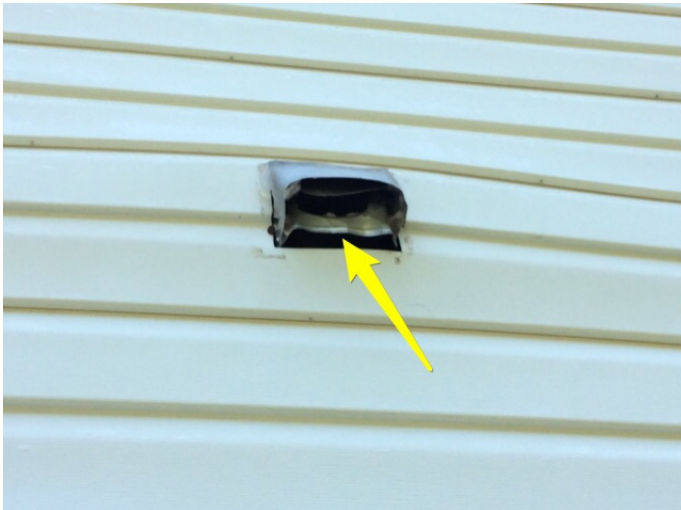
**RE 54:** - A bent vent termination cover and unsealed at the bottom, requiring repair or replacement was observed at the rear of the home above the deck.

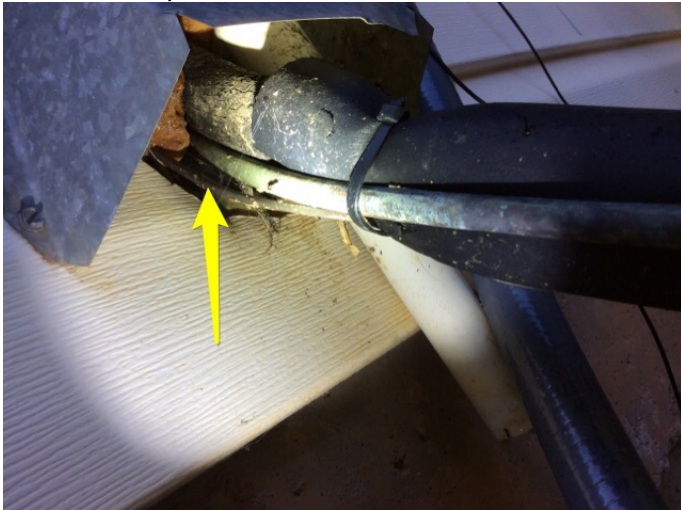
**RE 55:** - Recommend installing flexible sealant around the A/C pipe set wall penetration found at the rear of the home to prevent moisture and insect intrusion.

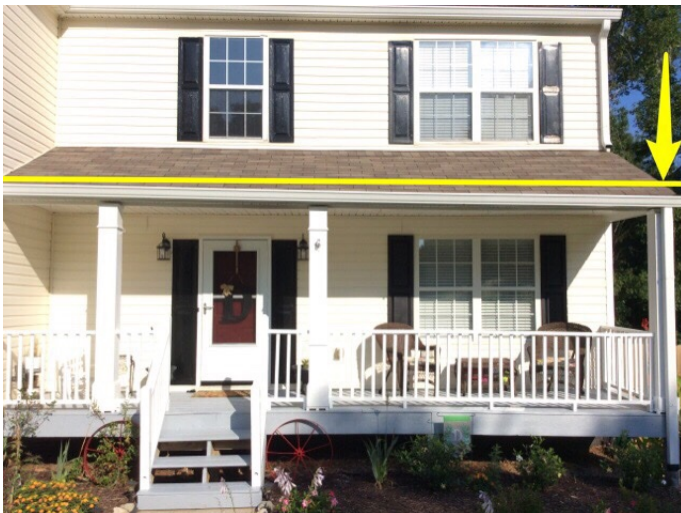
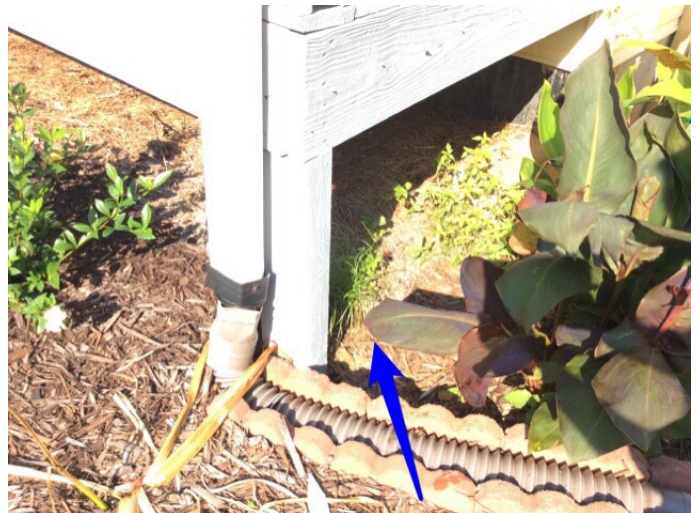
**MA RE 57:** - The two far left front porch joists were found without ledger strip support and will require joist hanger support brackets.

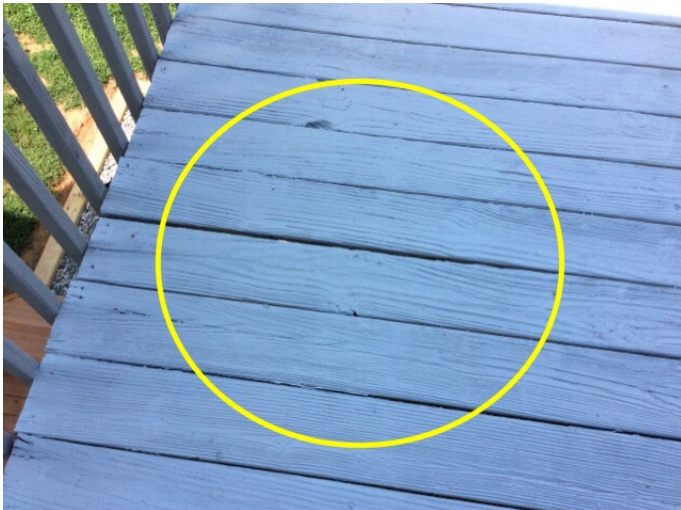
**SA RE 59:** - Although ledger board flashing was visible along the ledger board at the rear deck there were sections that were observed deteriorated, indicating the metal gauge may have been undersized and the entire flashing may need replacing.

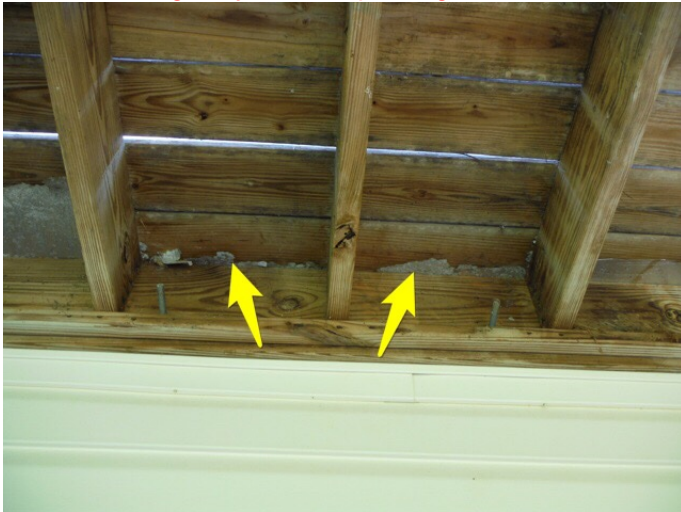
**SA RE DE 60:** - The rear deck swayed side to side when tested indicating the deck requires additional lateral support. The deck outer banding joist was not bearing on the center support post as a 1/4 inch gap was visible. Recommend advice and services of a qualified deck contractor. Recommend adding mechanical attachment (brackets) between the rear deck support posts and the outer band joist framing. Recommend adding lateral support (diagonal bracing) at the two outside posts along the deck sides. Recommend adding metal brackets at diagonal bracing connections as needed. Recommend adding additional diagonal X-bracing under joists as needed to stabilize deck.

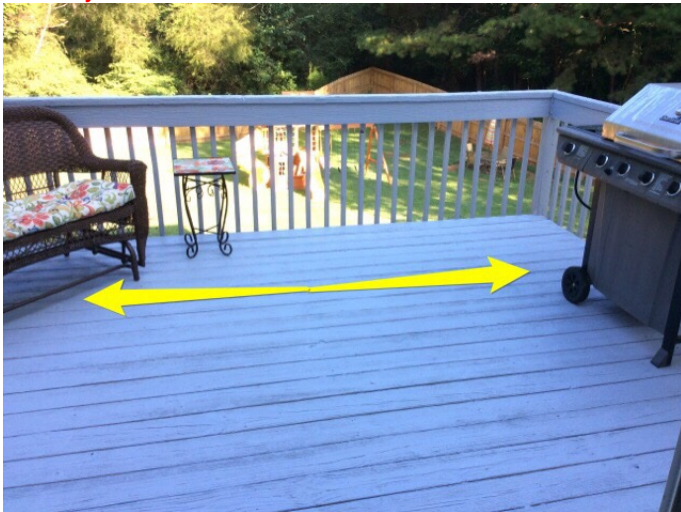
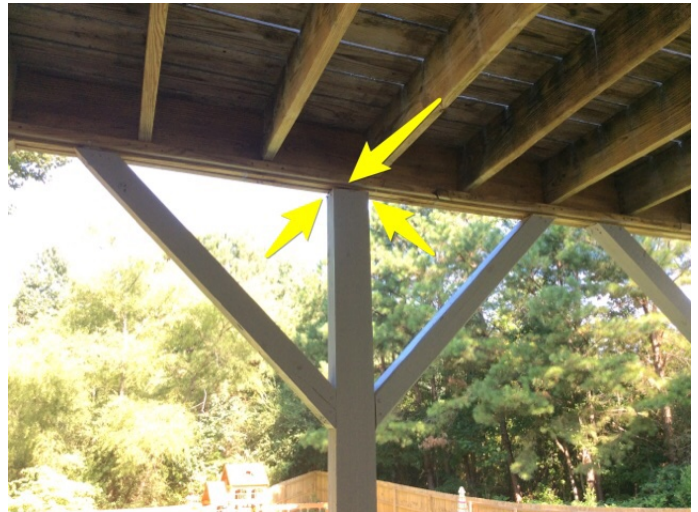
**UP 61:** - At least two of the rear deck posts were connected to their footings with a metal pedestal type bracket. Soil contact was visible at all three posts. Recommend pouring concrete around all post bases to prevent soil contact and future moisture damage problems.

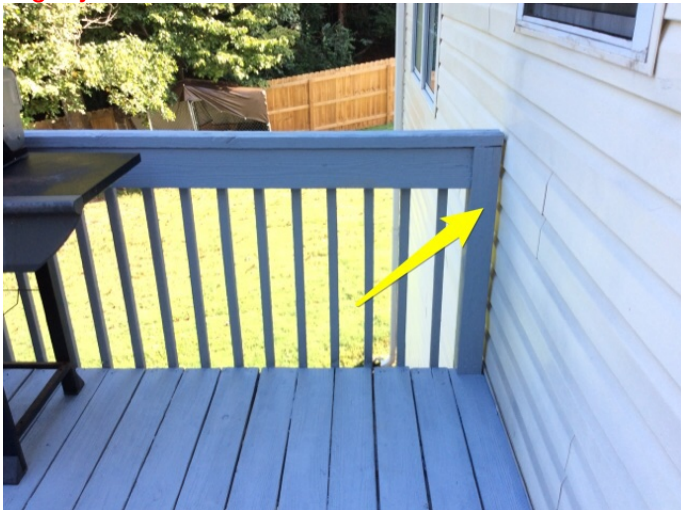
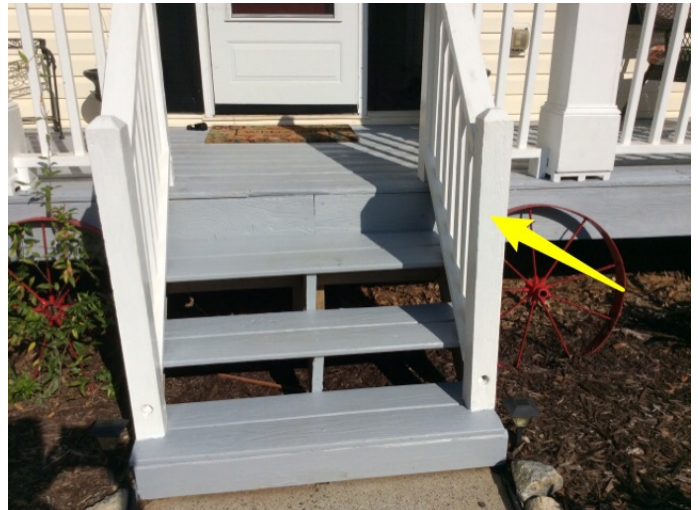
**SA RE 62:** - Guard railings were found loose at the right side of the deck. Recommend that guard railings be reinforced with two bolts per post and deck strong ties in accordance with present standards. Note, current deck standards require a deck post every 6 feet. The front porch right guardrail post was found loose and requires tighten. Note, it appears the front porch stairs / walkway have settled slightly as the stairs were slightly tilted.

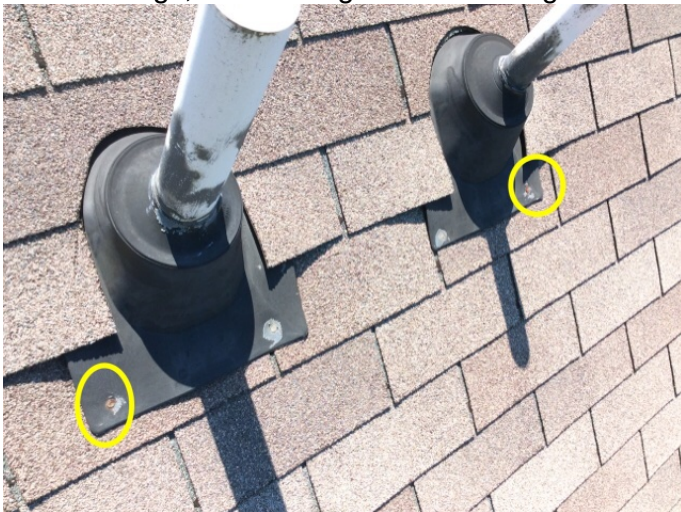
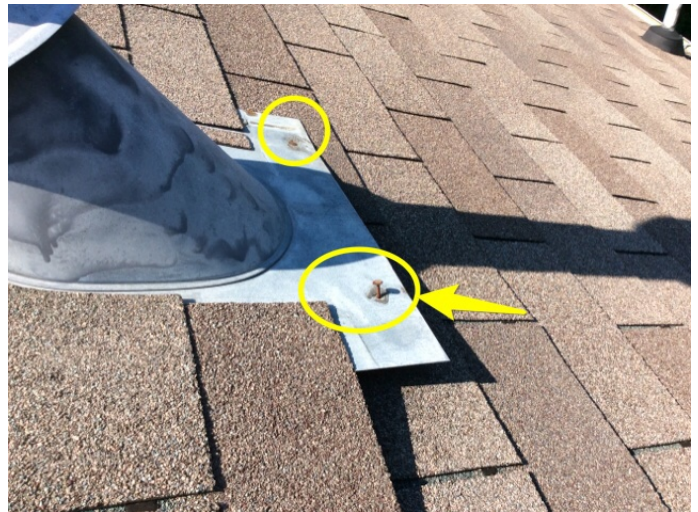
**MA 73:** - Recommend cleaning leaves from roof valley on the left side of the home to prevent shingle damage over time.

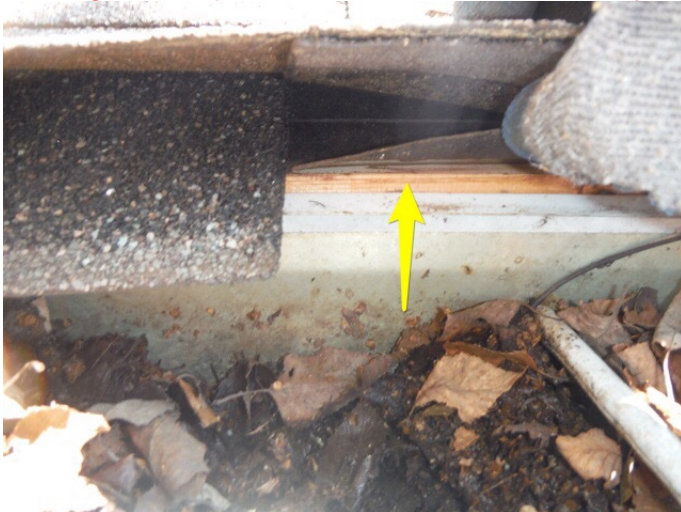
**RE 74:** - Drip edge flashing was not visibly installed at the perimeter rakes and eaves of the home. Drip edge flashings are required in accordance with industry standards as of 2014.

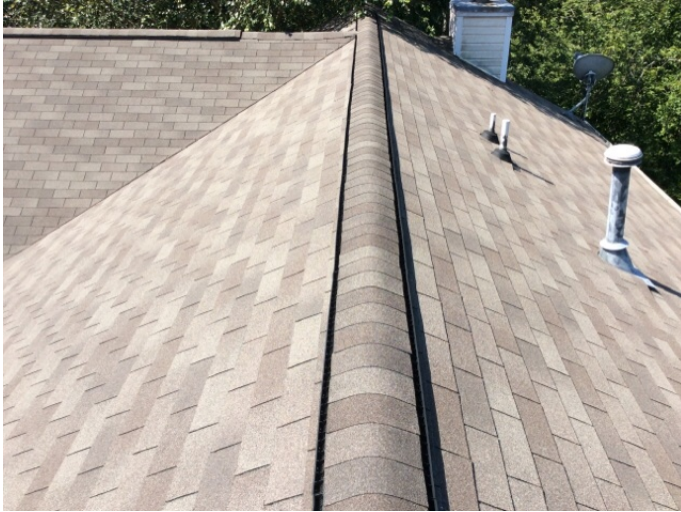
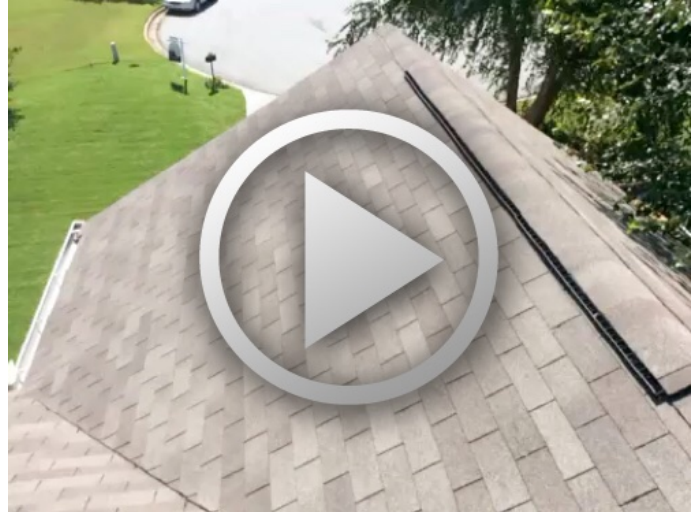
**75:** - GREAT NEWS! Excluding any listed maintenance and repair items, the overall visible roofing surface, chimney cricket, and roof / attic ventilation were observed to be in serviceable condition at the time of the inspection. If connected to the Internet, a video is available that shows a 360° view of the roof.

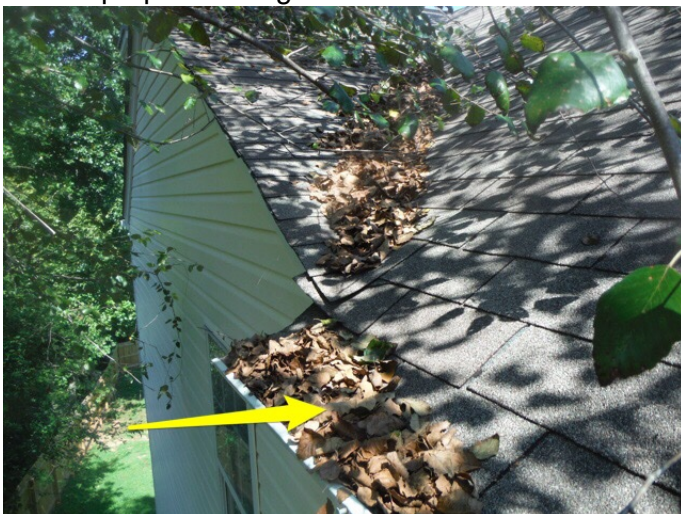
**MA 77:** - The roof gutters were found filled with debris on the left side of the home which should be removed to ensure proper drainage.

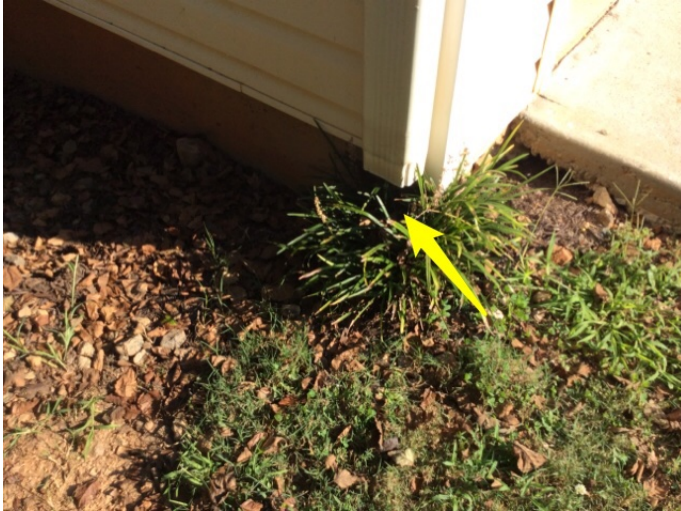
**MA RE 79:** - A detached roof gutter downspout strap requiring correction was observed at the rear left corner of the home.

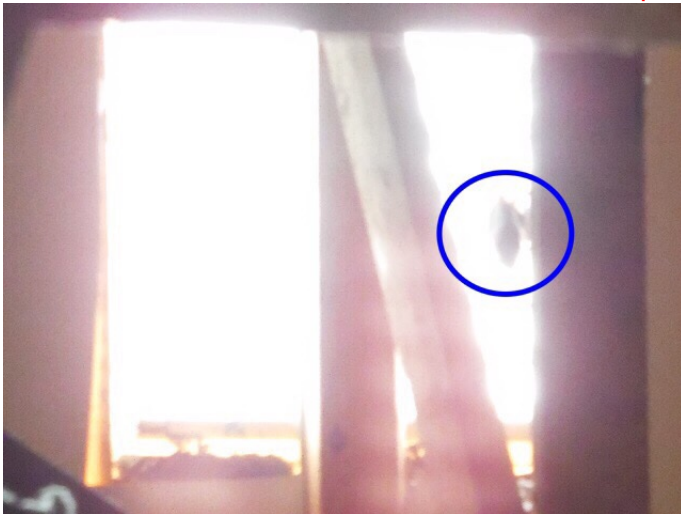
- RE 85:** - A bat was visible in the gable end vent louvers on the front of the home and bat guano was visibly in the lower section of this gable end vent. Recommend cleaning by a professional, repair screen if needed and add a 2nd screen to the outside of the louvers to prevent bats from nesting between the louvers.

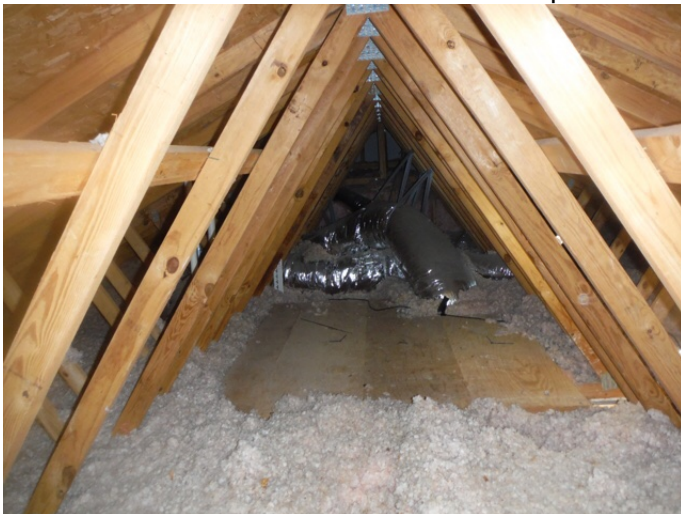
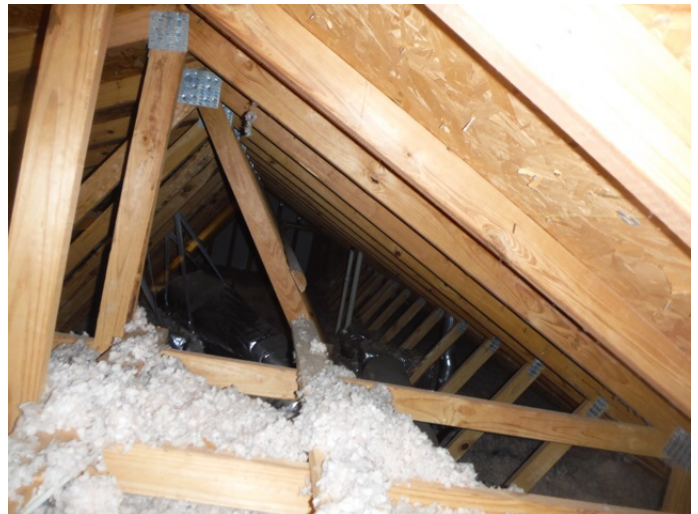
## Insulation/Energy

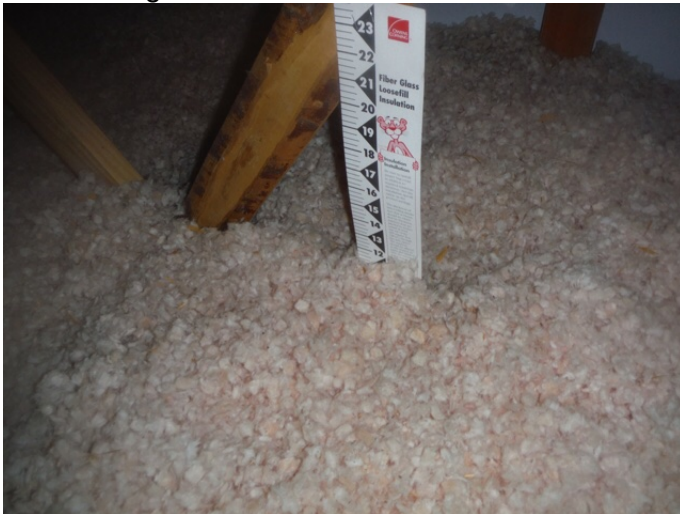
**88:** - The level of insulation approximately 12 inches in the attic would appear to provide about R-25 insulating value. This provides good resistance to heat transfer by present standards. Note, the R-value is less where attic flooring is installed.

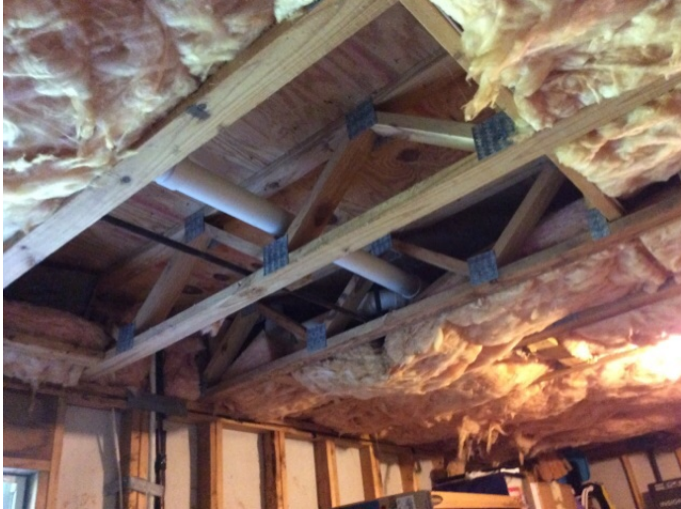
## ENERGY SAVING ITEMS

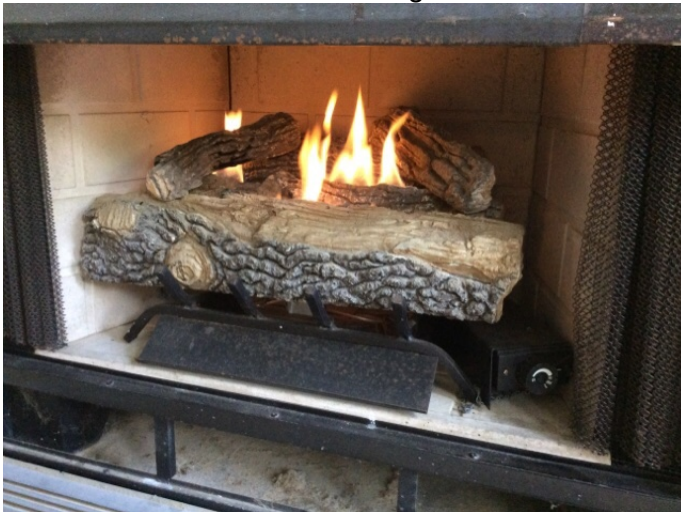
- MA SA 104:** - Recommend installing a damper stop safety clamp at the family room fireplace to always keep the damper partially open when using gas log fireplaces required to prevent carbon monoxide poisoning.

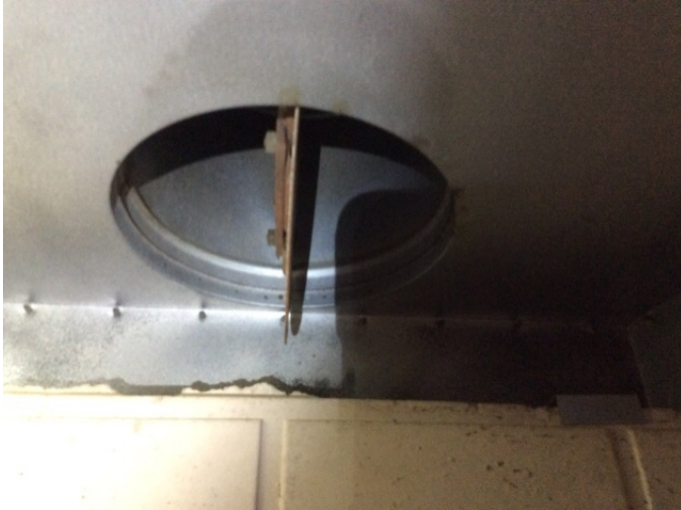
- RE 105:** - A crack was observed at the family room fireplace hearth extension.

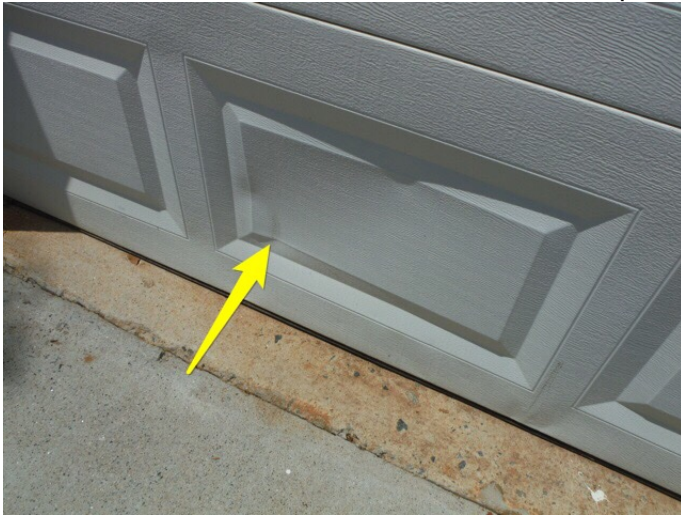
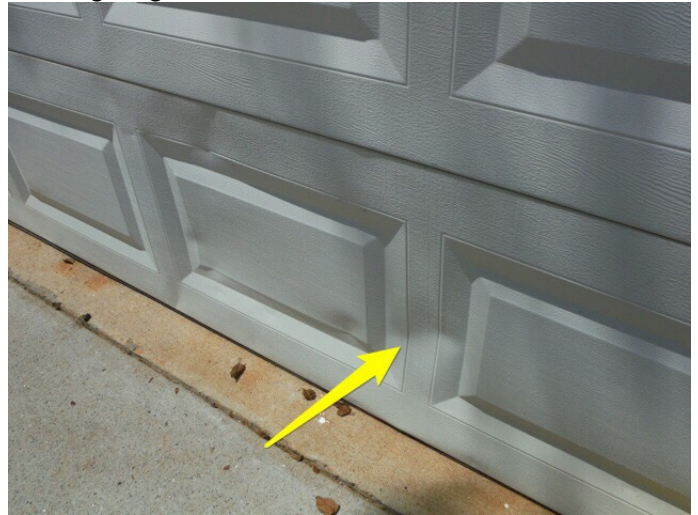
**SA RE DE** 111: - The left garage door right lift cable was found off its pulley system preventing operation and testing of the garage door. Recommend correction/repair by a qualified garage door contractor.

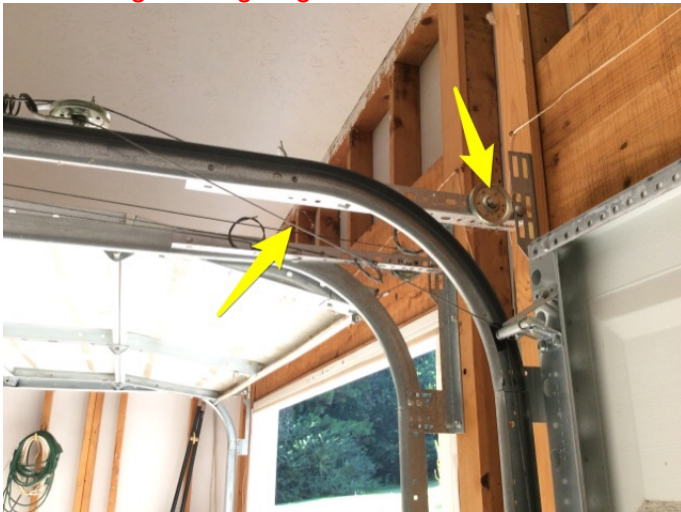
**RE 112:** - Dents in the garage door roller metal track were found at the lower right side of the right garage door. This did not prevent operation, only smooth operation, recommend correction.

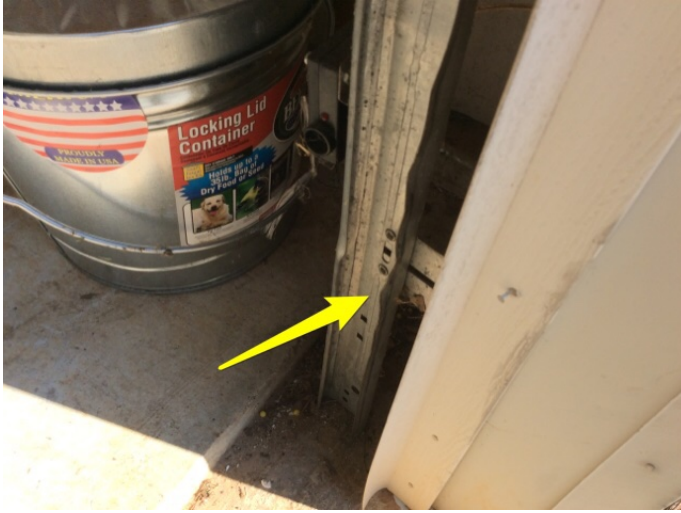
#### **GARAGE DOOR OPENER**

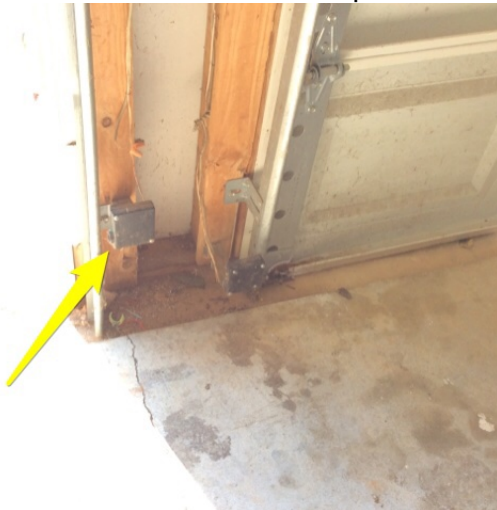
**MA SA 114:** - Required red emergency release ropes and handles were not installed at both garage door automatic opener control arm attachments.

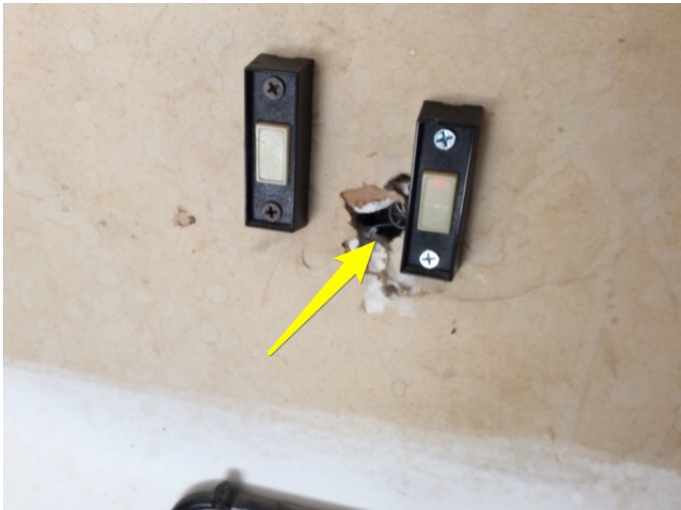
**MA 115:** - Garage wall surfaces were found with small voids or blemished and can be repaired in the course of routine maintenance.

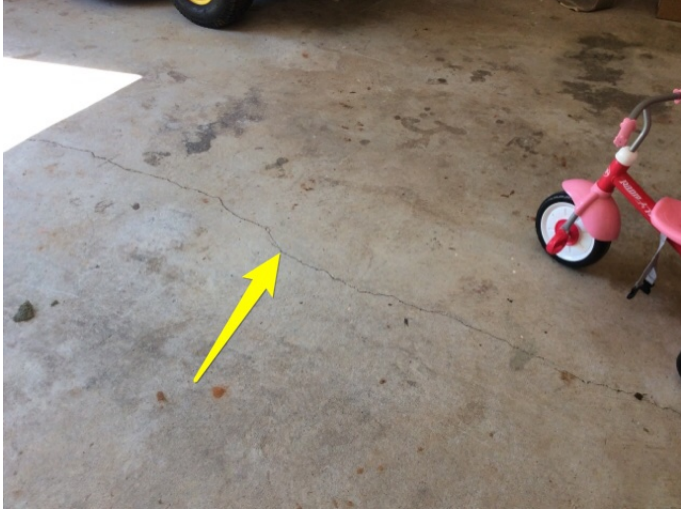
**MO 116:** - Minor common concrete cracking was observed in the garage floor slab, but no vertical displacement of any portion of the slab. No action is required. Some homeowners install epoxy coating with flakes on the garage floor to cover unsightly cracks and protect surface from stains.

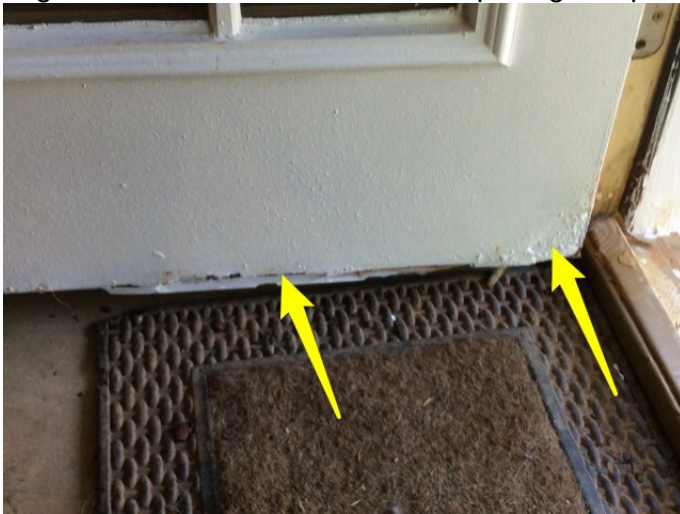
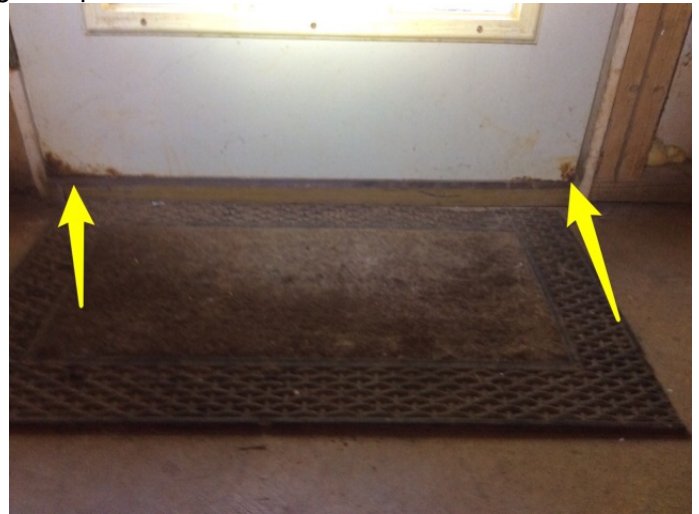
**MA 129:** - The second floor left center bedroom closet door was observed to rub its frame when tested and requires adjustment.

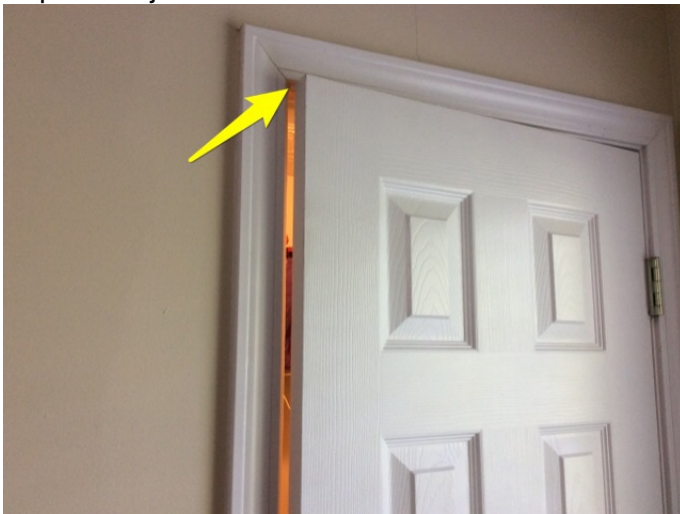
**MA RE 130:** - the second floor rear left bedroom mirror door was found with a small crack in the top left corner and did not slide when tested and requires correction.

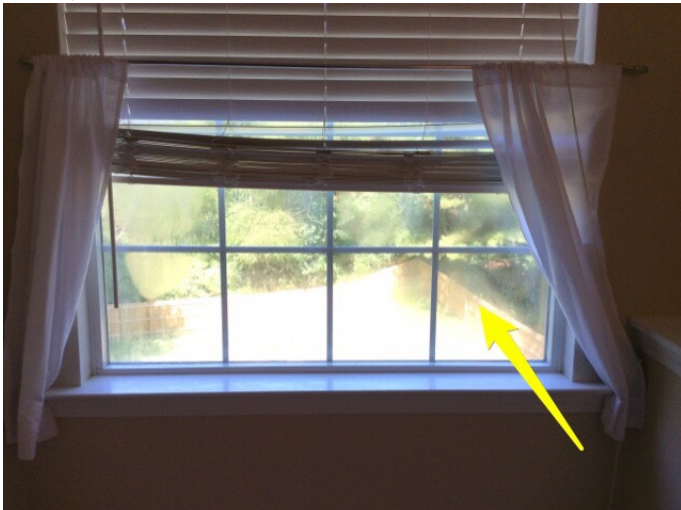
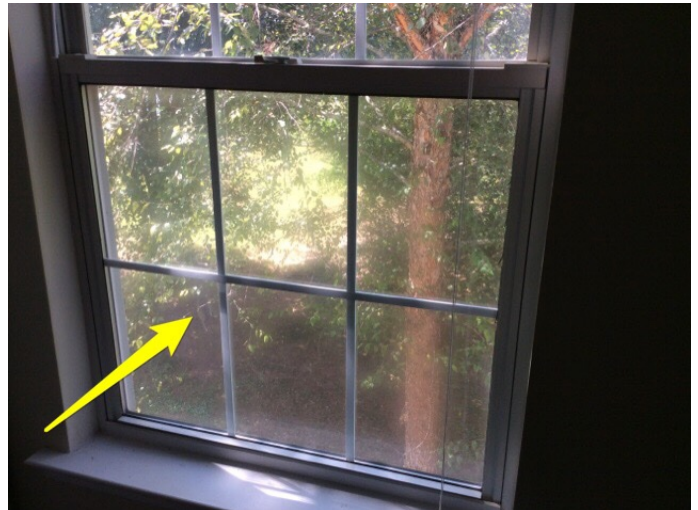
**RE DE 131:** - Approximately 14 windows were observed with failed thermal seals or "fogged" requiring replacement in the following locations; Master bathtub picture window, second-floor bedroom left side window, second-floor front left bedroom right window, second floor front master bedroom windows, rear deck sliding glass both doors, foyer window, front living room window, rear dining windows, two windows in the family room, and the kitchen window.

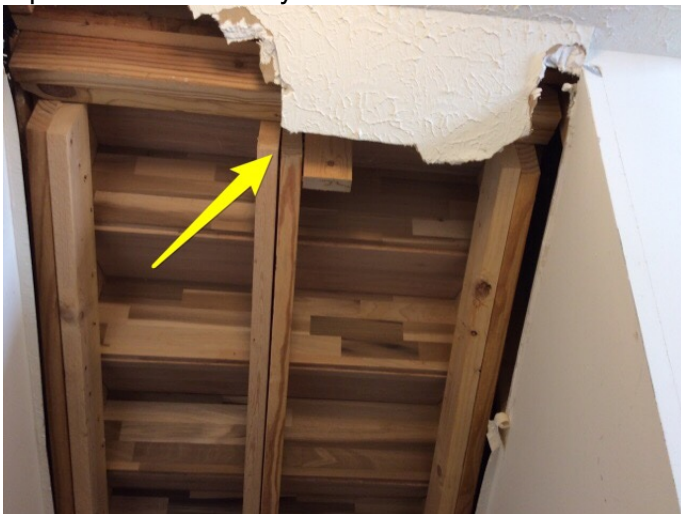
**SA RE 132:** - The sheetrock ceiling in the stairwell to the basement was observed removed and should be replaced for fire safety reasons.

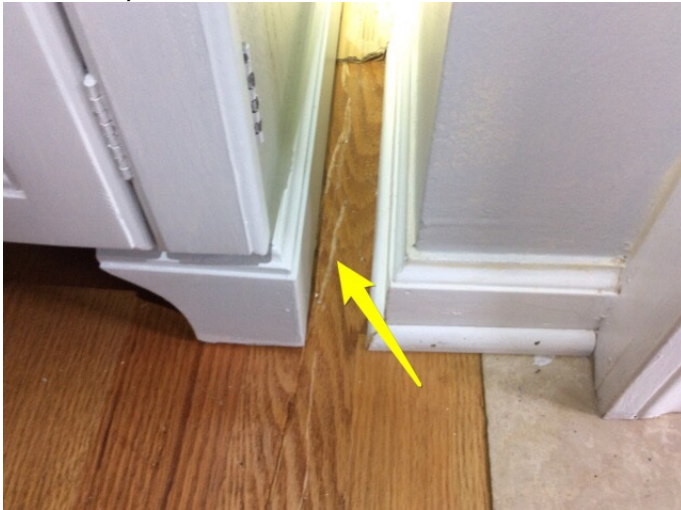
**RE 134:** - Wood flooring moisture damage was observed around the main level 1/2 bathroom commode base that will require sanding and re-finishing.

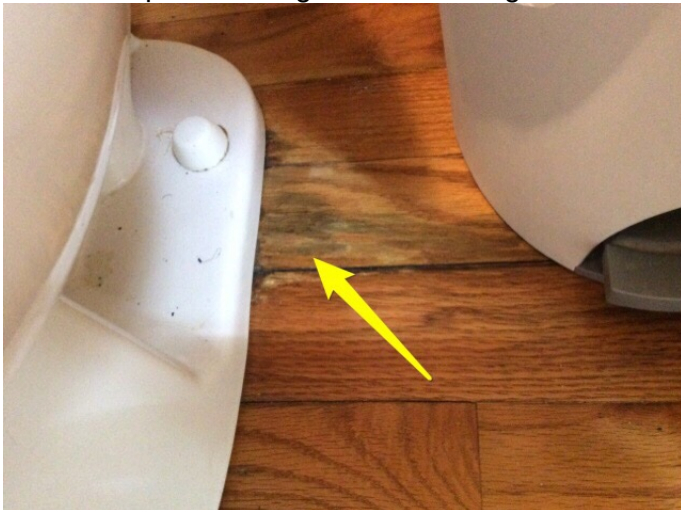
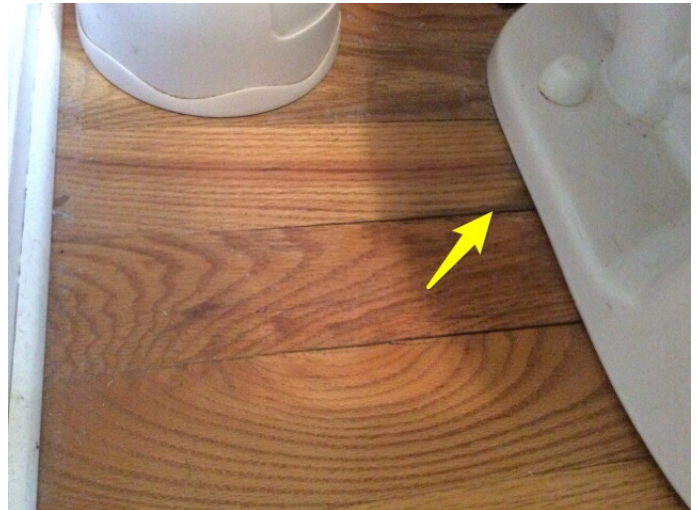
**RE** 135: - A cracked floor tile was observed in the kitchen in front of the dishwasher.
