# Confidential Inspection Report

LOCATED AT:  
4000 Sample Ridge Lane  
Cumming, Georgia 30028

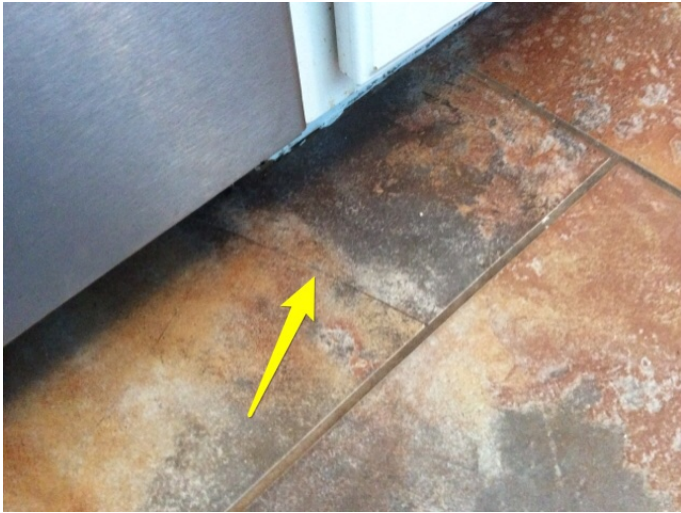
**RE** 135: - A cracked floor tile was observed in the kitchen in front of the dishwasher.

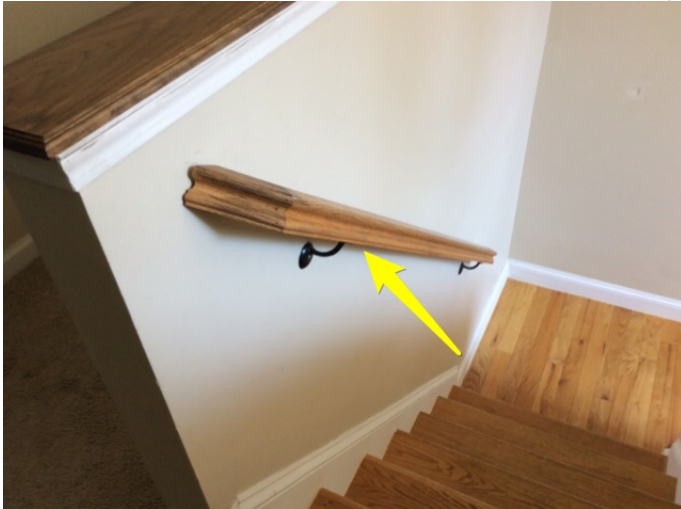
**MA SA RE** 136: - A loose interior wall handrail requiring tightening was observed at interior stairs.

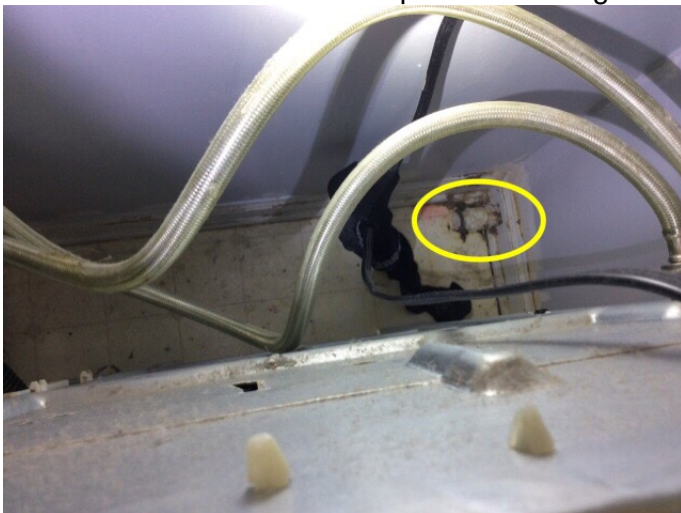
**UP** **141:** - The hookups for the washer and dryer were not tested, but appear to be properly installed and in serviceable condition. Recommend using steel braided washing machine water hoses that are resistant to breakage, rather than other types of washing machine water hoses.

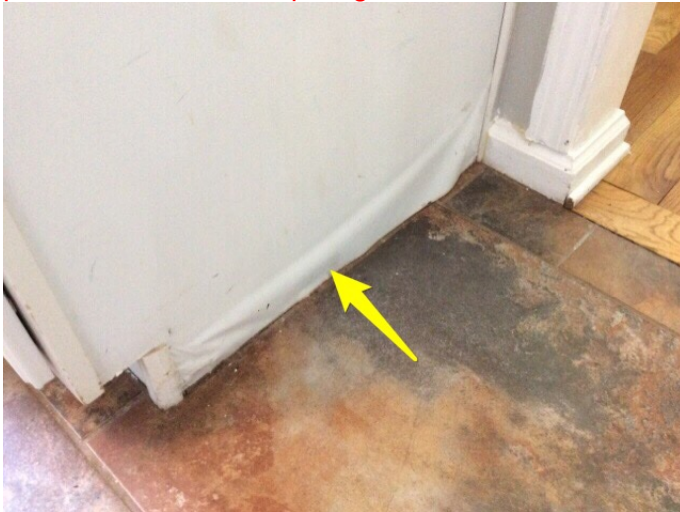
**147:** - The cabinets were found in serviceable and fair condition.

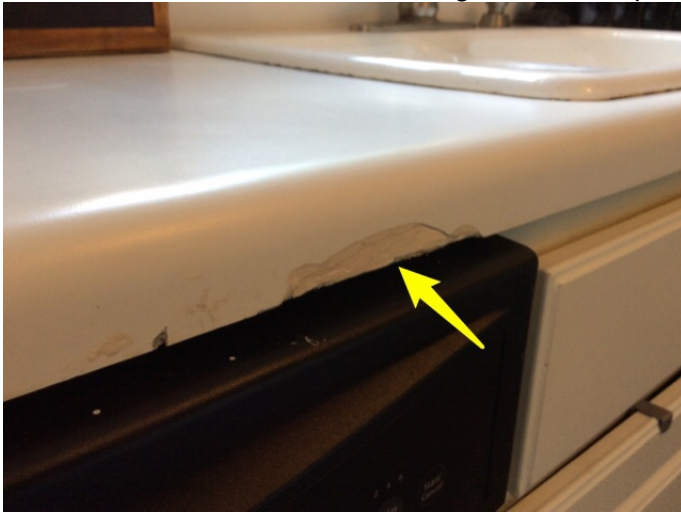
**RE 148:** - A small section of damaged countertop edge was observed at the kitchen dishwasher.

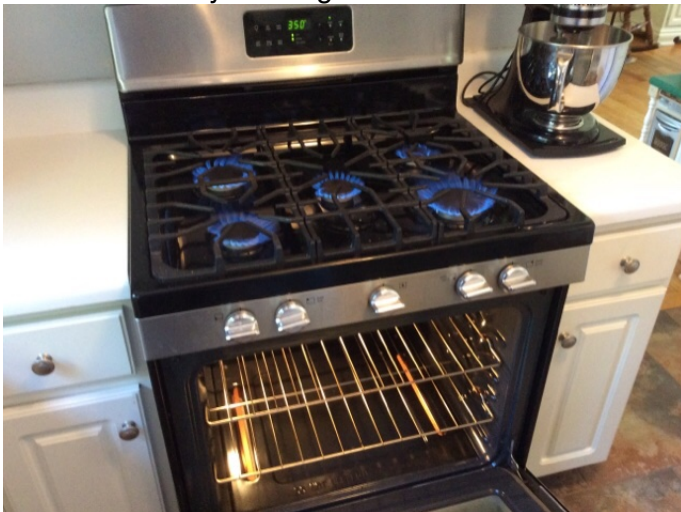
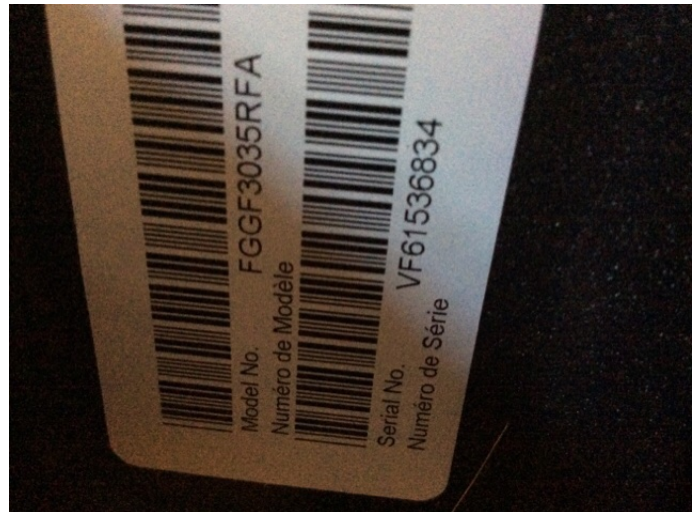
**149:** - The range top burners, oven and broiler were turned on with the normal operating controls and found to be in satisfactory working condition.

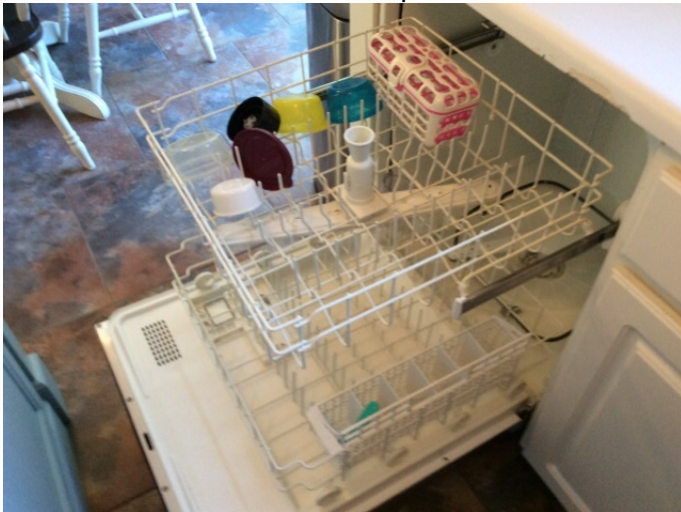
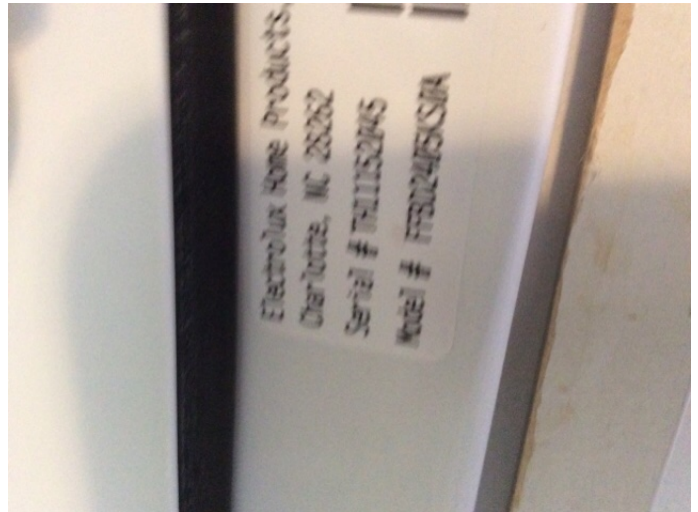
**RE 151:** - The dishwasher responded to normal user controls and was found in serviceable condition.

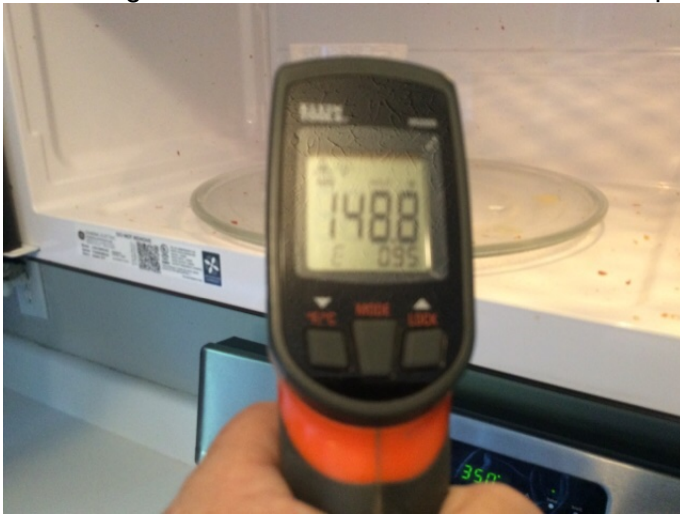
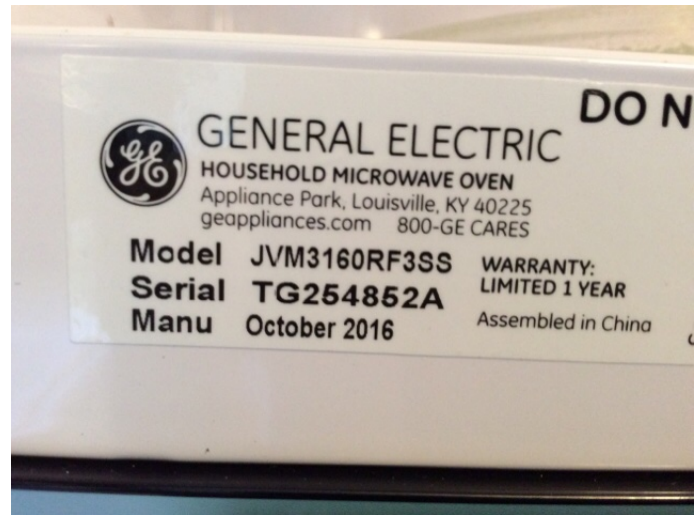
**152:** - The microwave operated serviceably using normal operating controls at the time of the inspection. Surface lightbulb was burned out at the time of inspection.

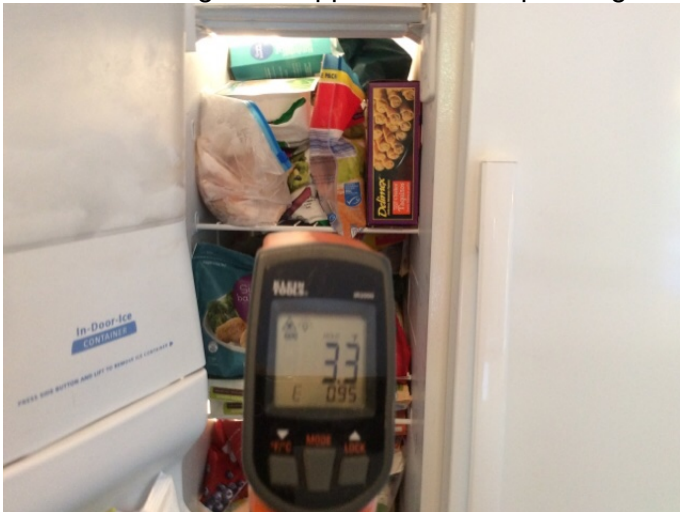
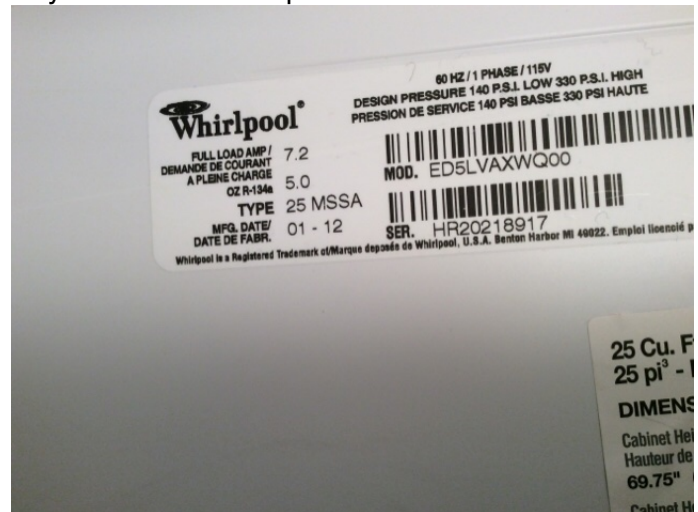
**154:** - The refrigerator appeared to be operating serviceably at the time of inspection.

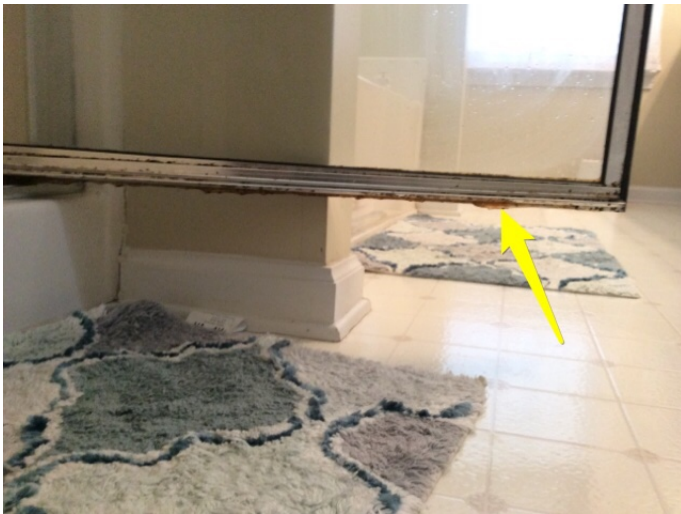
**MA 160:** - A deteriorated rubber sweep seal requiring replacement was observed at the bottom of the master bathroom shower door.

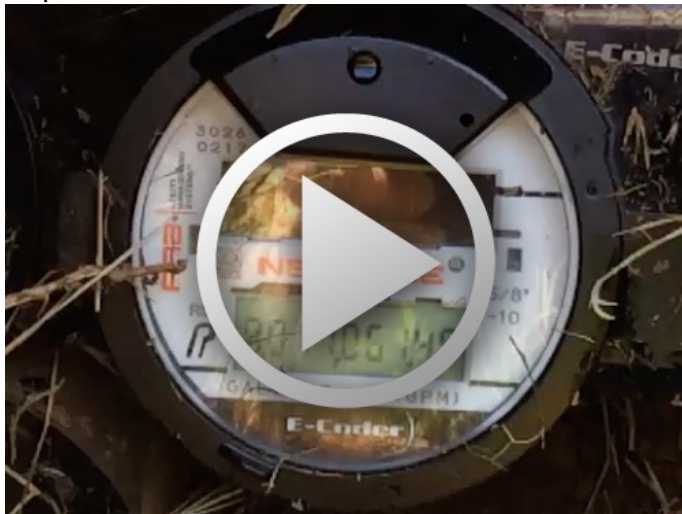
### **WATER SHUT-OFF LOCATION**

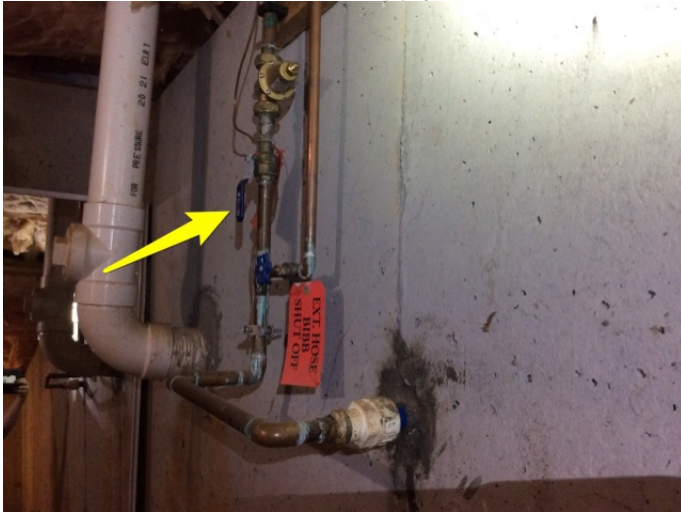
**167:** - The domestic water supply main shut-off valve was located in the front wall in the basement.

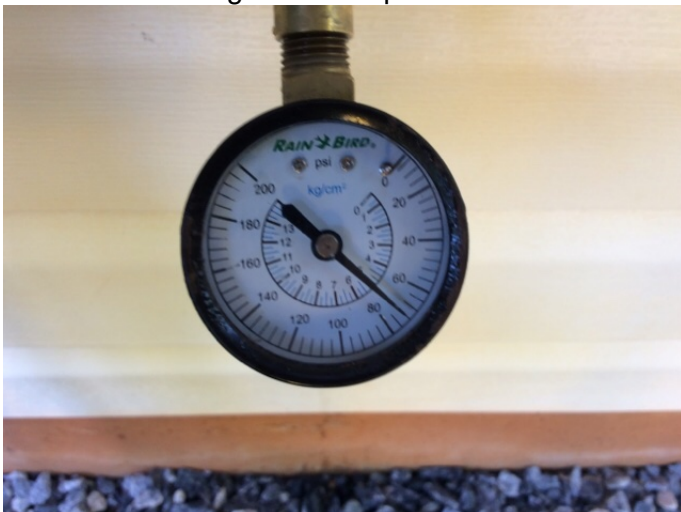
## EXTERIOR PLUMBING

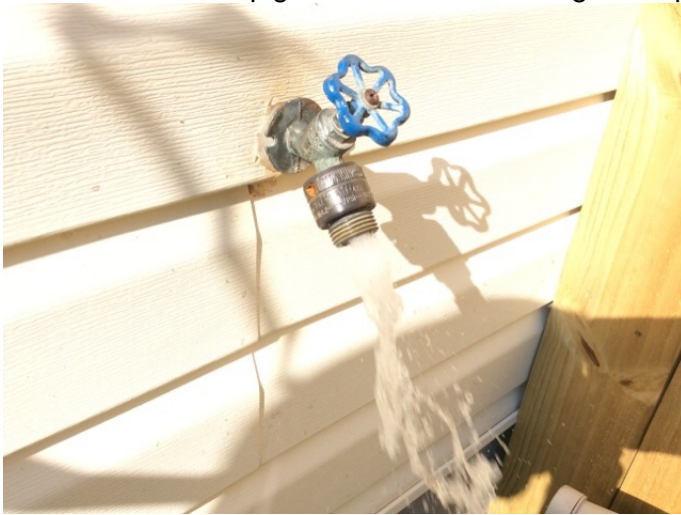
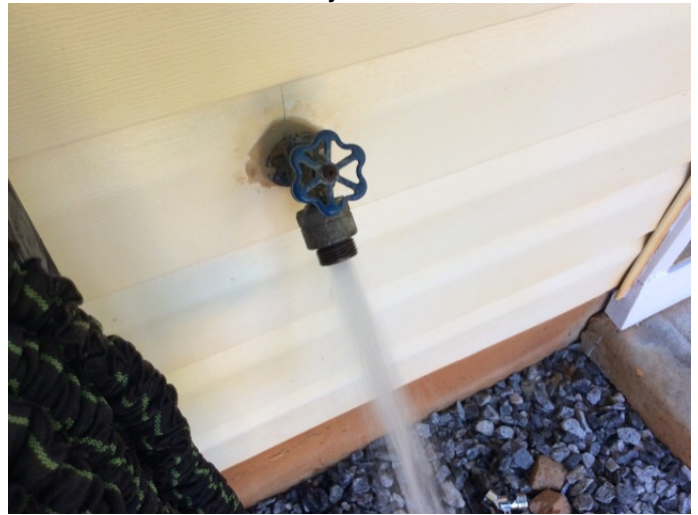
**171:** - The exterior hose bibb spigots operated serviceable when tested. Recommend installing fasteners to secure hose bibb spigots to walls and adding anti-siphon devices for health safety.

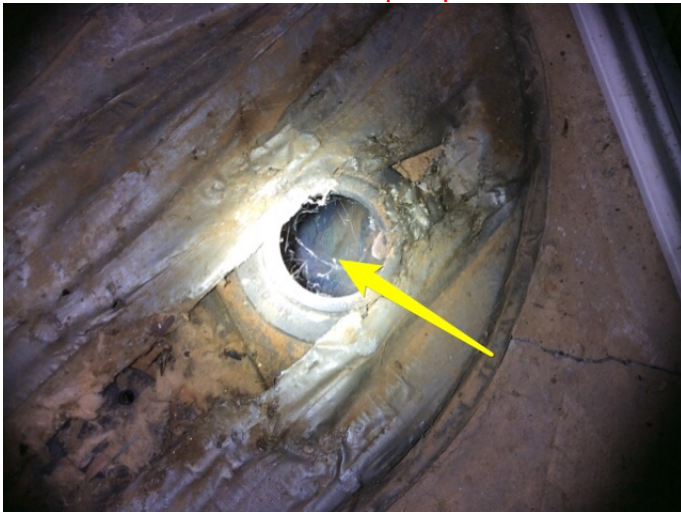
**MO RE 174:** - A sewage ejector pump hold tank container was found full of water at the front basement left corner. Recommend water is pumped out of container and monitored for possible water intrusion.

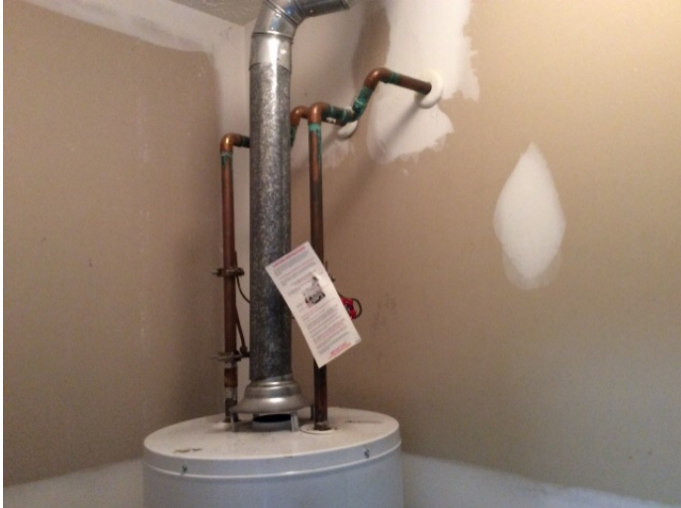
**RE 185:** - An expansion device, (tank or pressure relief valve) was not located on the cold water supply pipe system necessary for newer water heaters after year 2000, requiring installation by a licensed plumber.

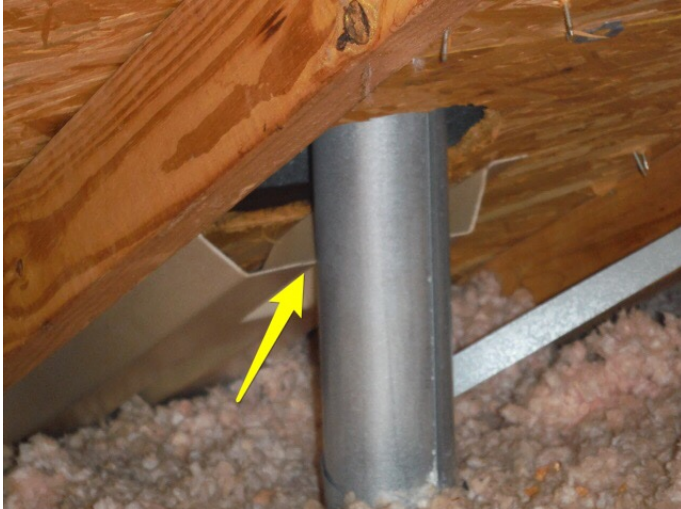
**SA RE 187:** - Recommend installing required missing screw fasteners on the legs of the gas flue draft hood at the water heater.

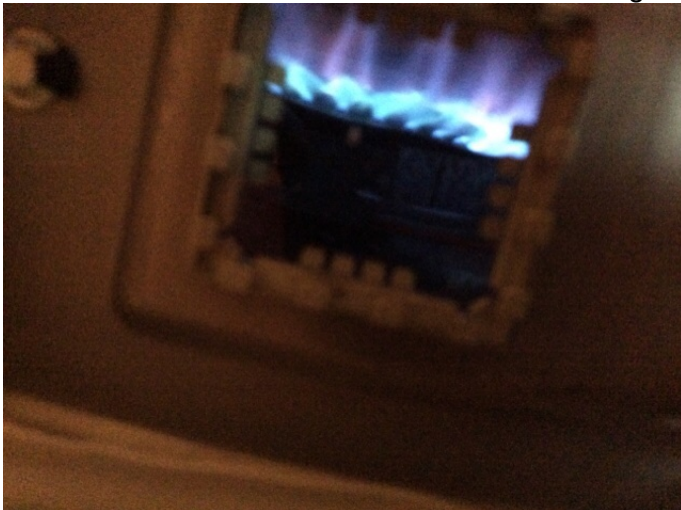
#### **WATER CONNECTORS**

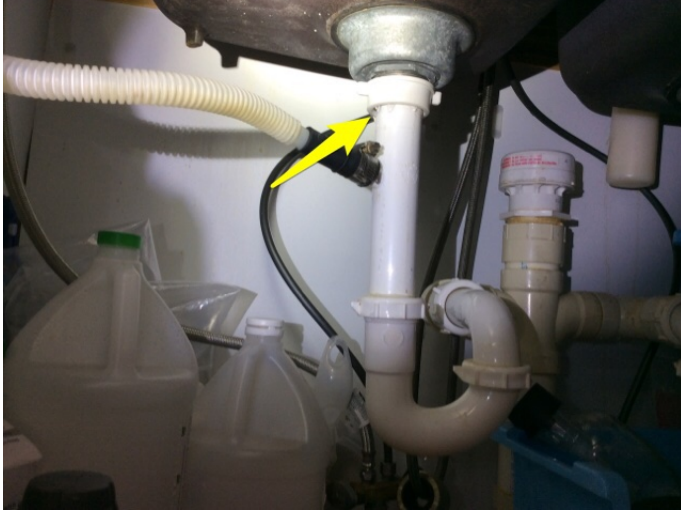
**RE** 192: - An active drain pipe fitting leak requiring repair was observed below the left kitchen sink.

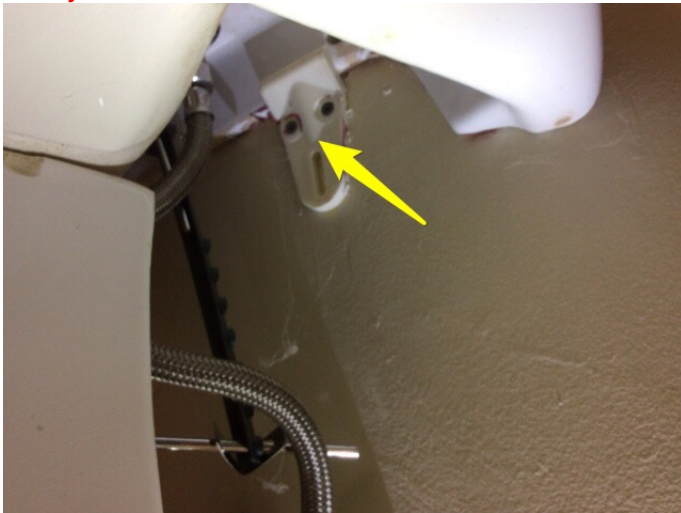
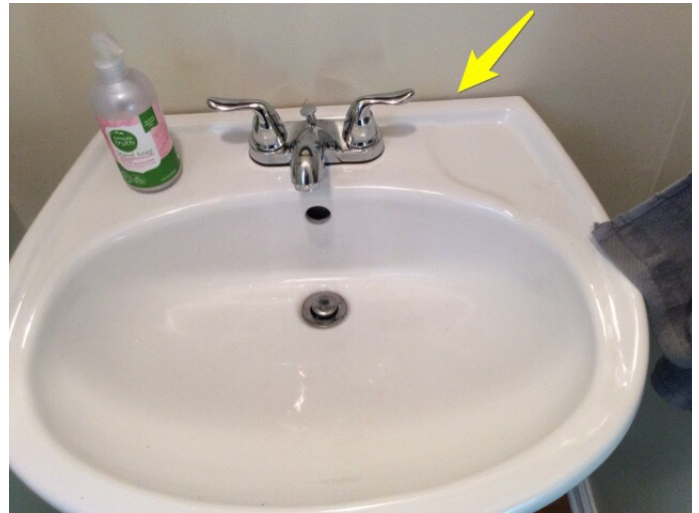
**SA** **RE** 193: - Proper mechanical attachment was not installed of the loose pedestal sink in the main level 1/2 bathroom. The plastic brackets appear to have cracked and require replacement with metal brackets. This is a safety concern for small children.

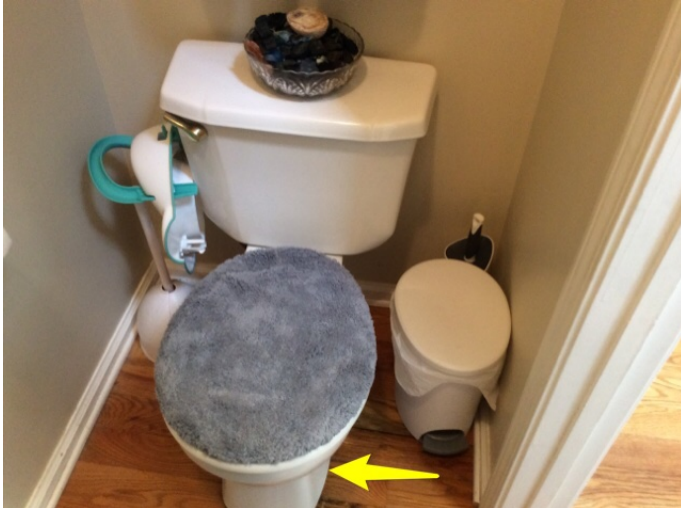
**MA** **RE** **194:** - The 1/2 bathroom commode was observed loose at base / floor junction and requires tightening and possible a new wax seal since it was excessively loose.

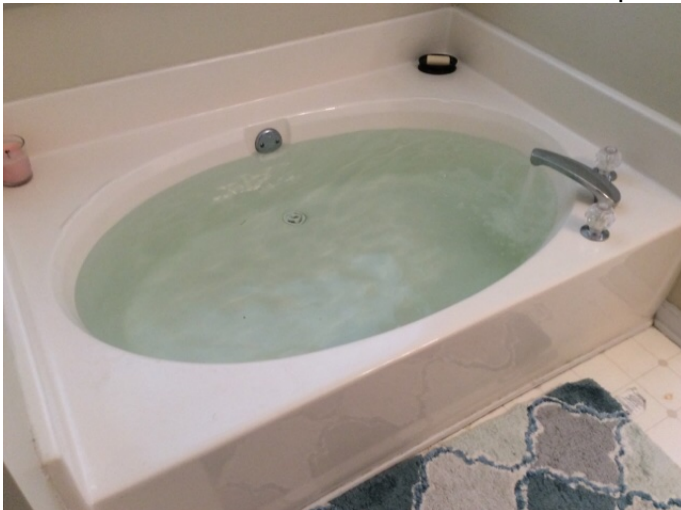
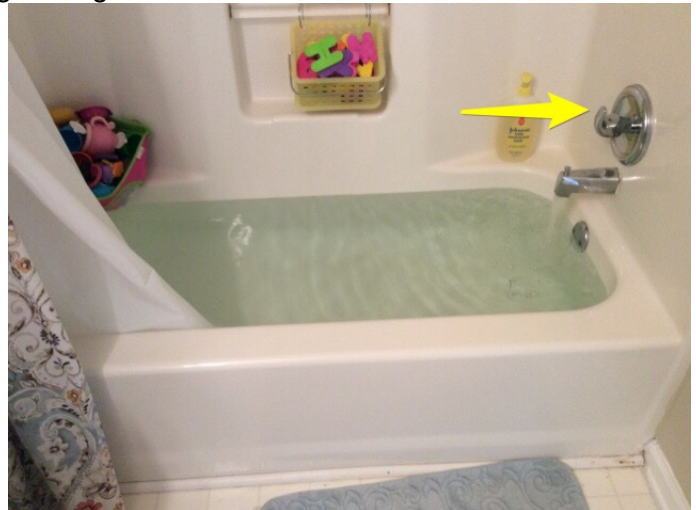
**MA** **195:** - All bathtubs were filled to the overflow for the inspection and appear to be properly installed and in serviceable condition. A loose faucet handle requiring tightening was found at the 2nd floor hall bathtub.

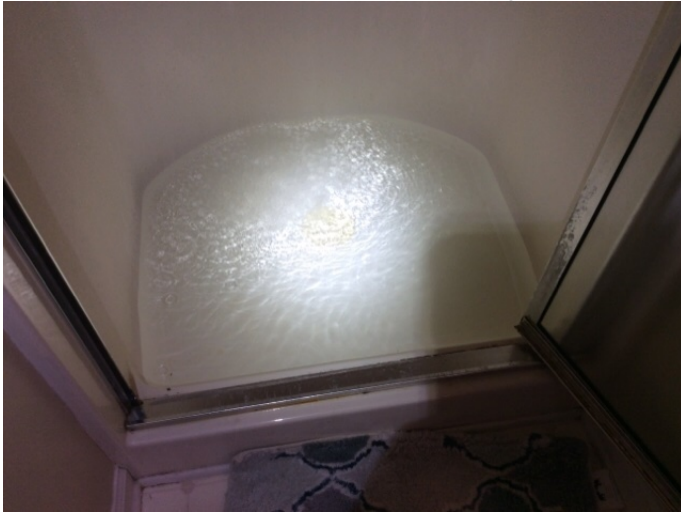
## Air Conditioning & Ventilation

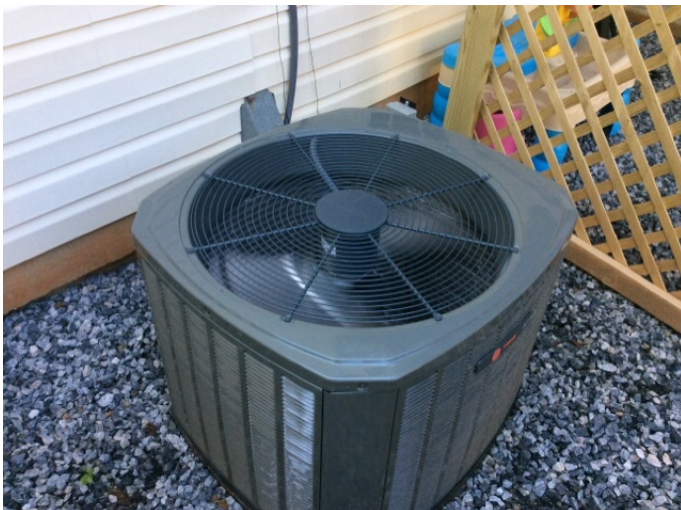
- 201:** - Number of units: 1  
**202:** - Equipment configuration: Split or remote system  
**203:** - Unit was dated 2017

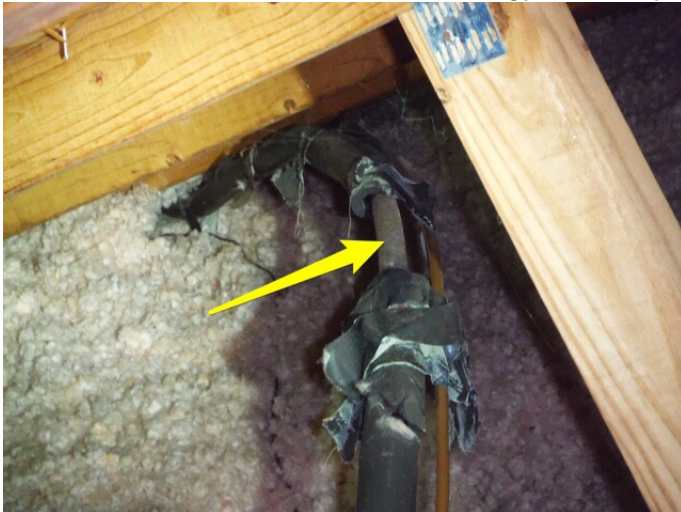
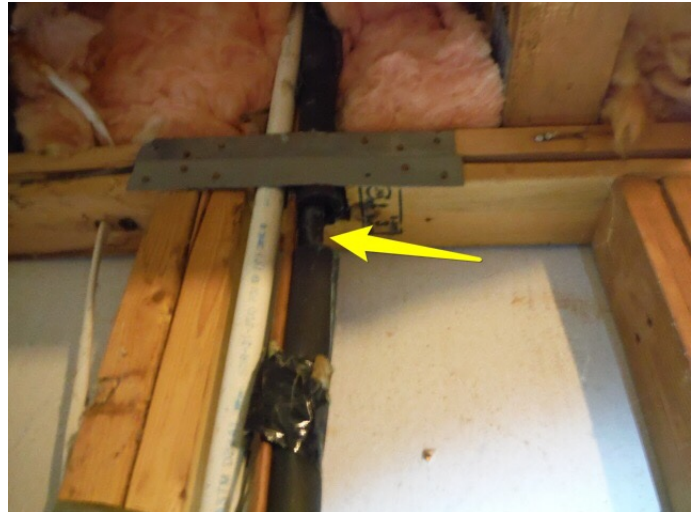
- MA RE 206:** - Foam insulation was found deteriorated and missing from portions of the refrigerant line in the attic and rear basement wall. Recommend that all missing insulation be replaced to prevent dripping condensation below and increase energy efficiency.

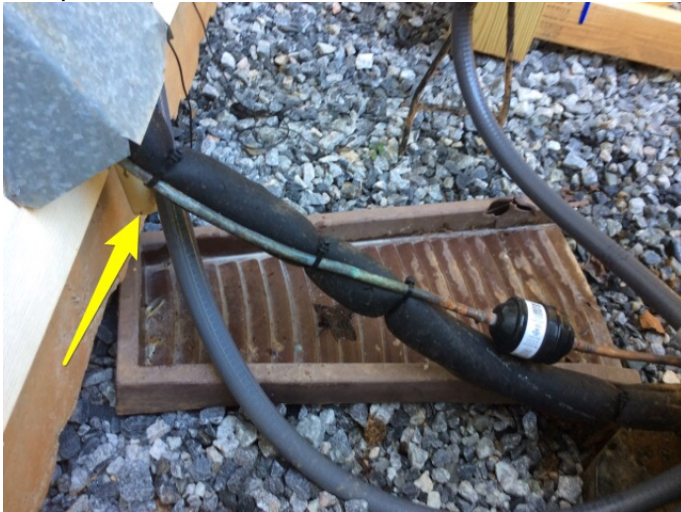
## CONDENSING/COMPRESSOR UNIT

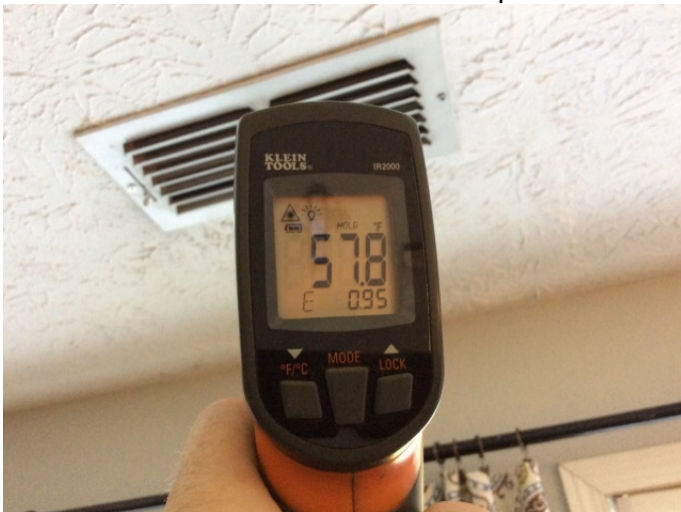
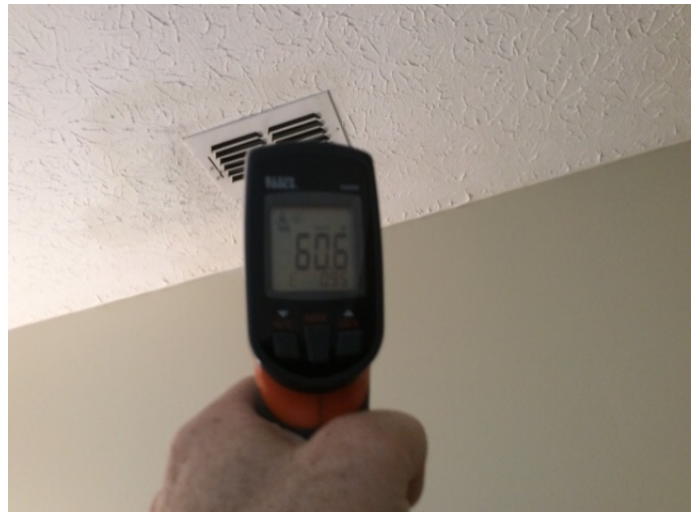
**210:** - GREAT NEWS! The A/C condensing units for each level were observed to operate serviceably in cooling mode when tested with normal operating controls and the ducts, registers and air flow were observed to be serviceable at the time of the inspection.

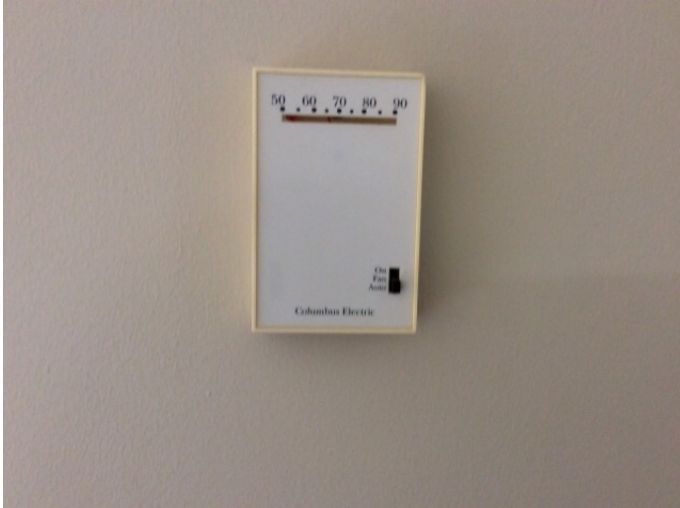
**UP 212:** - The 2nd floor thermostat did not appear to be functioning and the system did not appear to be a zoned system, meaning there is only one thermostat in the foyer controlling the whole house.

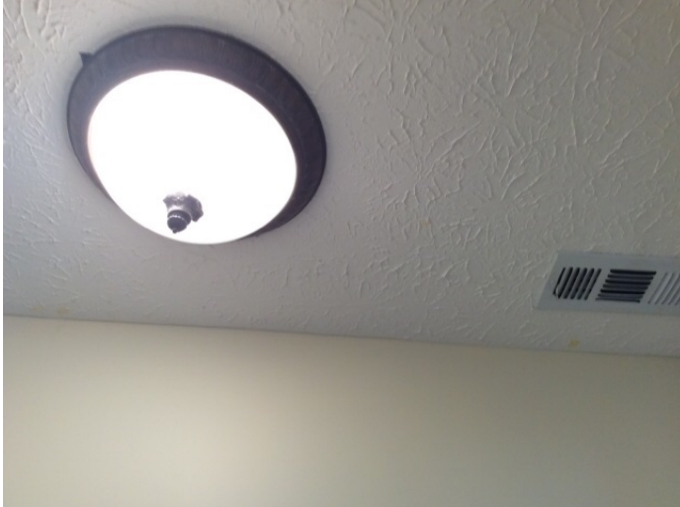
**RE 213:** - The main level bathroom ventilation fan did not have an air intake opening, but the fan could be heard running when tested. Within a minute of testing, an unusual motor burning smell was detected. Recommend corrections and possible replacement by a licensed contractor.

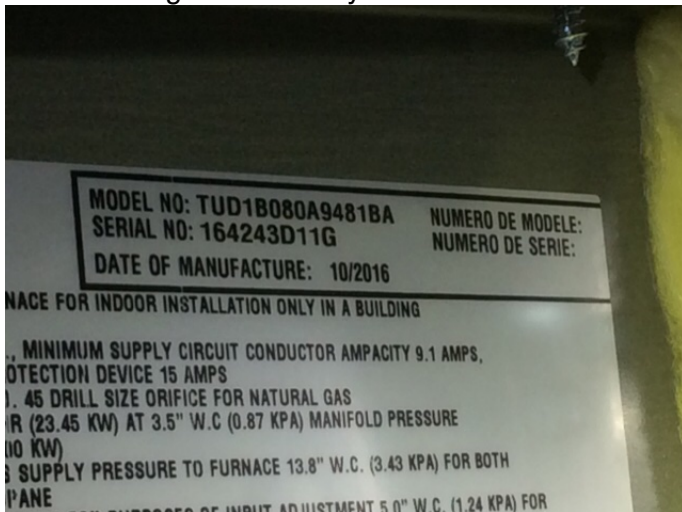
**MA** **221:** - Filter size: 16 x 25 x 1 inch conventional disposable type. Recommend replacement upon move-in and every change of season thereafter.

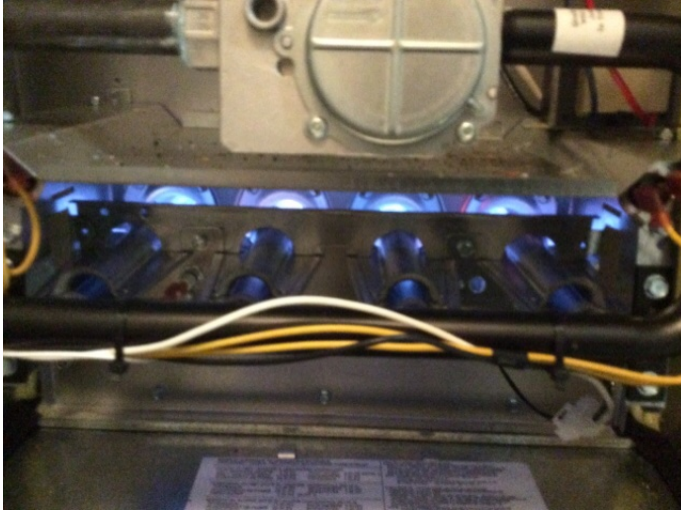
**222:** - The burners were inspected and found to be clean and in good working order.

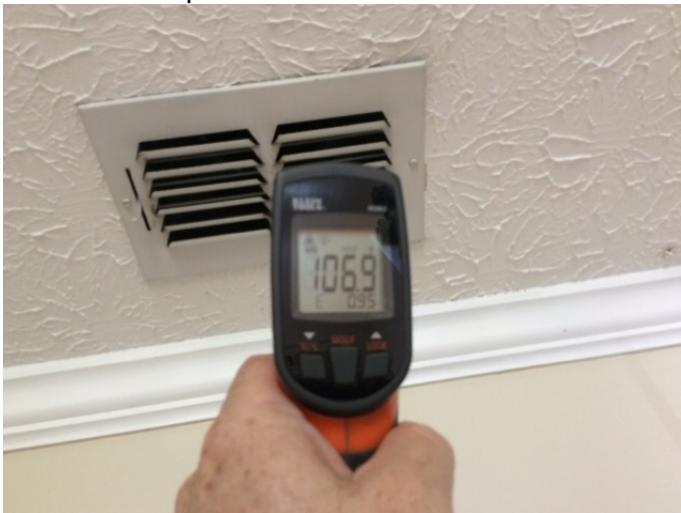
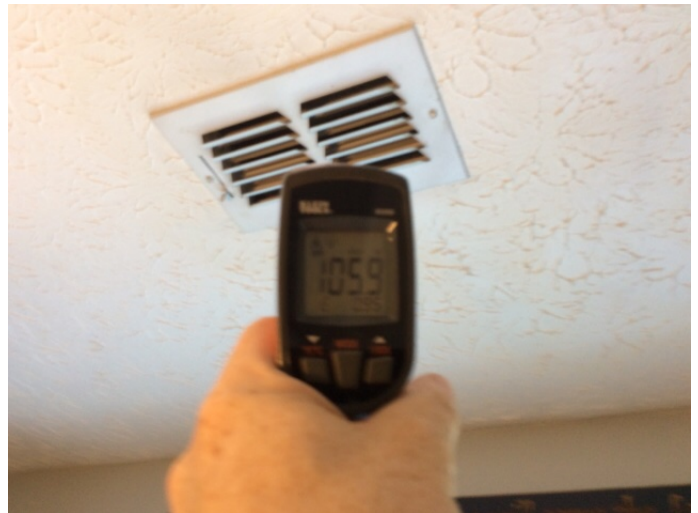
**225:** - GREAT NEWS: The furnace system was observed to operate serviceably in heating mode when tested with normal operating controls and the ducts, registers and air flow were observed to be serviceable at the time of the inspection.

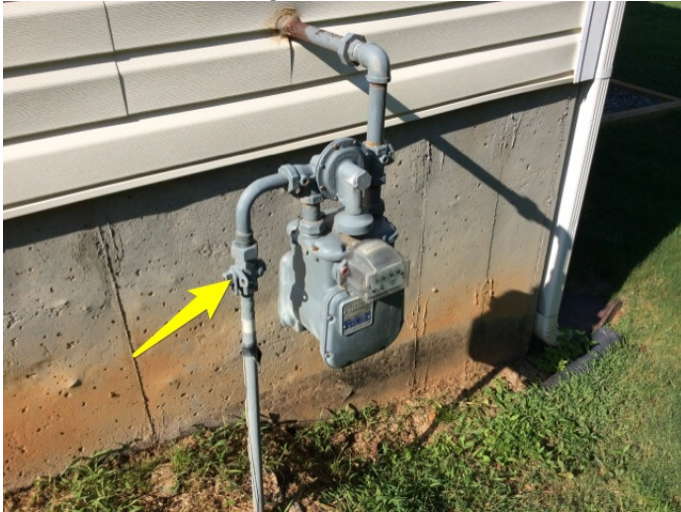
**227:** - The gas meter was located outside on the right side of the home. The main gas supply shutoff valve is located on the riser pipe between the ground and the meter and should be turned 90 degrees (either way) in order to shut off the gas.

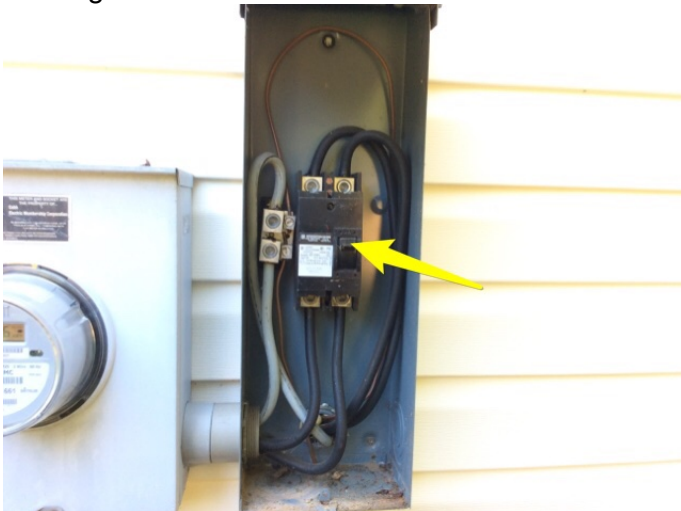
## DISTRIBUTION PANEL

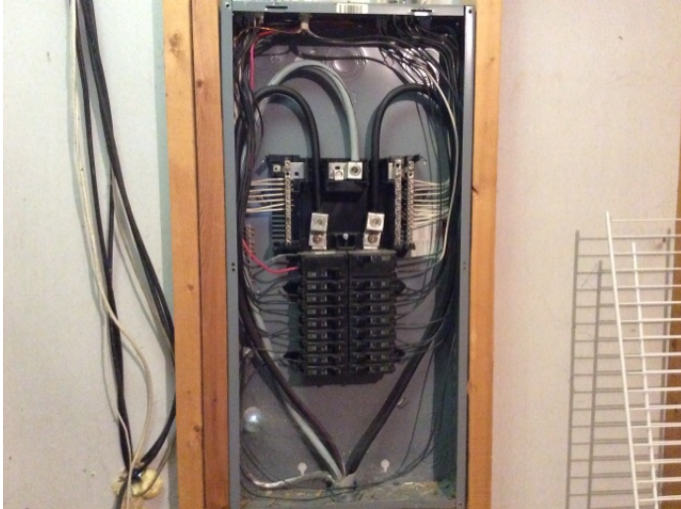
**237:** - GREAT NEWS! The 150 amp main electrical service panel, system earthing, basement sub-panel, panel bonding, isolation of neutral / grounding circuit wires, and circuit breaker size / circuit breaker ampacity were observed to be in serviceable condition at the time of the inspection.

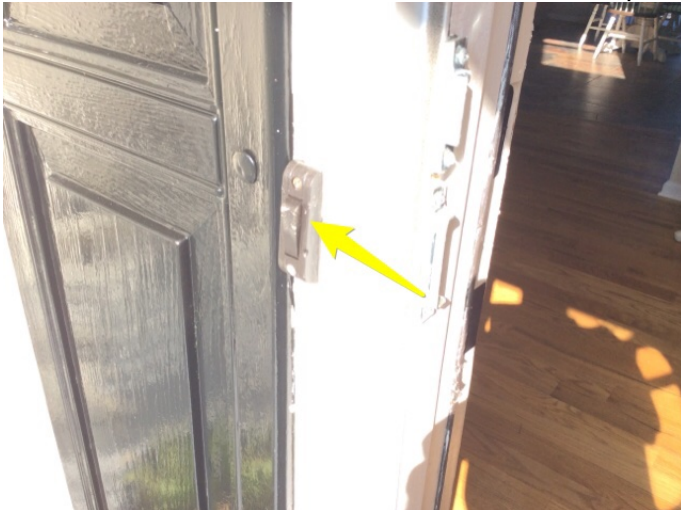
**238:** - The front entrance door bell did not operate when tested requiring repair.

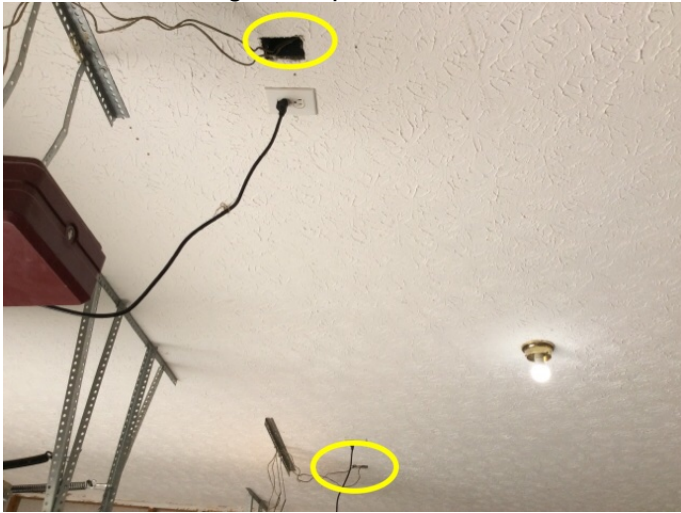
**MA** 240: - Missing cover plates were observed in the garage ceiling.

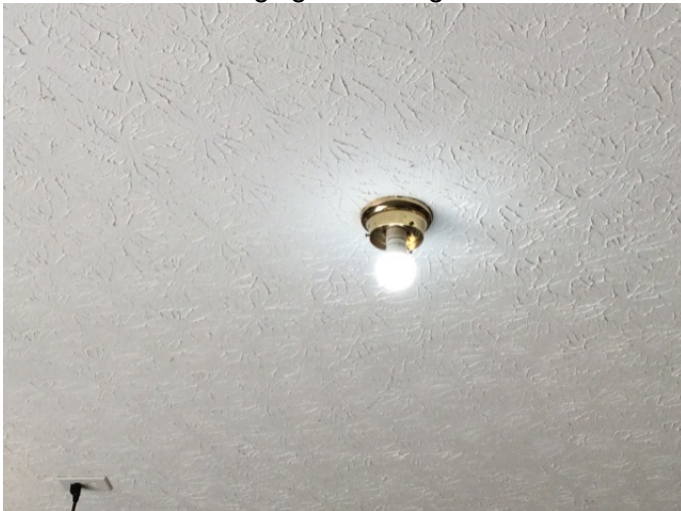
**RE 242:** - The ceiling fan in the second floor left center bedroom made unusual bearing noise during operation and may require replacement.

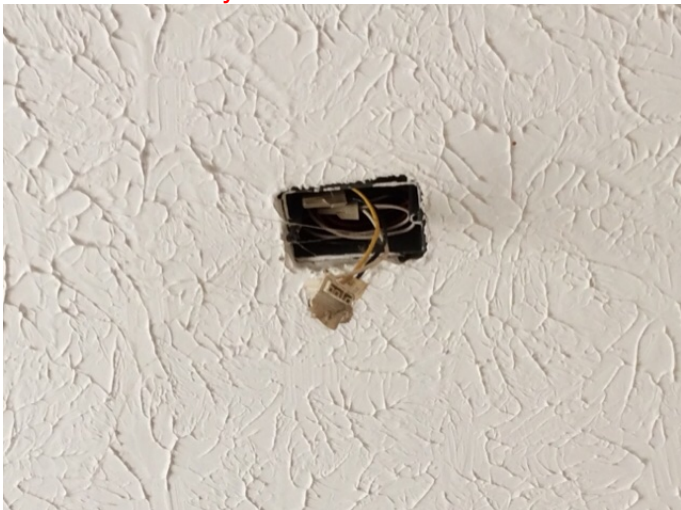
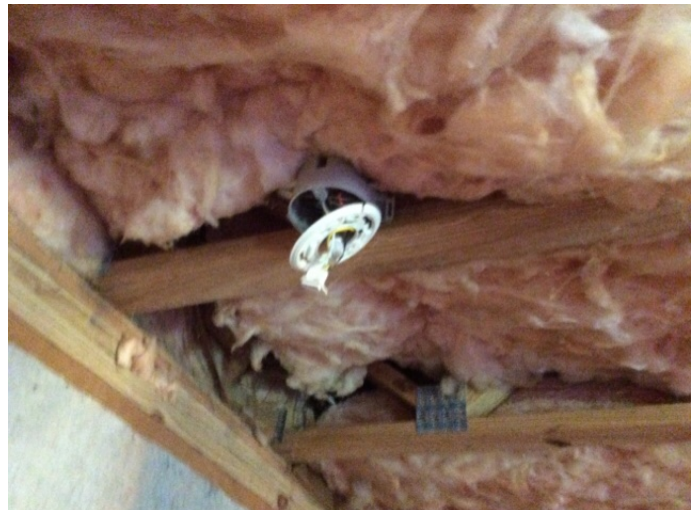
**MA SA 244:** - Required smoke detector were found missing and require replacement in the garage, basement and foyer.

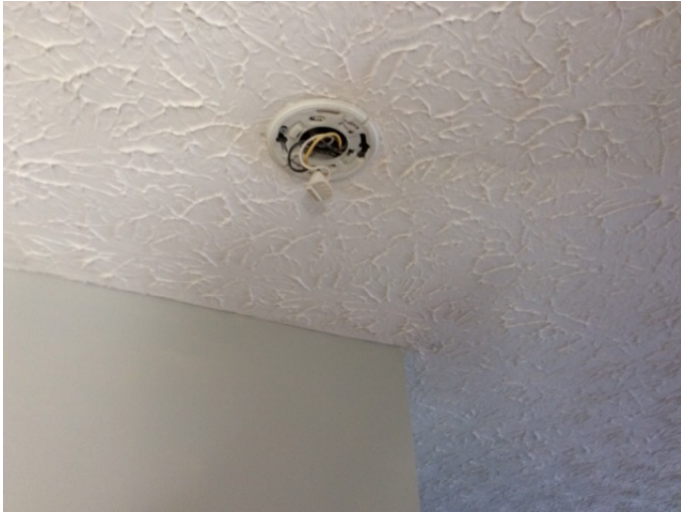
#### **RECEPTACLES: OVERALL**
