Confidential Pre-Drywall Inspection Report

LOCATED AT:
5360 Blue Mountain Lane Lot #175
Cumming, GA 30040

INSPECTED ON:
Wednesday, March 2, 2022

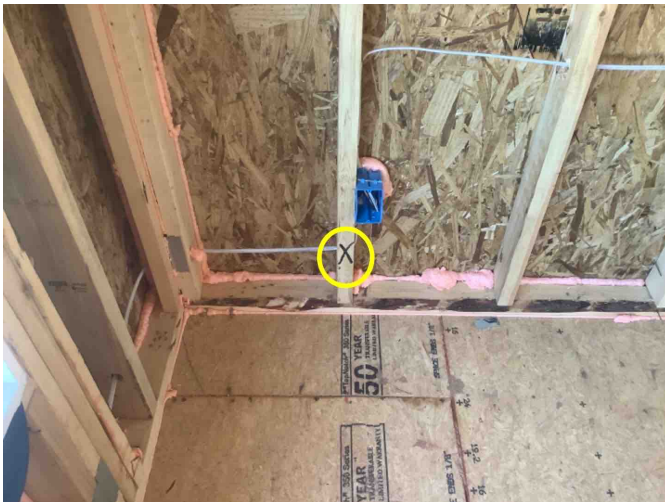
2nd level front center bedroom

RE 22: Nail protective guards are required where electrical wires or pipes are within 1-1/4" from the edge of a stud to prevent damage. Also, they are recommended at all studs (regardless of the 1-1/4" rule) behind kitchen cabinets and bathroom vanity cabinets where screws are much longer 2-1/2". Nail guards were found missing at locations where the inspector marked with an "X" on the studs as shown in the pictures captions below; 2nd level front center bedroom, Master bedroom, Kitchen, Family room, Main level bedroom, Kitchen multiple and Main level hall multiple

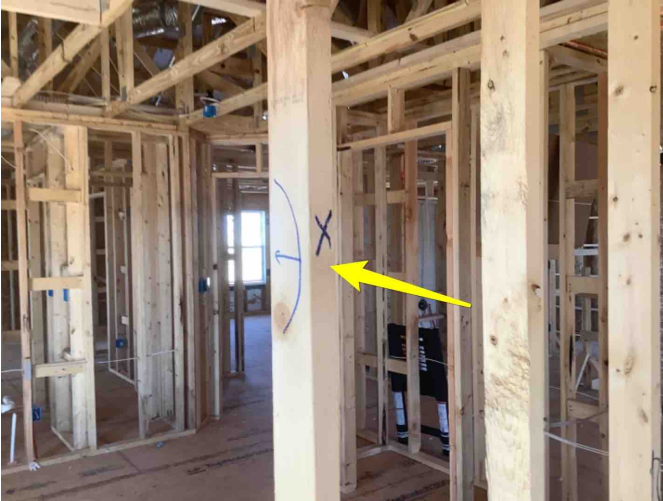
2nd level master bedroom

RE 23: Bowed/warped studs requiring correction were found where the inspector marked the studs with (- for left bow, or -) for right bow, located as shown in the pictures & captions below: 2nd level master bedroom, Family room, Rear garage wall, Main level right side bedroom, Laundry room, Left side garage and Kitchen

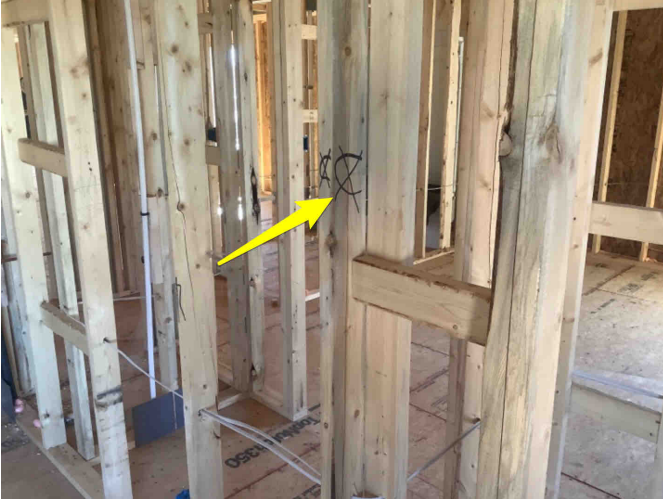
2nd level front center bedroom

RE 24: Cracked through, spiral cracked or extensively damaged wood studs requiring replacement or sistering were observed at the locations shown in the picture captions below and marked by the inspector with an CX; 2nd level front center bedroom, Master bedroom, 2nd level front right bedroom, Master closet, 2nd level hallway, 2nd level top of stairs, Second level hall, Master water closet, Second level front right bedroom closet, Master bedroom dead space and Master bedroom sitting area.

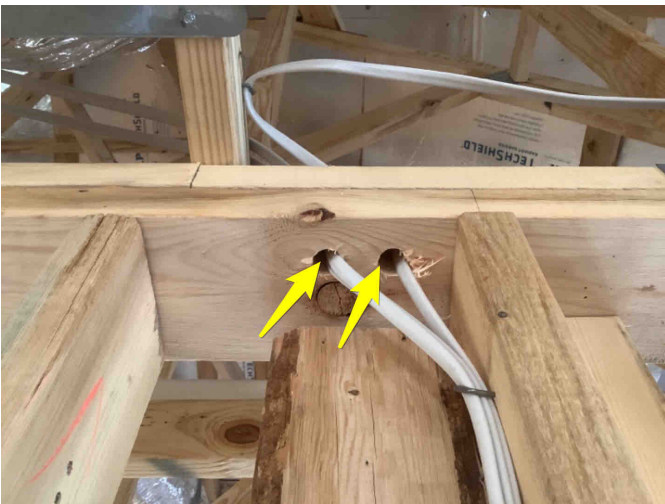
2nd level hall

RE 25: Fire-stopping foam sealant required at all wire, pipe & duct penetrations between floors at both top and bottom plates were found missing at the following locations; 2nd level hall, Master bedroom and Mudroom.

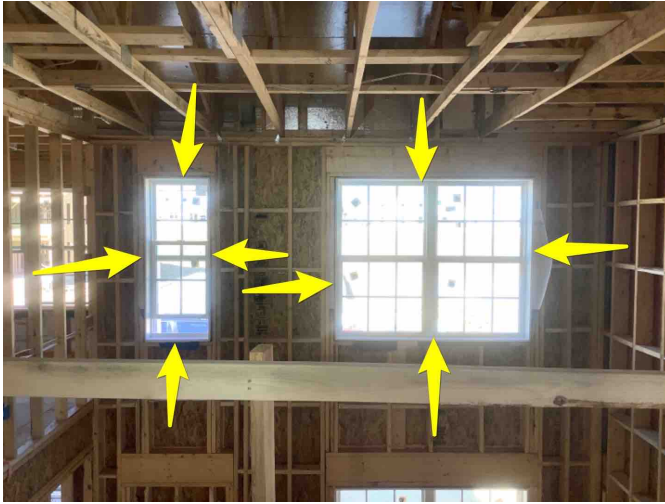
Foyer

RE 26: Foam sealant was observed missing around a window that requires installation in the Foyer.

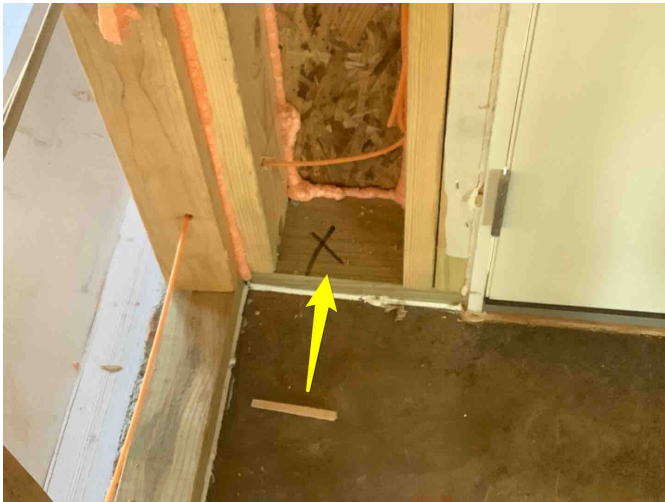
Front door

RE 27: Sill plate anchor fasteners (straps, power shots, or bolts) are required to be spaced no more than (4, 5 or 6) feet apart and 1 foot from plate ends or openings around the perimeter exterior walls of the home. Sill plate anchor straps, bolts, or power shots were found missing where the inspector marked with an X around the perimeter wall sill plates and require correction at the following locations: Front door, Front left x3, Dining room, Kitchen x3, Family room, Garage and Rear right.

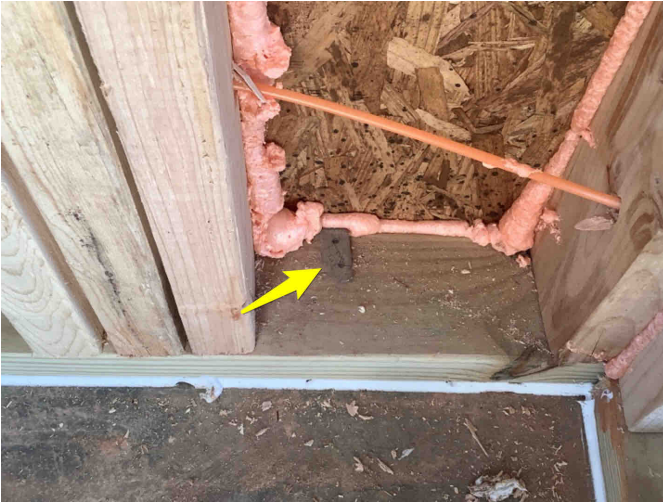
Main level right side bedroom

RE 28: Wall anchor strap fasteners/nails were found missing and require correction at the wall sill plates in the following locations; Main level right side bedroom, Garage and Garage.

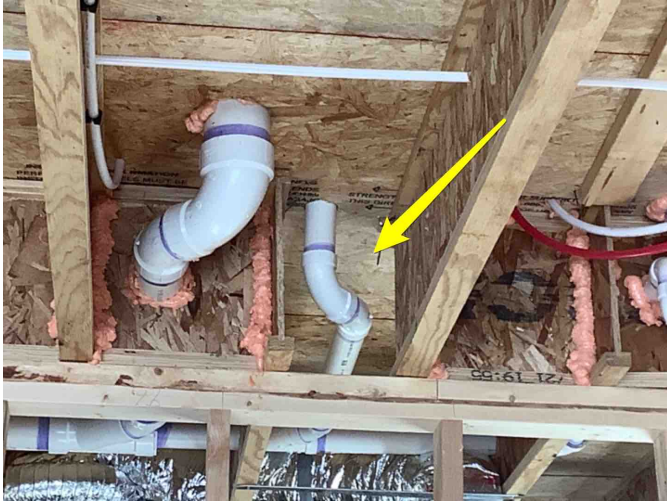
RE 29: A prohibited opening was observed at the garage to living space floor joist junction. All openings require fire blocking and fire stopping as needed to seal off the garage from the habitable living space.

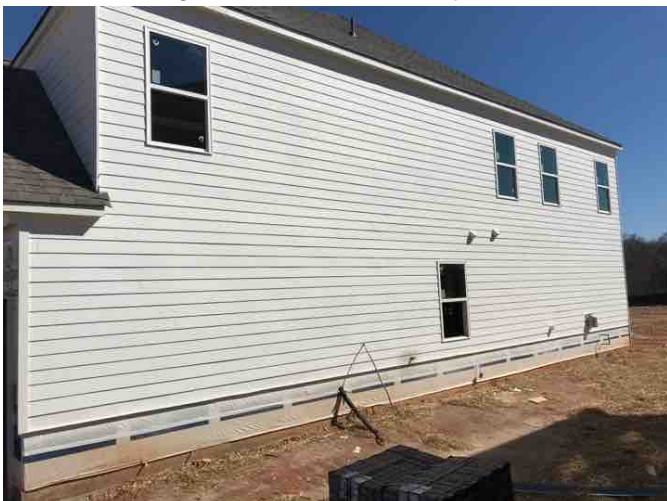
Right side

MO RE 31: Overall the fiber-cement board appeared properly installed and in new condition. Brick or stone cladding at the front had not yet been installed at the time of the inspection.

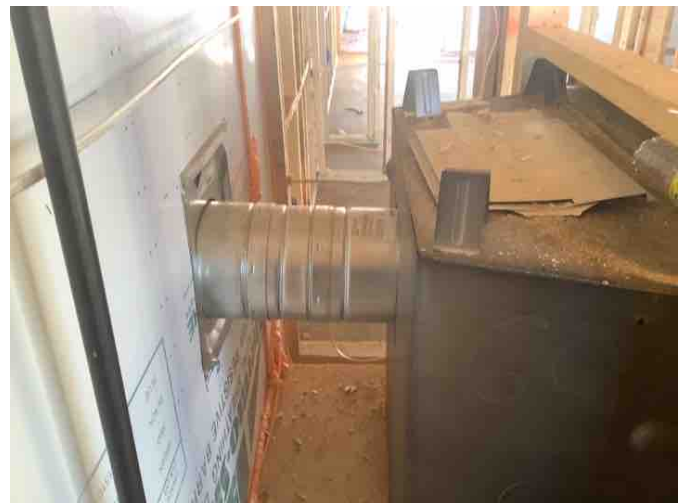
-Family room

40: The family room fireplace and flue appeared to be roughed-in correctly with proper clearances from combustible materials.

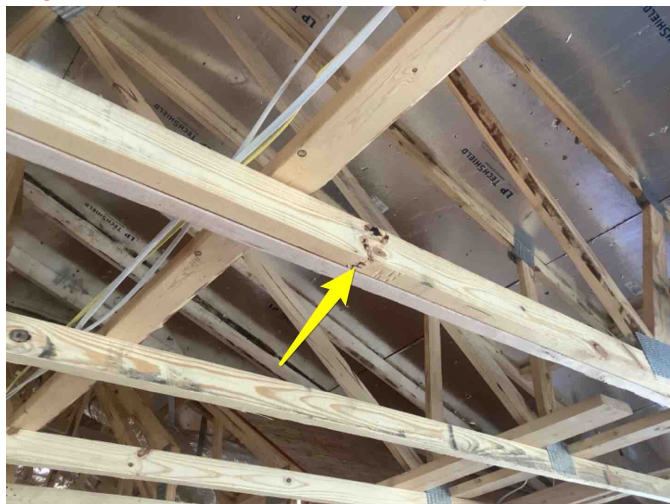
2nd level front left

RE EV 44: Two cracked truss members were observed in the 2nd level front left, Above loft/master closet and Second floor right center bedroom attic areas. Usually the repair consists of two sister/scab boards nailed on each side the full length of the web. Since this is an engineered product it is required that a letter of approval is provided for the design of the repair or alteration of the truss from a licensed professional engineer. Thereafter, recommend any needed corrections by a qualified framing contractor.

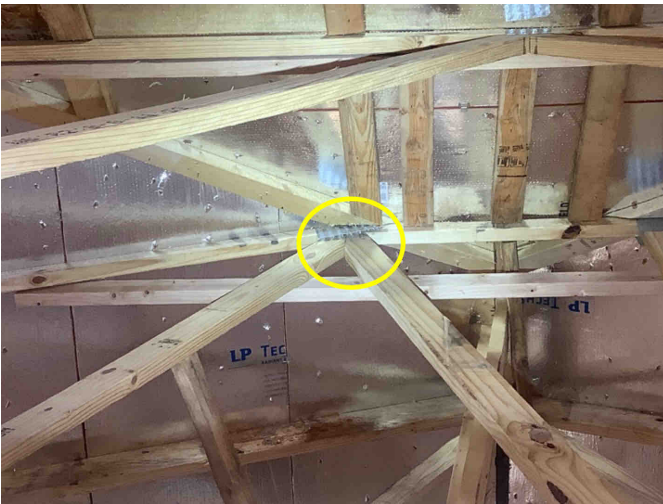
RE 45: Multiple loose/detached gusset plates were observed above the Above loft requiring correction by a qualified contractor. Recommend a letter of approval is provided for design of repair or alteration from a licensed professional engineer and the repair performed by a qualified contractor which typically involves adding plywood on the sides of truss where the damaged gusset plate is located.

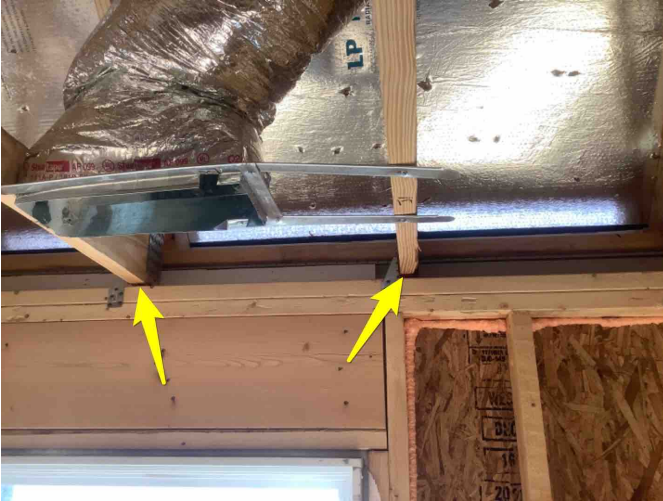
2nd level right side center bedroom

RE 46: Two roof trusses were observed not fully bearing on the top wall plates in the 2nd level right side center bedroom. Recommend correction by a qualified framing contractor.

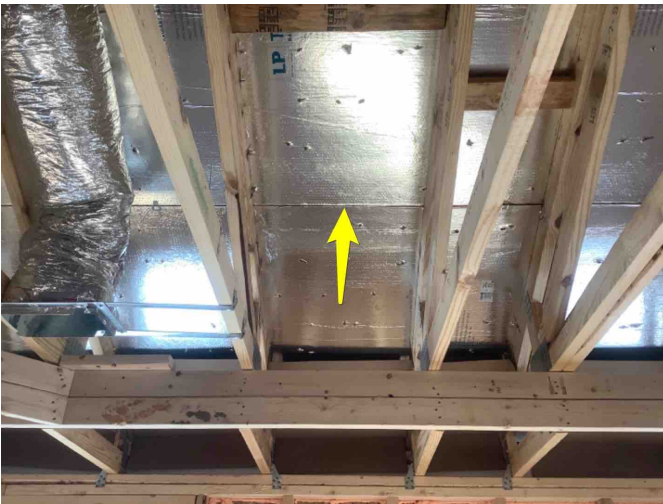
Master bedroom

RE 47: A roof sheathing H-clip was found missing in the attic above the Master bedroom. Recommend installation of wood blocking at any locations where clips were missing.

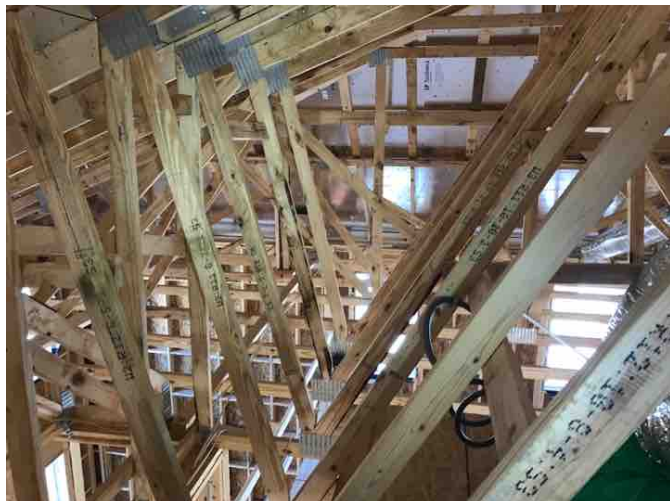
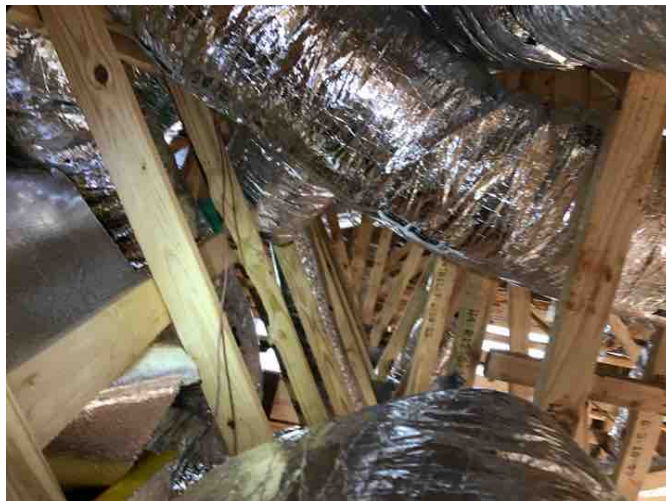
48: Excluding any listed items, the overall roof/attic trusses, lateral/diagonal bracing and roof decking were observed in serviceable condition at the time of the inspection.

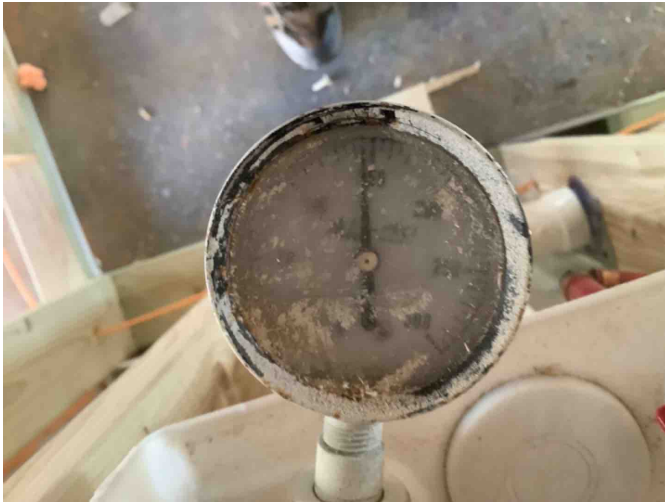
MO 53: The completed rough-in plumbing system consisted of PVC type drain pipes with PEX type water service pipes with 3/4" plastic main water pipe entering the slab. The plumbing rough-in system was observed to be in serviceable condition at the time of the inspection. The water supply pressure test was at 150 psi located in the laundry room indicating the water supply system was not under a pressure test which is typically required to pass municipal inspection, but may or may not have already occurred. Also, recommend monitoring gauge to ensure air pressure does not decrease, which if it does, may indicate a leak in the water pipes.

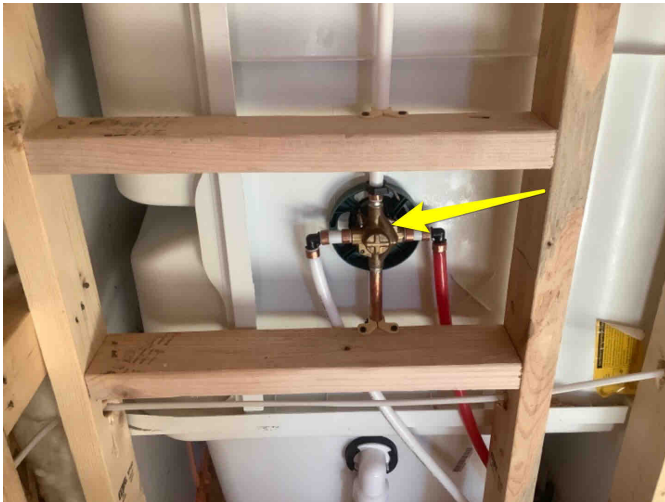
2nd level right side bedroom

RE 54: A bathtub and shower faucet was found slightly loose in the 2nd level right side bedroom. Typically wood blocking is installed directly behind the rough-in of the faucets in order to screw them down tight with the provided holes in the metal flange, otherwise additional strapping will be required in order to tighten the faucet. Recommend corrections by a qualified plumbing contractor.

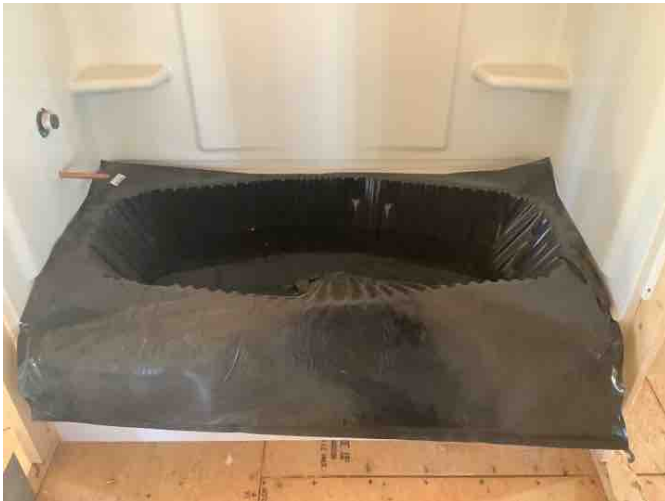
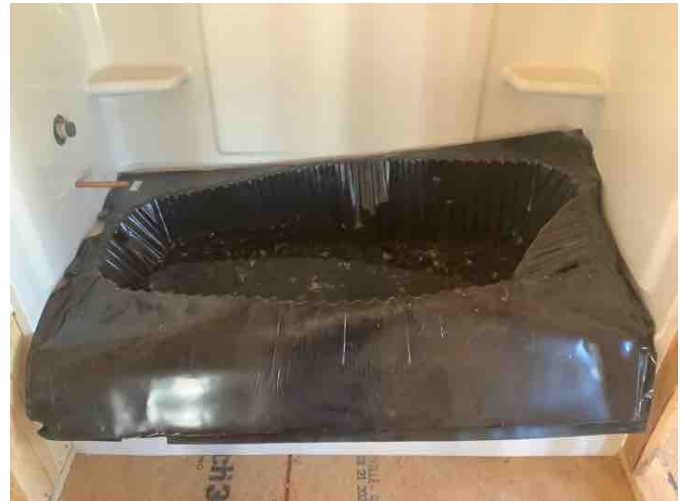
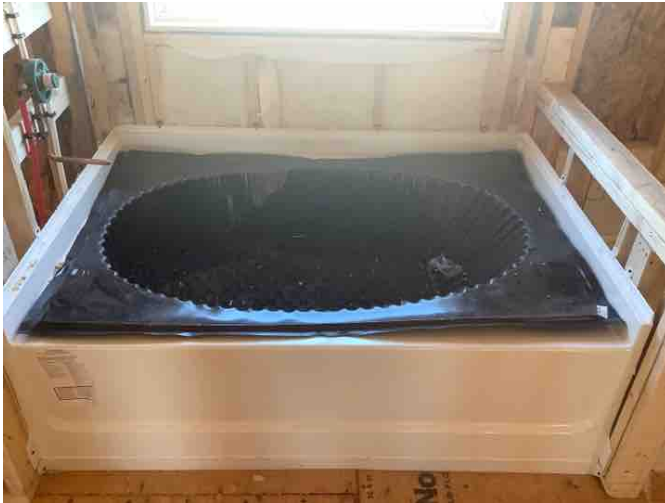
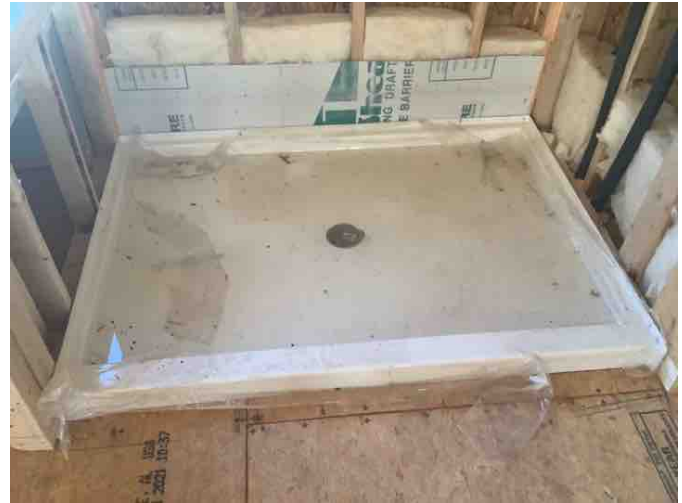
MO 55: The visible drain piping appears to be properly installed and in serviceable new condition. The tubs and showers were full of water necessary to test the drain piping system indicating it is ready for municipal rough-in inspection.

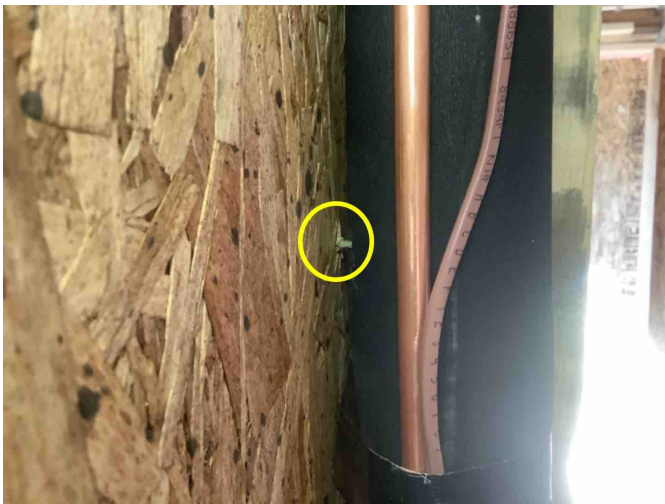
RE 56: Two siding nails were found directly behind the A/C refrigerant lines and condensate pipe in the 2nd level front right bedroom possibly causing punctures in the lines. Recommend evaluation and any need corrections by a qualified licensed HVAC contractor.

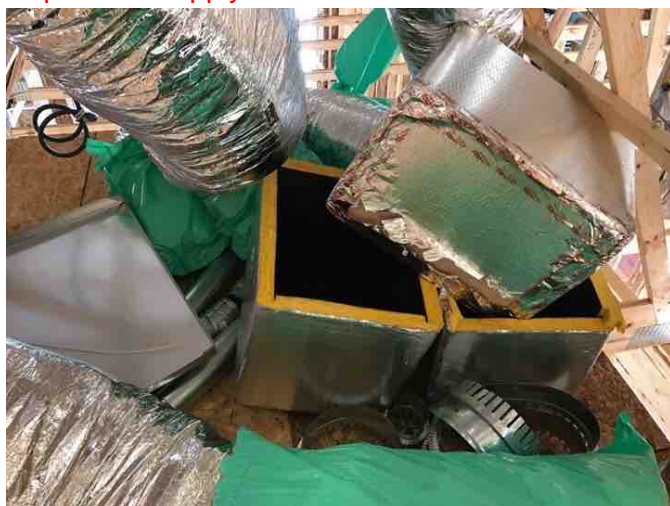
RE 57: The rough-in HVAC attic unit was not yet installed at time of inspection. However, the distribution ducts, the condensation drain pipes were observed to be in serviceable condition at the time of the inspection. Supply and return ducts were run to each room or area.

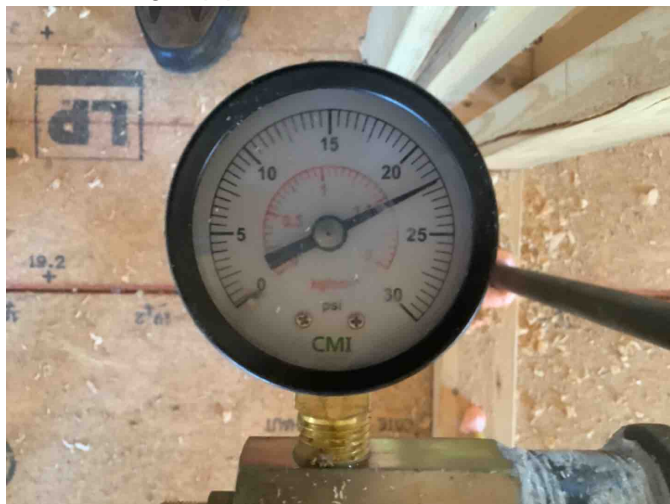
MO 58: The rough-in gas piping appeared to be properly installed when inspected. The gas pressure test gauge was at 23 psi, so it was under a pressure test typically required by the municipal inspection. Recommend monitoring gauge to ensure air pressure does not decrease, which if it does, may indicate a leak in the gas pipes.
