Confidential Pre-Drywall Inspection Report

LOCATED AT:
5360 Blue Mountain Lane Lot #175
Cumming, GA 30040

INSPECTED ON:
Wednesday, March 2, 2022

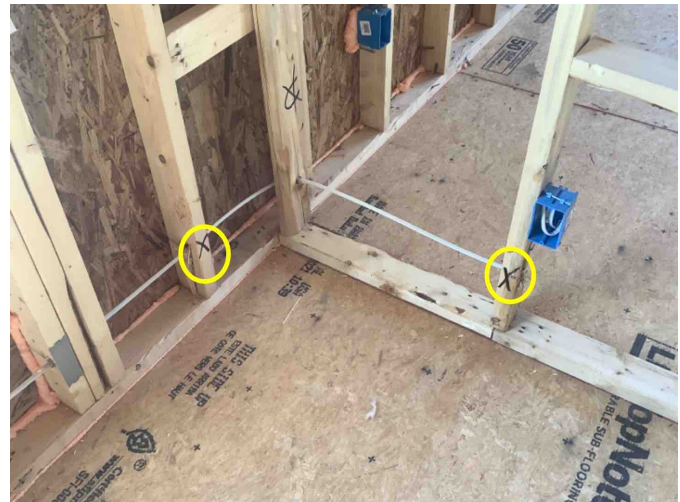
Master bedroom

RE 22: Nail protective guards are required where electrical wires or pipes are within 1-1/4" from the edge of a stud to prevent damage. Also, they are recommended at all studs (regardless of the 1-1/4" rule) behind kitchen cabinets and bathroom vanity cabinets where screws are much longer 2-1/2". Nail guards were found missing at locations where the inspector marked with an "X" on the studs as shown in the pictures captions below; 2nd level front center bedroom, Master bedroom, Kitchen, Family room, Main level bedroom, Kitchen multiple and Main level hall multiple

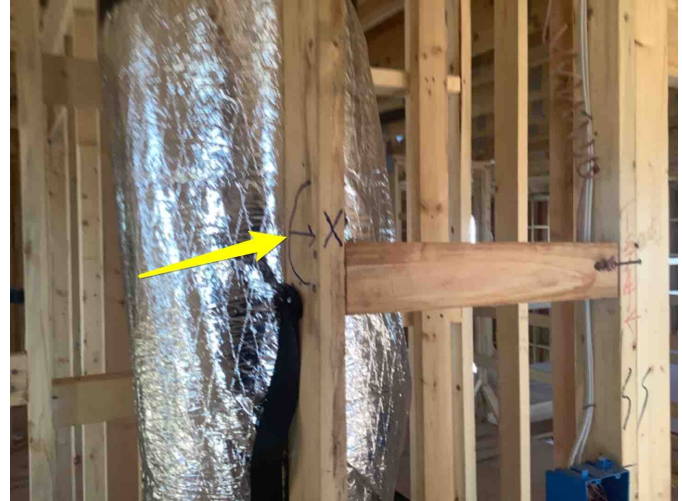
-2nd level master bedroom

RE 23: Bowed/warped studs requiring correction were found where the inspector marked the studs with (- for left bow, or -) for right bow, located as shown in the pictures & captions below: 2nd level master bedroom, Family room, Rear garage wall, Main level right side bedroom, Laundry room, Left side garage and Kitchen

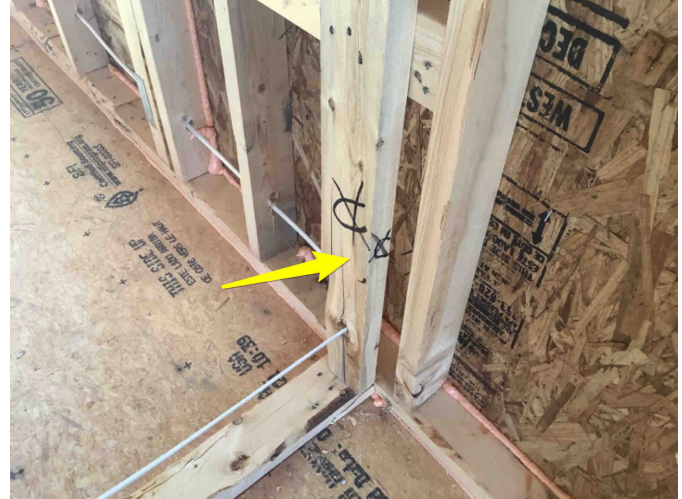
RE 24: Cracked through, spiral cracked or extensively damaged wood studs requiring replacement or sistering were observed at the locations shown in the picture captions below and marked by the inspector with an CX; 2nd level front center bedroom, Master bedroom, 2nd level front right bedroom, Master closet, 2nd level hallway, 2nd level top of stairs, Second level hall, Master water closet, Second level front right bedroom closet, Master bedroom dead space and Master bedroom sitting area.

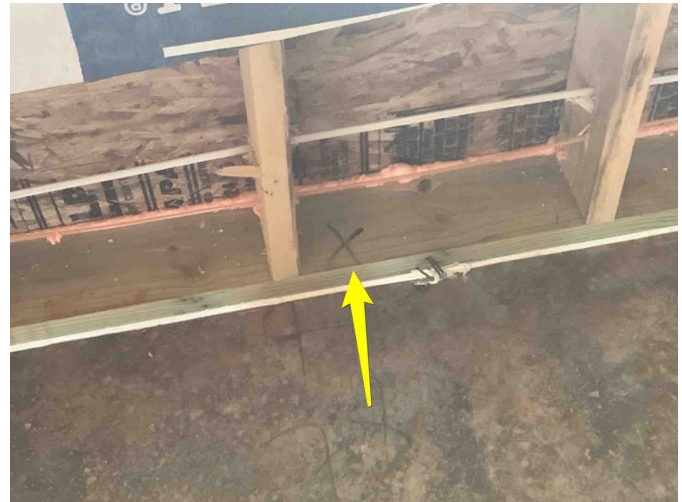
Front left x3

RE 27: Sill plate anchor fasteners (straps, power shots, or bolts) are required to be spaced no more than (4, 5 or 6) feet apart and 1 foot from plate ends or openings around the perimeter exterior walls of the home. Sill plate anchor straps, bolts, or power shots were found missing where the inspector marked with an X around the perimeter wall sill plates and require correction at the following locations: Front door, Front left x3, Dining room, Kitchen x3, Family room, Garage and Rear right.

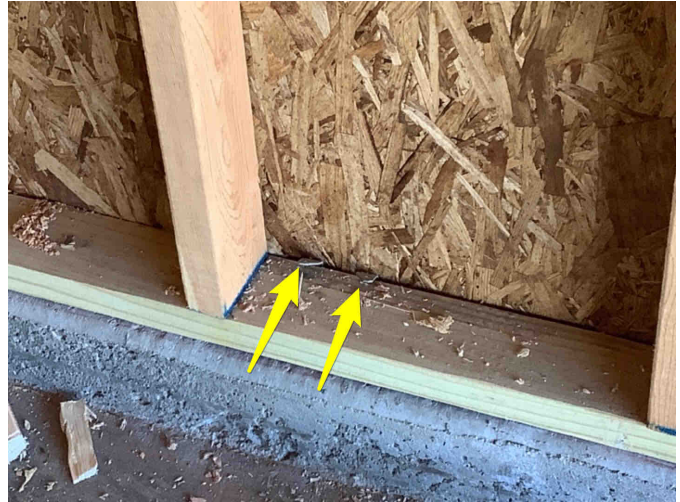
RE 28: Wall anchor strap fasteners/nails were found missing and require correction at the wall sill plates in the following locations; Main level right side bedroom, Garage and Garage.

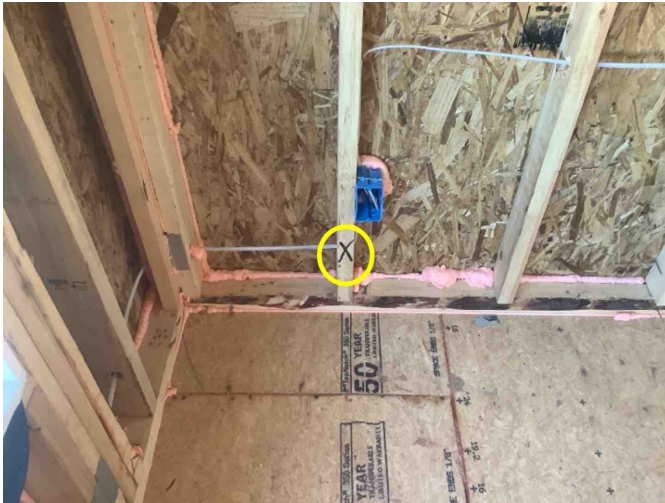
2nd level front center bedroom

RE s-22: Nail protective guards are required where electrical wires or pipes are within 1-1/4" from the edge of a stud to prevent damage. Also, they are recommended at all studs (regardless of the 1-1/4" rule) behind kitchen cabinets and bathroom vanity cabinets where screws are much longer 2-1/2". Nail guards were found missing at locations where the inspector marked with an "X" on the studs as shown in the pictures captions below; 2nd level front center bedroom, Master bedroom, Kitchen, Family room, Main level bedroom, Kitchen multiple and Main level hall multiple

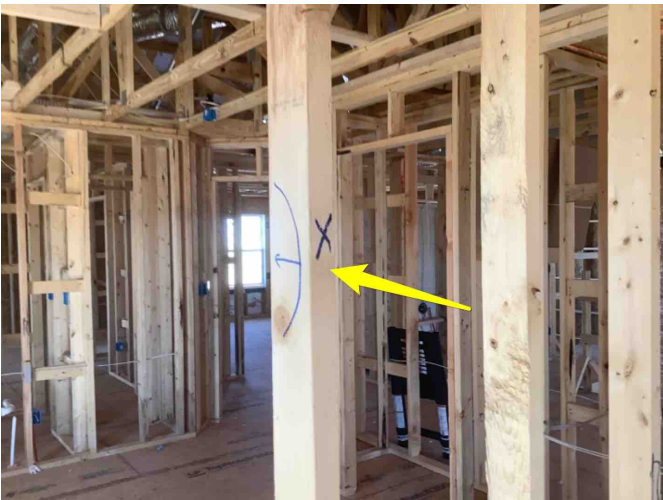
2nd level master bedroom

RE s-23: Bowed/warped studs requiring correction were found where the inspector marked the studs with (- for left bow, or -) for right bow, located as shown in the pictures & captions below: 2nd level master bedroom, Family room, Rear garage wall, Main level right side bedroom, Laundry room, Left side garage and Kitchen

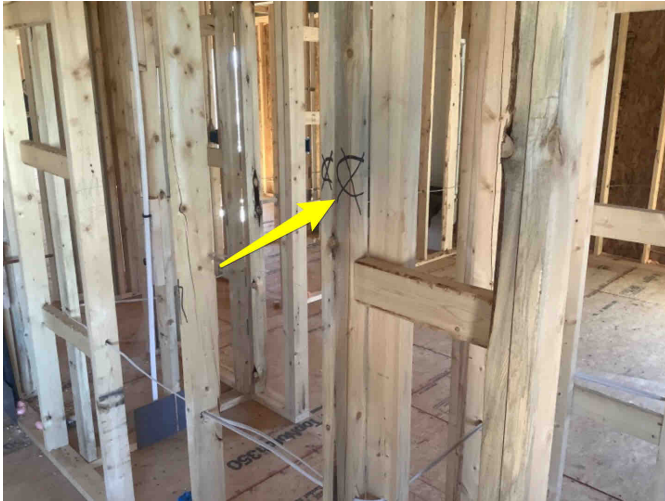
2nd level front center bedroom

RE s-24: Cracked through, spiral cracked or extensively damaged wood studs requiring replacement or sistering were observed at the locations shown in the picture captions below and marked by the inspector with an CX; 2nd level front center bedroom, Master bedroom, 2nd level front right bedroom, Master closet, 2nd level hallway, 2nd level top of stairs, Second level hall, Master water closet, Second level front right bedroom closet, Master bedroom dead space and Master bedroom sitting area.

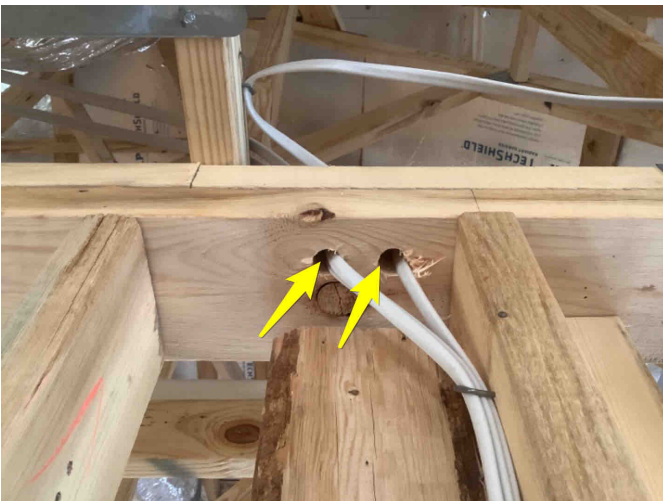
2nd level hall

RE s-25: Fire-stopping foam sealant required at all wire, pipe & duct penetrations between floors at both top and bottom plates were found missing at the following locations; 2nd level hall, Master bedroom and Mudroom.

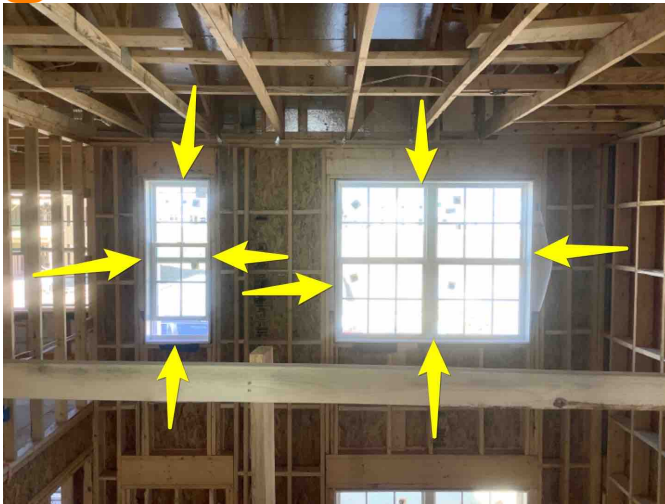
Foyer

RE s-26: Foam sealant was observed missing around a window that requires installation in the Foyer.

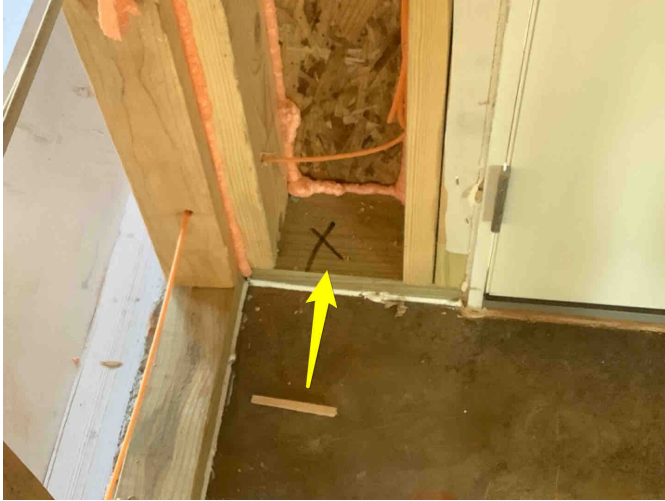
Front door

RE s-27: Sill plate anchor fasteners (straps, power shots, or bolts) are required to be spaced no more than (4, 5 or 6) feet apart and 1 foot from plate ends or openings around the perimeter exterior walls of the home. Sill plate anchor straps, bolts, or power shots were found missing where the inspector marked with an X around the perimeter wall sill plates and require correction at the following locations: Front door, Front left x3, Dinning room, Kitchen x3, Family room, Garage and Rear right.

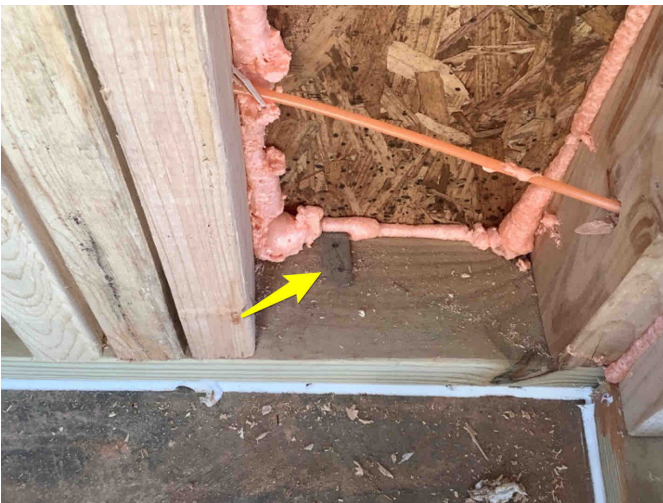
Main level right side bedroom

RE s-28: Wall anchor strap fasteners/nails were found missing and require correction at the wall sill plates in the following locations; Main level right side bedroom, Garage and Garage.

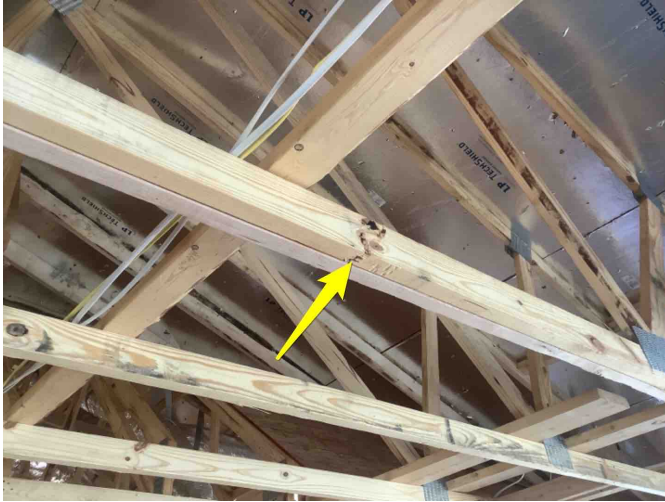
2nd level front left

RE EV s-44: Two cracked truss members were observed in the 2nd level front left, Above loft/master closet and Second floor right center bedroom attic areas. Usually the repair consists of two sister/scab boards nailed on each side the full length of the web. Since this is an engineered product it is required that a letter of approval is provided for the design of the repair or alteration of the truss from a licensed professional engineer. Thereafter, recommend any needed corrections by a qualified framing contractor.

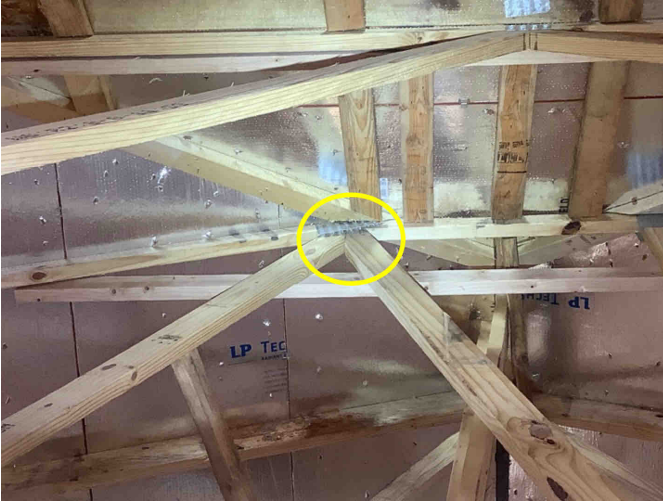
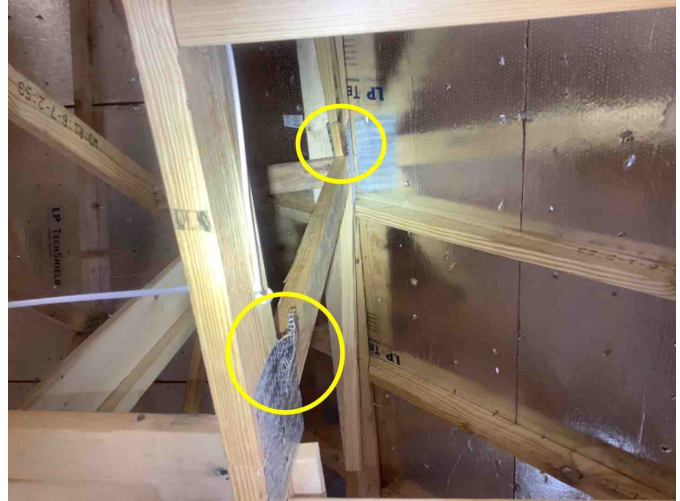
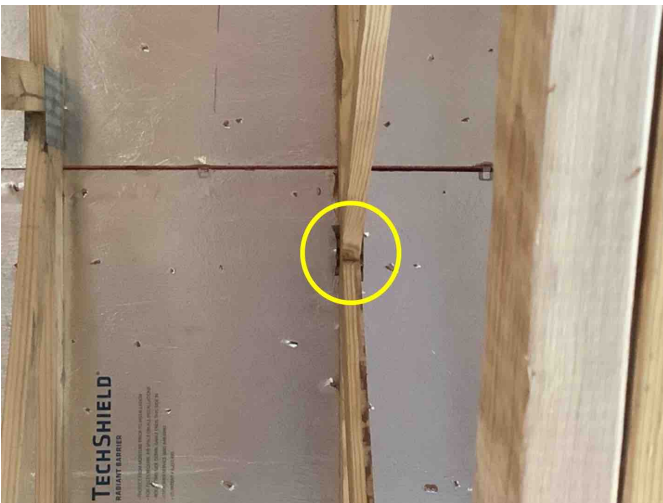
RE s-45: Multiple loose/detached gusset plates were observed above the Above loft requiring correction by a qualified contractor. Recommend a letter of approval is provided for design of repair or alteration from a licensed professional engineer and the repair performed by a qualified contractor which typically involves adding plywood on the sides of truss where the damaged gusset plate is located.

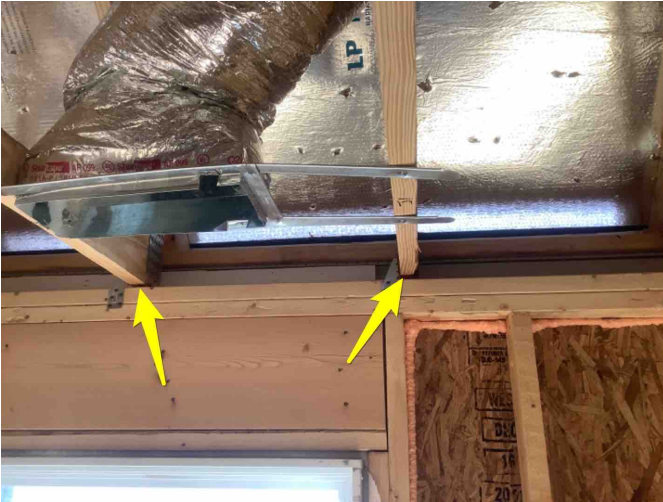
2nd level right side center bedroom

RE s-46: Two roof trusses were observed not fully bearing on the top wall plates in the 2nd level right side center bedroom. Recommend correction by a qualified framing contractor.

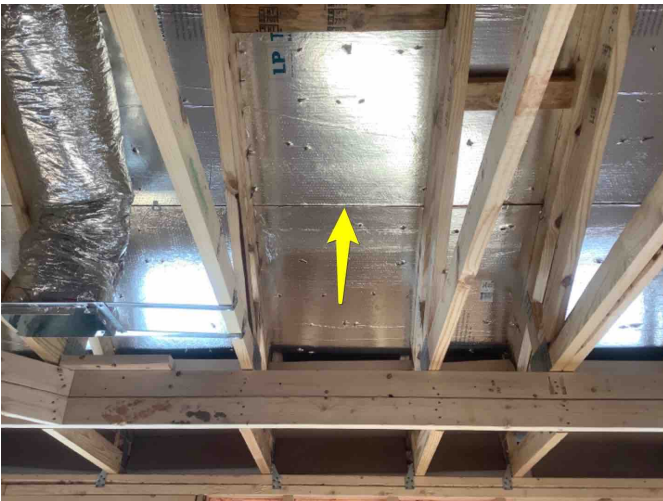
Master bedroom

RE s-47: A roof sheathing H-clip was found missing in the attic above the Master bedroom. Recommend installation of wood blocking at any locations where clips were missing.

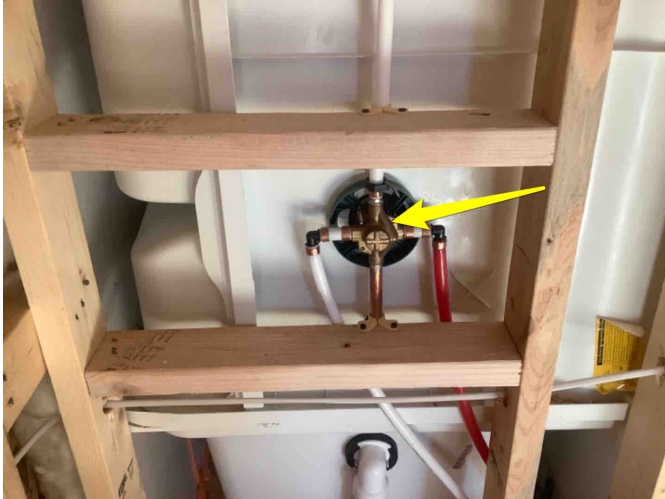
2nd level right side bedroom

RE s-54: A bathtub and shower faucet was found slightly loose in the 2nd level right side bedroom. Typically wood blocking is installed directly behind the rough-in of the faucets in order to screw them down tight with the provided holes in the metal flange, otherwise additional strapping will be required in order to tighten the faucet. Recommend corrections by a qualified plumbing contractor.

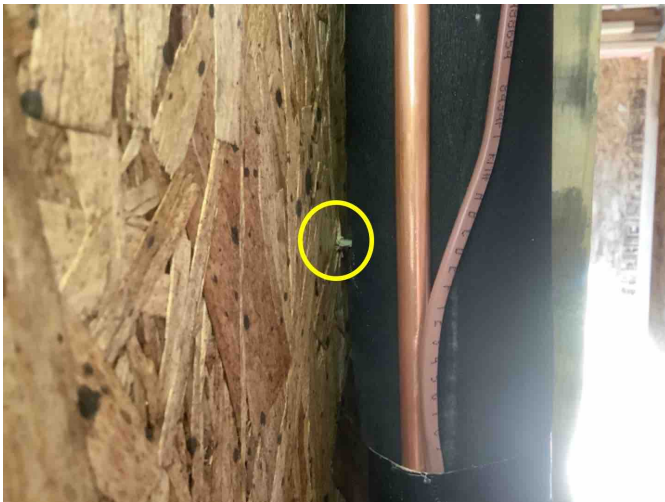
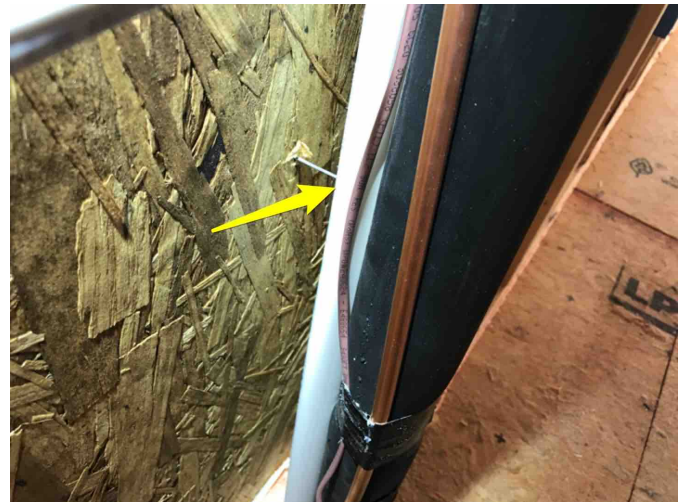
RE s-56: Two siding nails were found directly behind the A/C refrigerant lines and condensate pipe in the 2nd level front right bedroom possibly causing punctures in the lines. Recommend evaluation and any need corrections by a qualified licensed HVAC contractor.

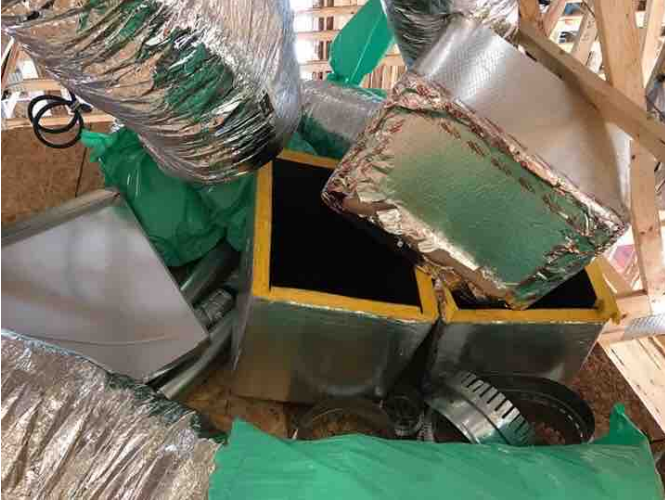
RE s-57: The rough-in HVAC attic unit was not yet installed at time of inspection. However, the distribution ducts, the condensation drain pipes were observed to be in serviceable condition at the time of the inspection. Supply and return ducts were run to each room or area.
