Confidential Inspection Report

LOCATED AT:
3000 Sample Road
Buford, Georgia 30519

INSPECTED ON:
Sunday, August 20, 2017

Inspector: Robert Conley ASHI #257097 NACHI #16052017
Conley Home Inspections, LLC
8189 Willow Tree Way, Alpharetta, GA 30005

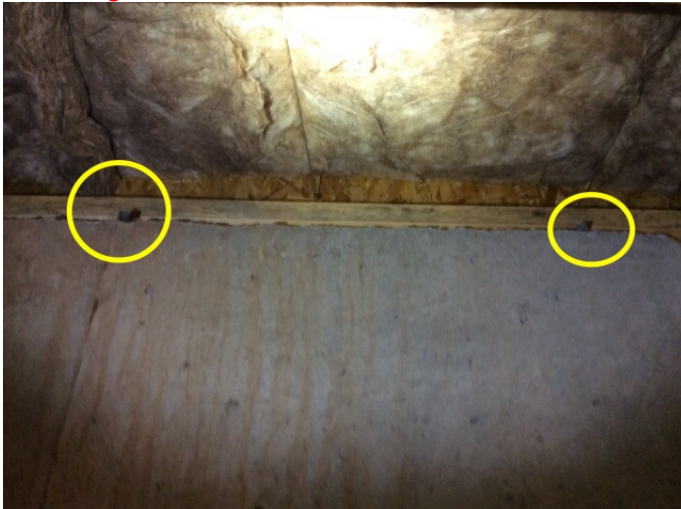
MUDSILL

RE 36: - Two sill plate anchor straps were found unattached at the left side front basement and required fastening.

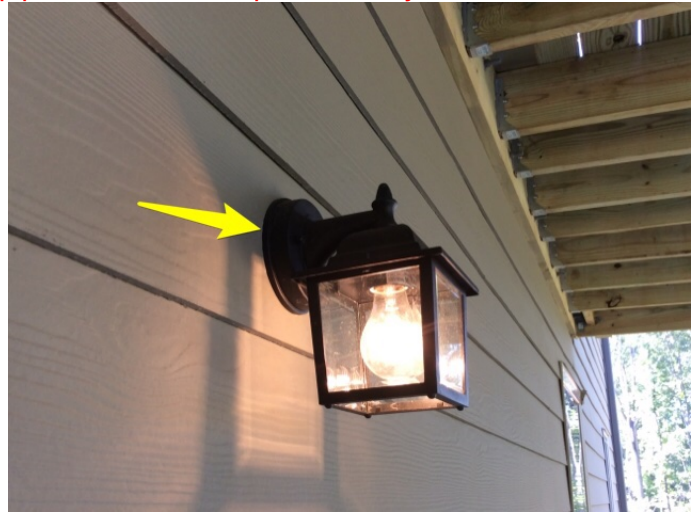
front right corner above front porch metal roof

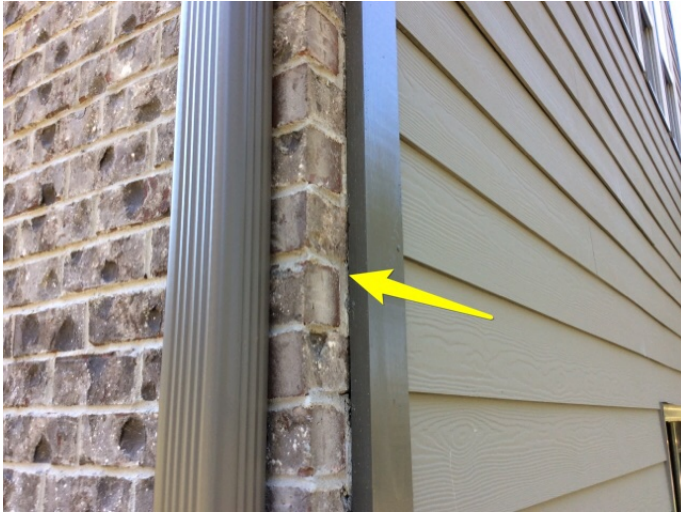
rear right corner siding and trim/brick junctions

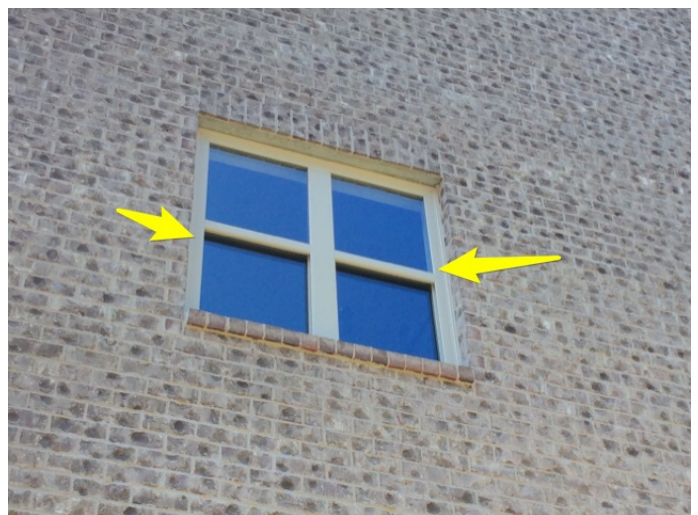
around all window trim/brick junctions at left side 2

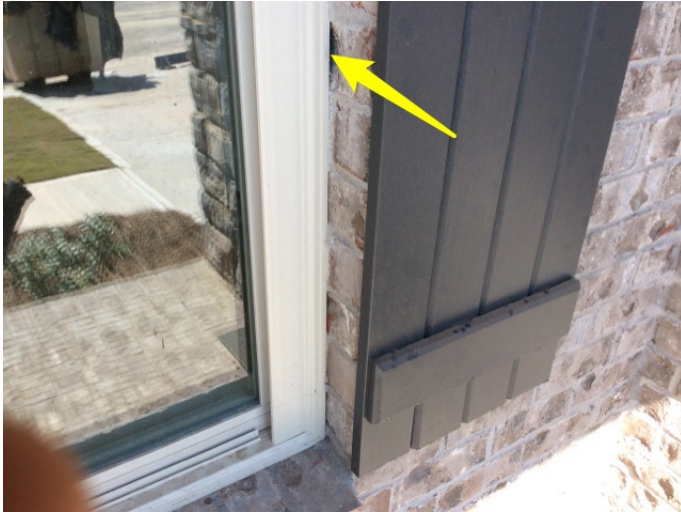
around all window trim/brick junctions at right side 1

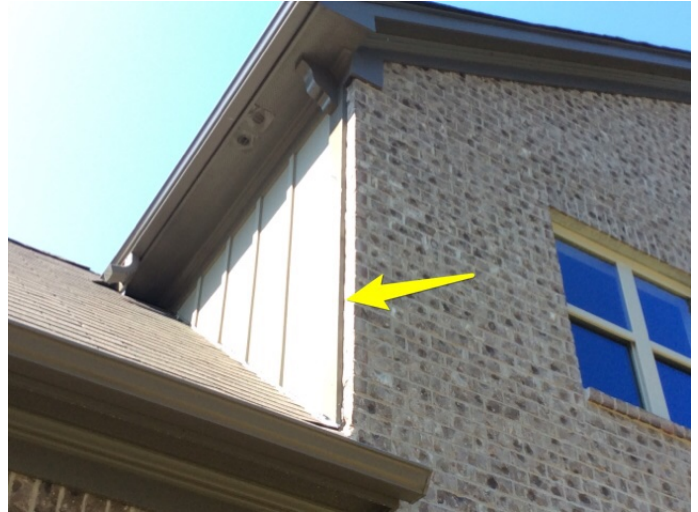
around all window trim/brick junctions at front 4

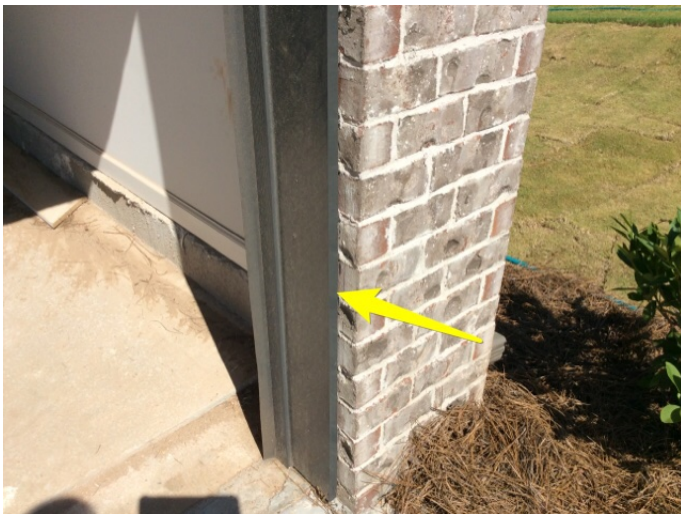
at trim/brick junction front right corner

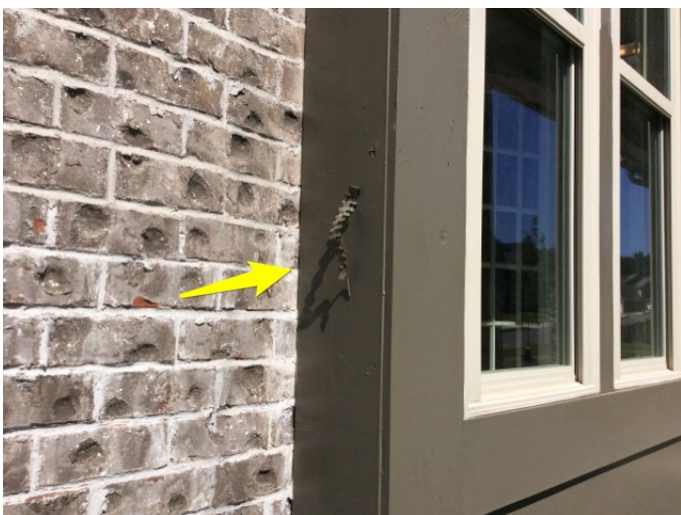
around front porch column base trim/stone junctions

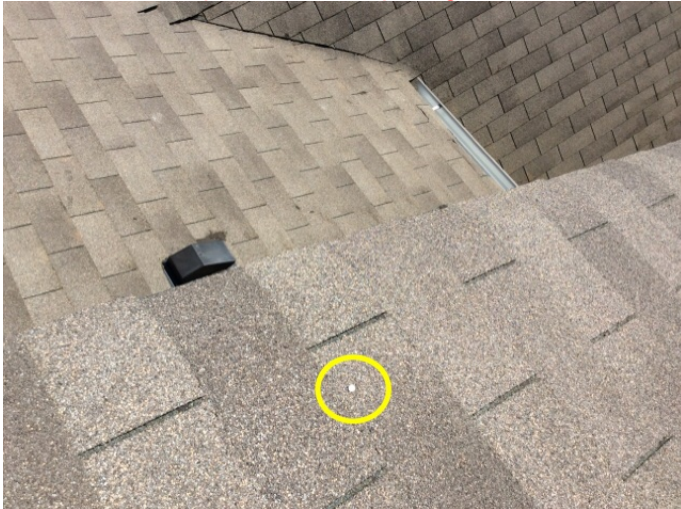
RE 59: - An exposed nail requiring sealant was observed at the front right edge of the main roof.

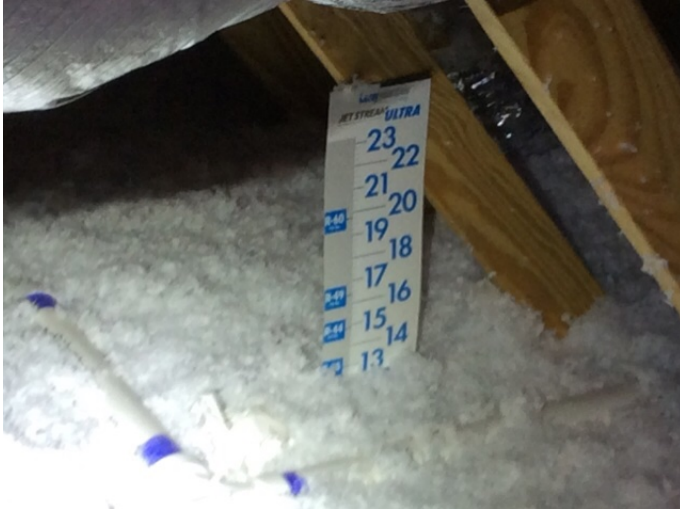
ATTIC INSULATION

76: - The level of insulation approximately 12-13 inches in the attic would appear to provide about R-30 insulating value. This provides very good resistance to heat transfer by present standards. Note, the R-value is less where attic flooring is installed.

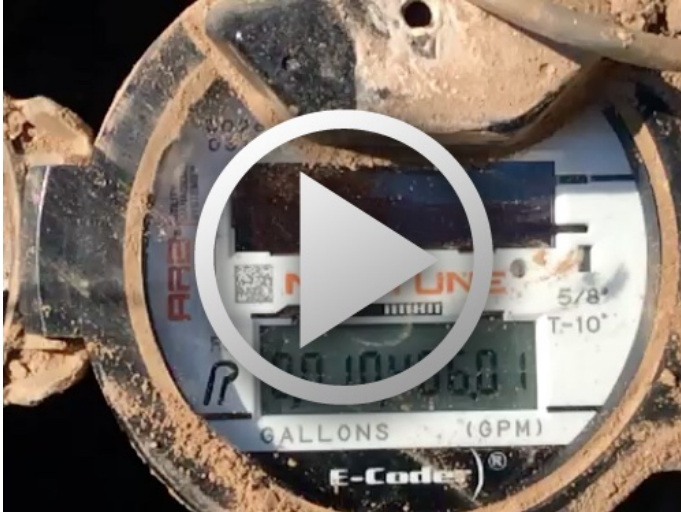
WATER METER

138: - Location of water meter was at the front left of the lot. The video shows the meter not moving while all water is turned off, indicating there were no leaks in the main pipe or supply piping at the time of the inspection.

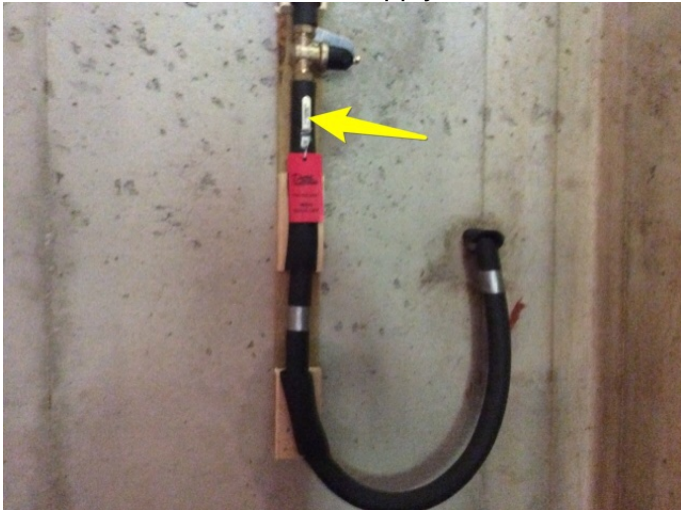
WATER SHUT-OFF LOCATION

139: - The domestic water supply main shut-off valve was located in the front wall in the left basement.

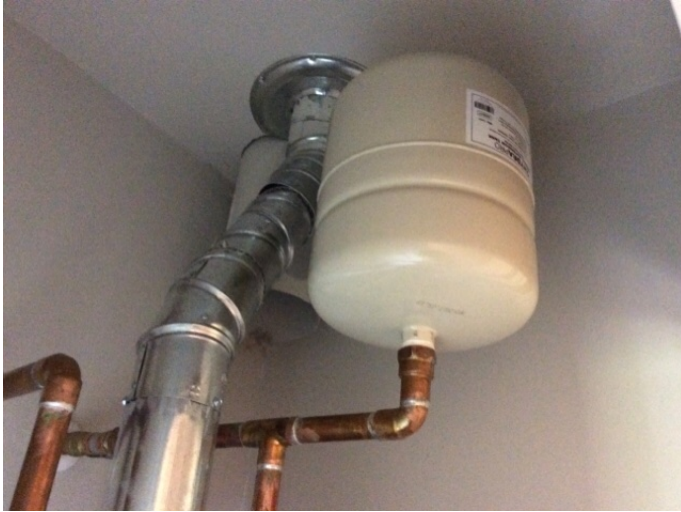
EXPANSION TANK/DEVICE

155: - The water heater is equipped with an expansion device that appears properly installed and in serviceable condition. However, review of this equipment functionality is beyond the scope of this inspection.

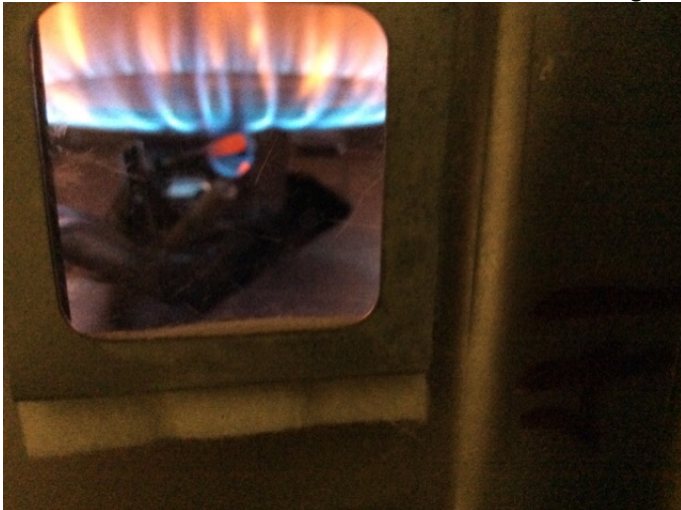
BURNERS

157: - The burner and burn chamber was found generally clean and appears to be in serviceable condition.

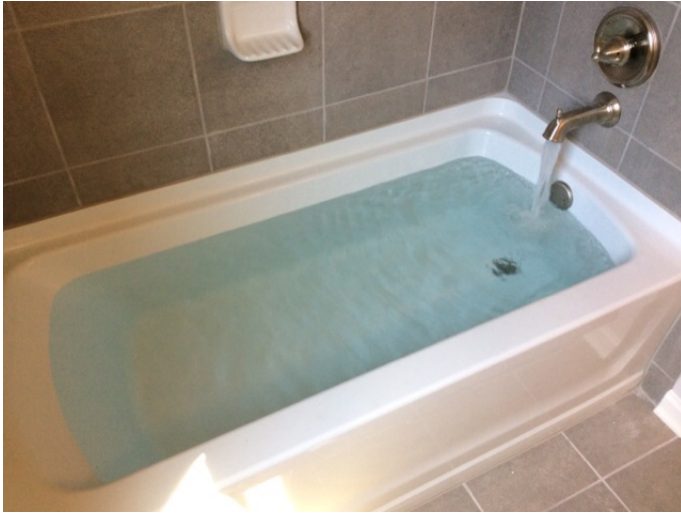
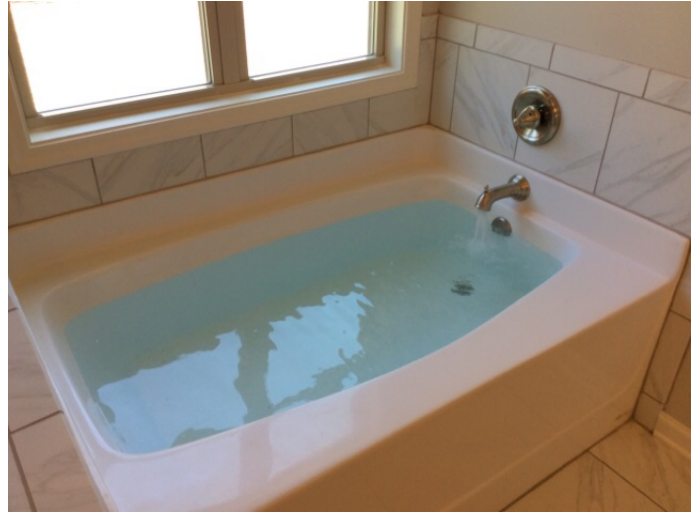
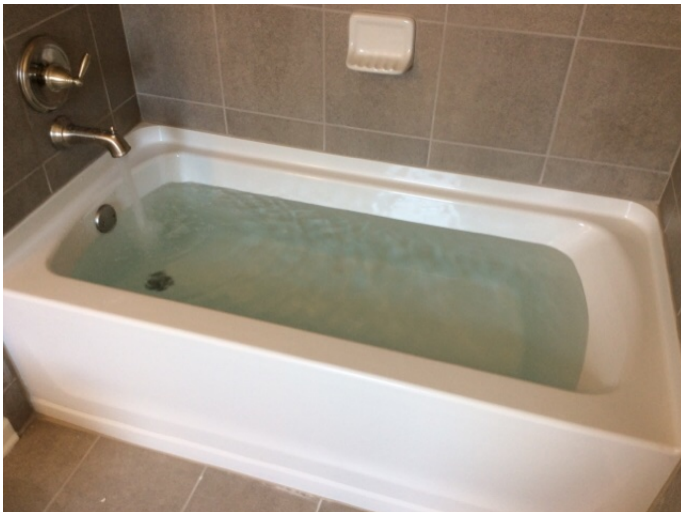
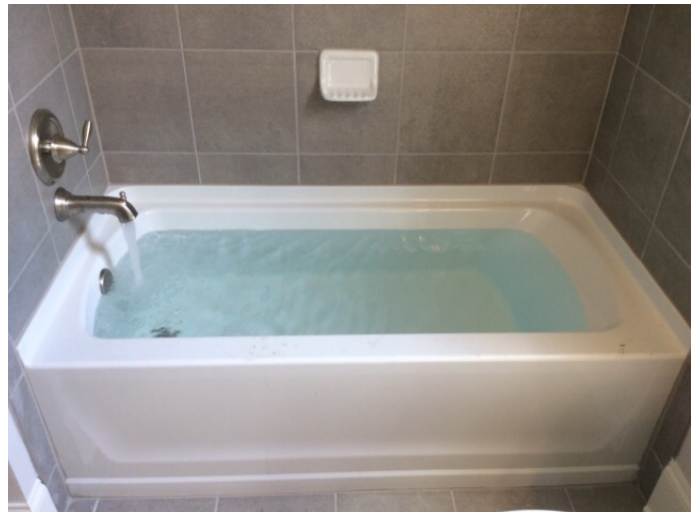
160: - All bathtubs were filled to the overflow for the inspection and appear to be properly installed and in serviceable condition.

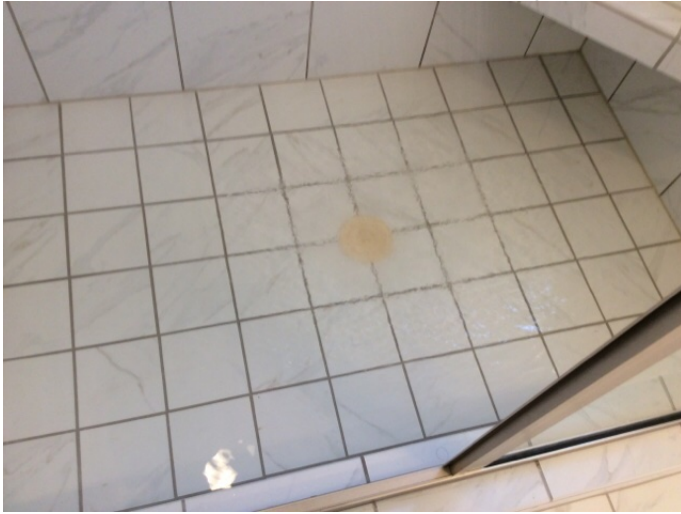
161: - The showers were filled for the inspection and appeared to be in serviceable condition.

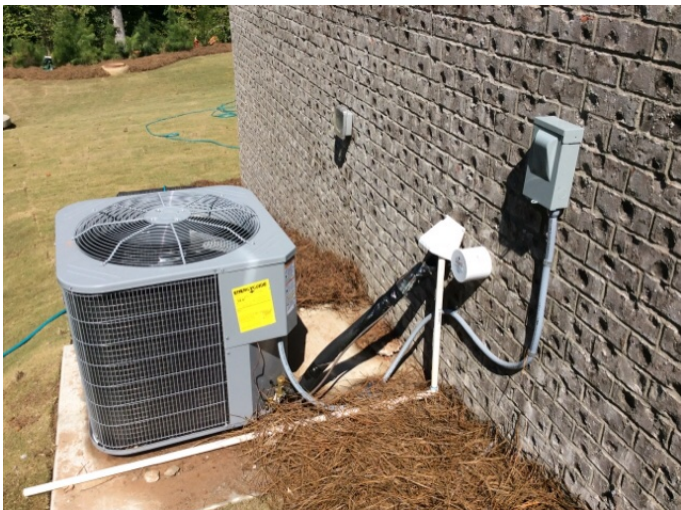
165: - Condenser location: Left side of structure

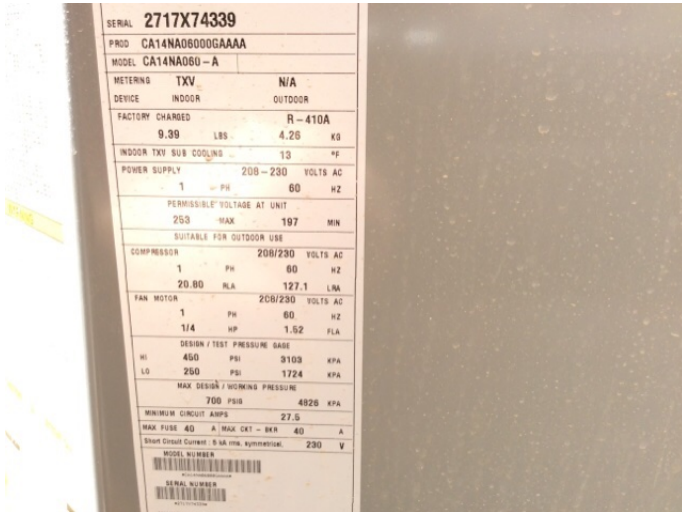
- 166:** - Number of units: 1
167: - Equipment configuration: Split or remote system
168: - Unit was dated 2017

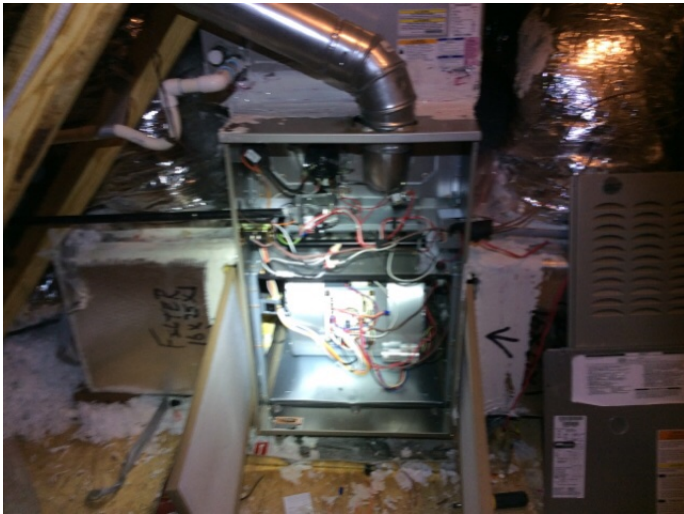
178: - Furnace location: Attic

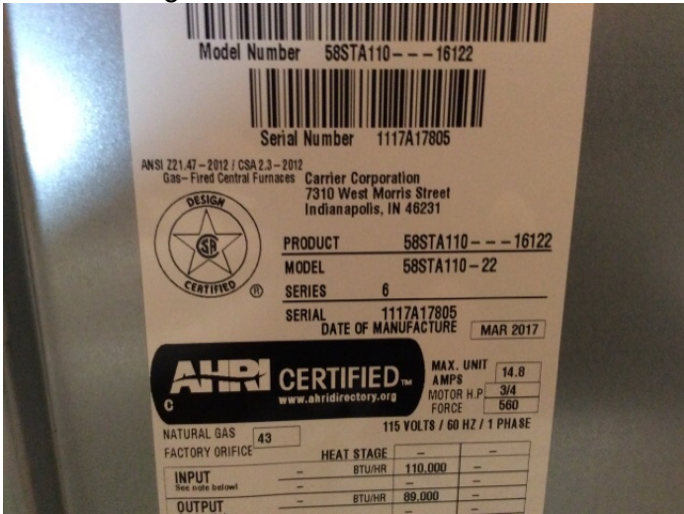
NE 179: - Age: 2017 new

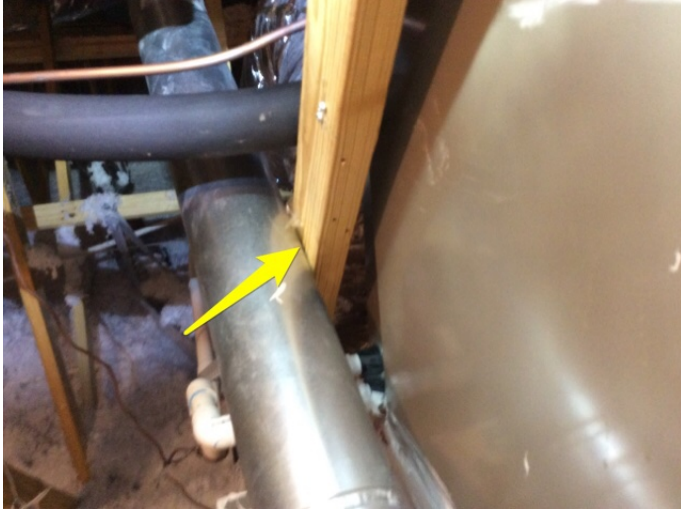
SA RE 185: - Contact with and lack of 1" required clearance from combustible materials (wood truss) was observed at the attic gas furnace flue exhaust pipe. Recommend a licensed HVAC reconfigure the pipe direction to maintain at least a 1" clearance from combustible materials.

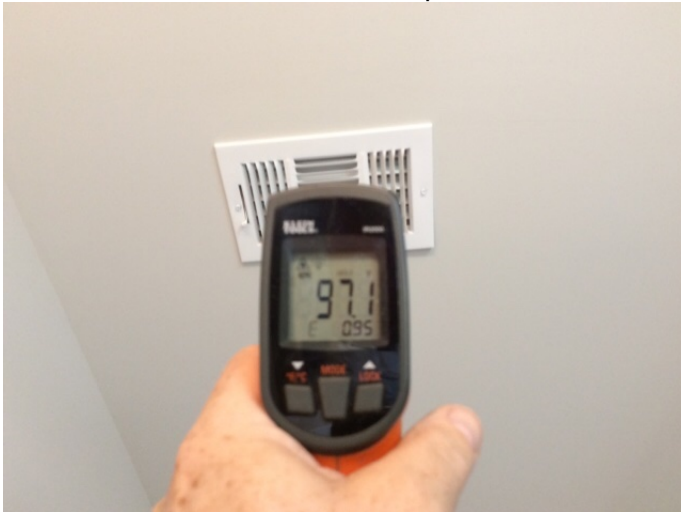
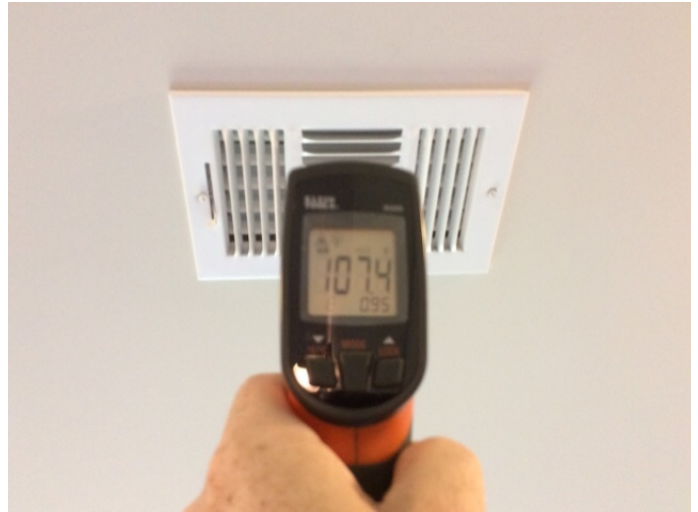
186: - GREAT NEWS: The zoned furnace system was observed to operate serviceably in heating modes when tested with normal operating controls and the ducts, registers and air flow were observed to be serviceable at the time of the inspection.

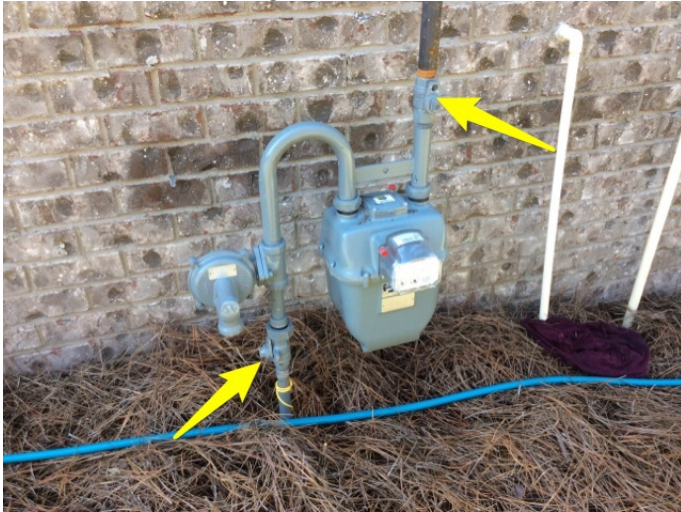
188: - The gas meter was located outside on the right side of the home. The main gas supply shutoff valve is located on the riser pipe between the ground and the meter and should be turned 90 degrees (either way) in order to shut off the gas.

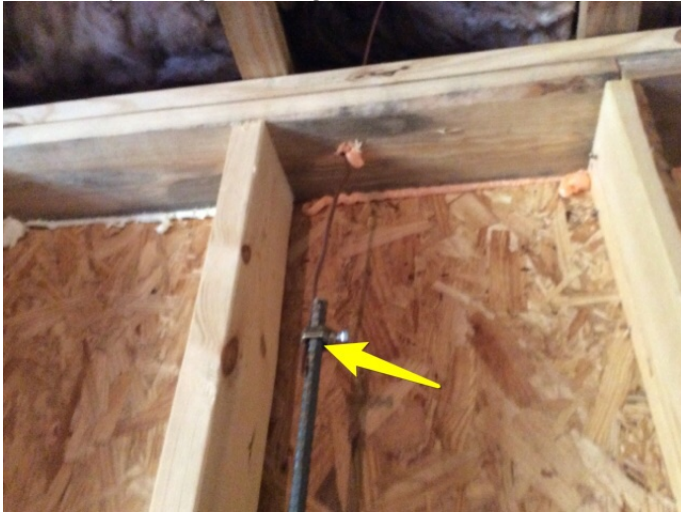
194: - System grounding source: Foundation steel - ufer

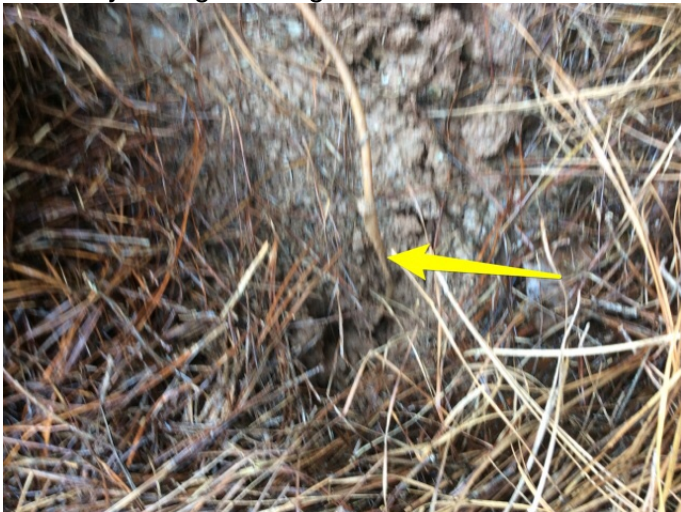
195: - System grounding source: in soil

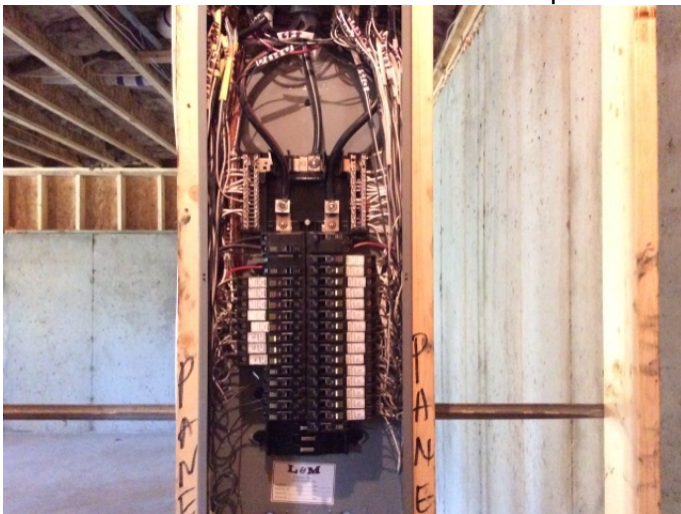
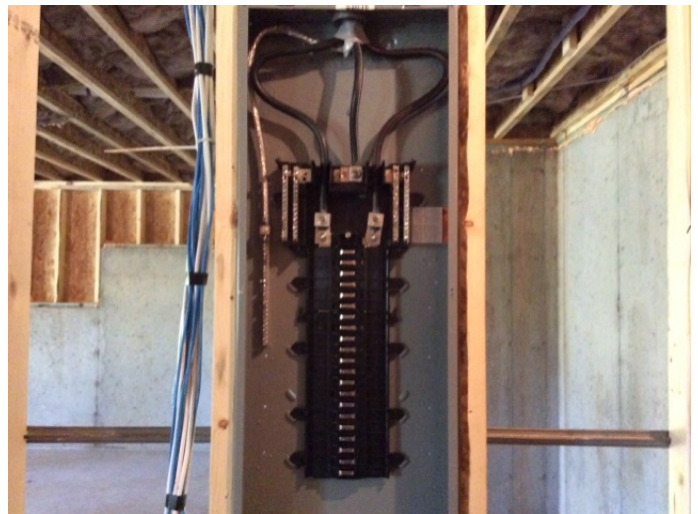
200: - GREAT NEWS! The 200 x2 amp electrical distribution panels, system earthing, panel bonding, isolation of neutral / grounding circuit wires, and circuit breaker size / circuit breaker ampacity were observed to be in serviceable condition at the time of the inspection.

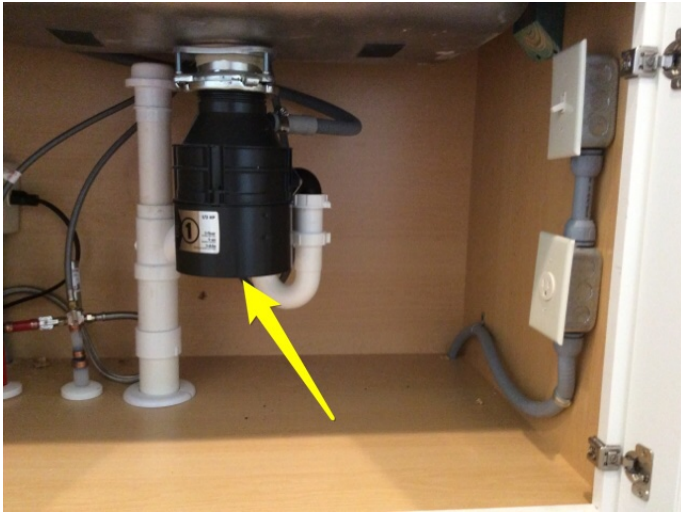
RE 201: - The kitchen sink disposal did not have electrical wires connected and requires correction by a licensed electrical contractor.

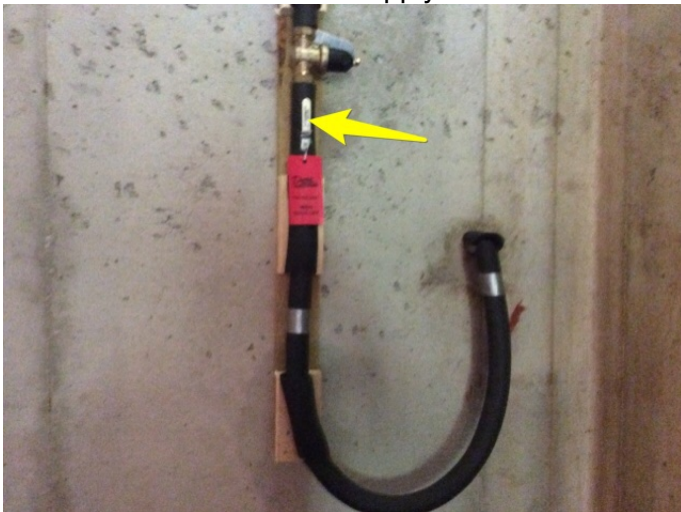
208: - The domestic water supply main shut-off valve was located in the front wall in the left basement.
